EPA-R2-73-142
JANUARY 1973

Water Infiltration Control to Achieve Mine Water Pollution Control

WATER INFILTRATION CONTROL TO
ACHIEVE MINE WATER POLLUTION CONTROL
A FEASIBILITY STUDY

Project 14010 HHG

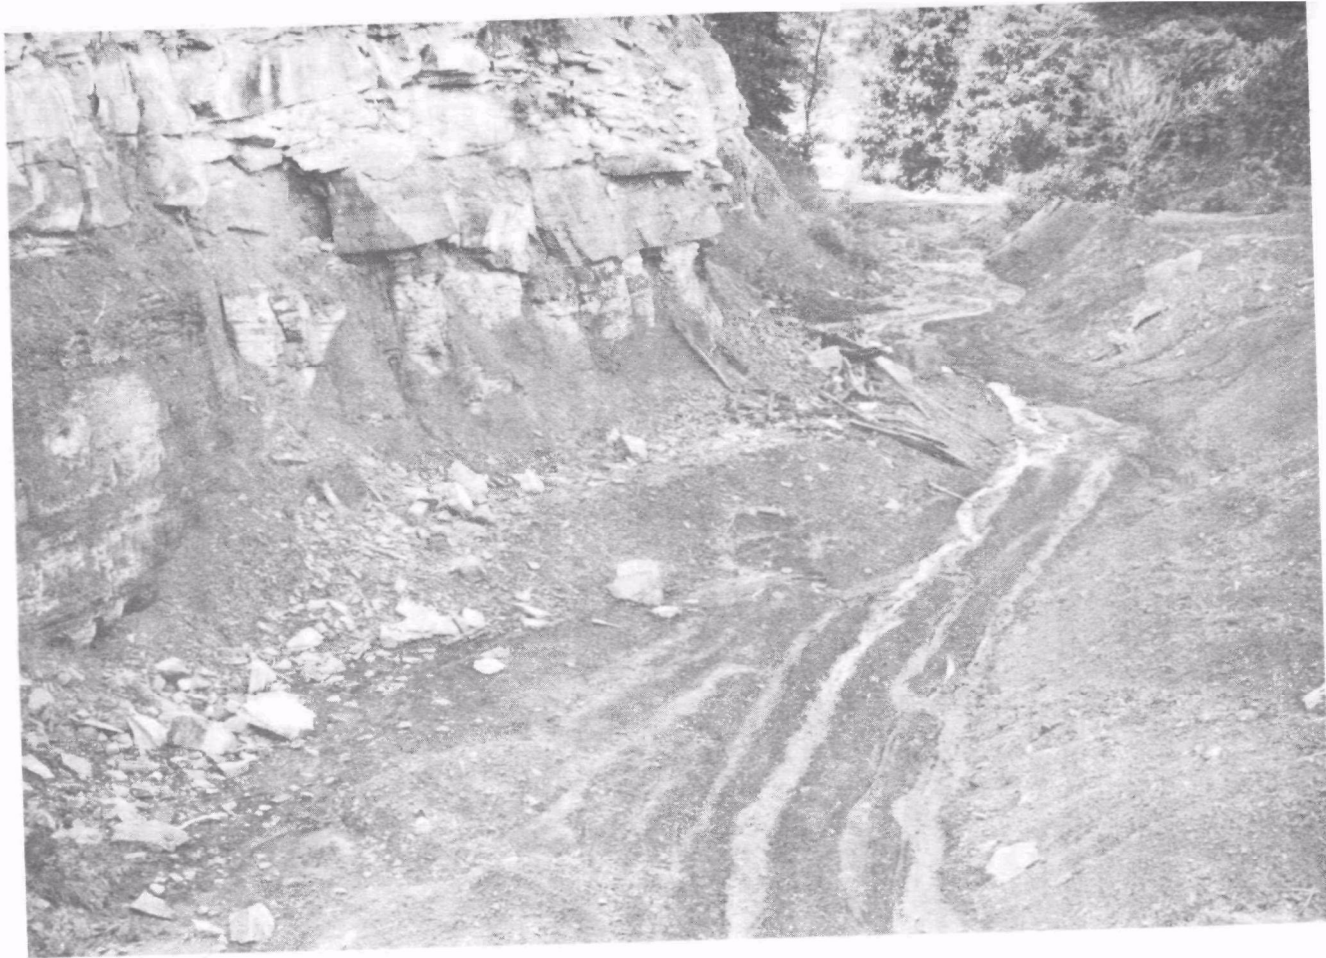
HIGHWALL AND BENCH SHOWING SURFACE WATER RUNOFF
SECTION C, STRIP AREA C
FIGURE 23

The total length of this strip area is approximately 2600 feet, the width of the bench varies from one hundred to one hundred fifty feet, and the height of the highwall is approximately fifty feet. The condition of the highwall is very solid, which indicates that there have been no drift mine interceptions in this area. With the exception of approximately 500 feet in the northwestern portion of this strip area, most of the strip has been backfilled with the slope toward the highwall. This area has apparently been planted in grasses which are just beginning to grow. The outslope, however, has no vegetative cover and the condition of this area is very rough. The northwestern section of this strip area has not been backfilled and the base of the highwall has apparently been extensively auger mined. Since the auger mining would have been to the dip in this area, all surface drainage eventually enters these auger mines. Figure 23 shows a portion of this area with associated surface water runoff. This entire strip area will probably be visible from Interstate 79. Reclamation work required at the site should include earth compaction seals in each of the auger mine openings to prevent surface water infiltration, regrading of the spoil bank and outslope in the northwestern portion of the strip to a contour backfill, planting of the area in some species of trees or grasses.

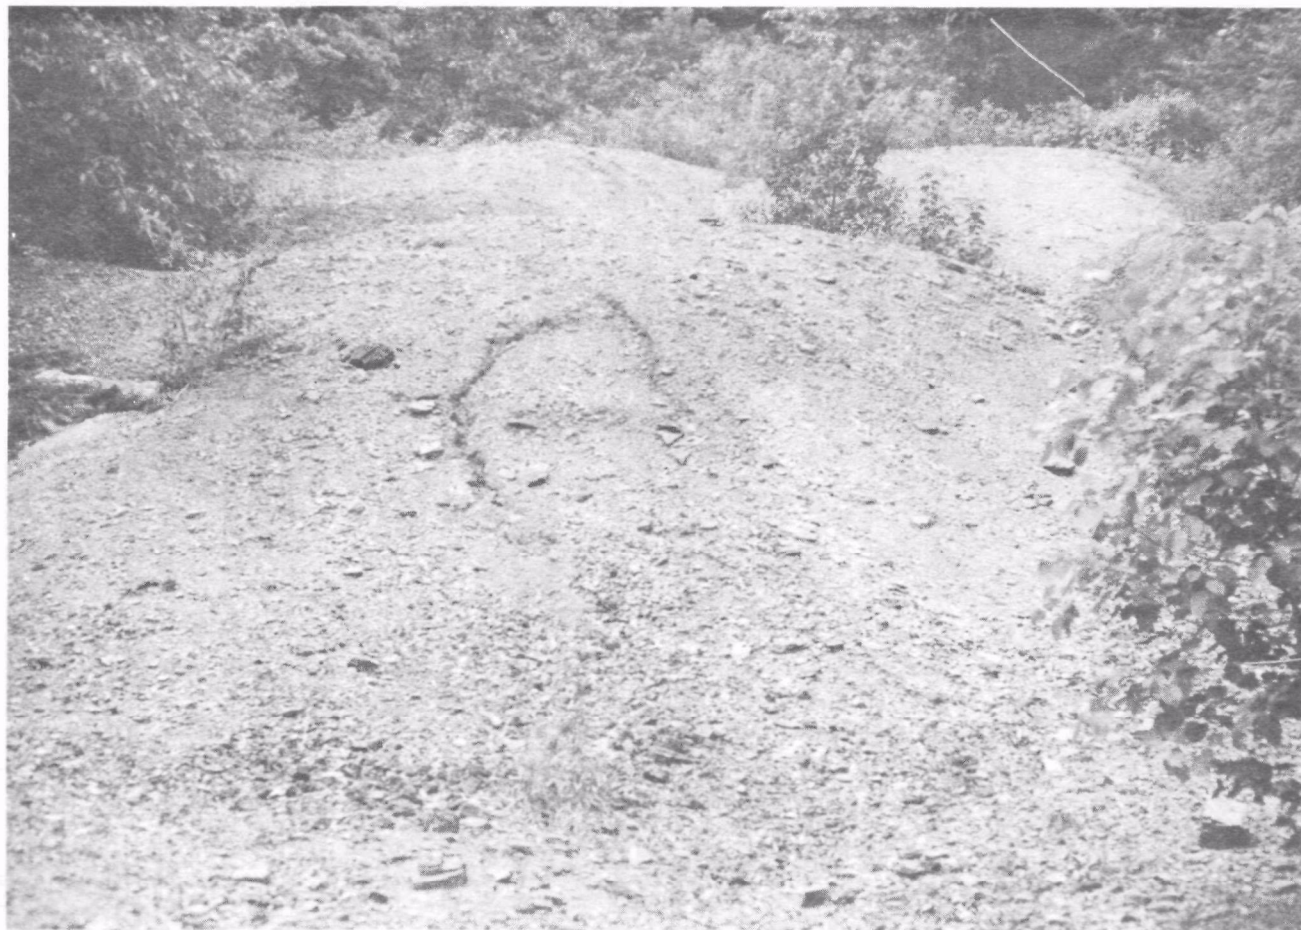
ABANDONED REFUSE DUMP
SECTION C, STRIP AREA S
FIGURE 25

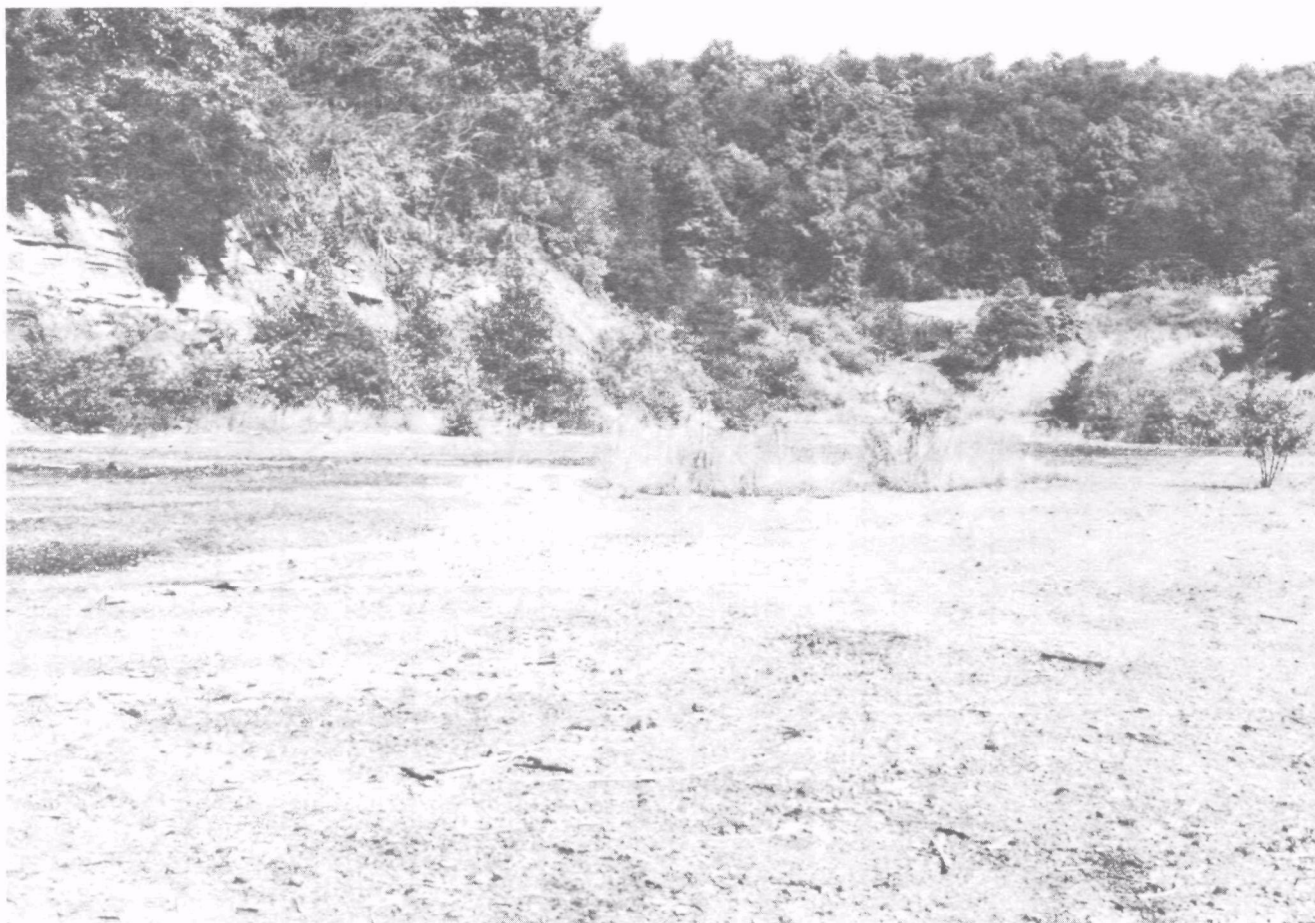
REGRADED BENCH AREA SHOWING LACK OF VEGETATION
SECTION G, STRIP AREA C
FIGURE 28

The height of the existing highwall in strip area C is twenty to twenty-five feet, the width of the bench varies from fifty to three hundred feet, and the height of the outslope is twenty to thirty feet. The total length of the strip is approximately fifteen hundred feet. The area has been backfilled with a slight dip of the backfill toward the highwall. The condition of the outslope is fairly smooth; however, there is no vegetative cover on the outslope or the bench (see Figure 28). There are no visible drift mine openings or interceptions in the area. There is evidence of surface runoff and, judging from the iron stains on the bottom of the stream bed, the drainage is acidic in nature. The location of the strip represents the headwaters of stream M7-3. The total drainage from all of the

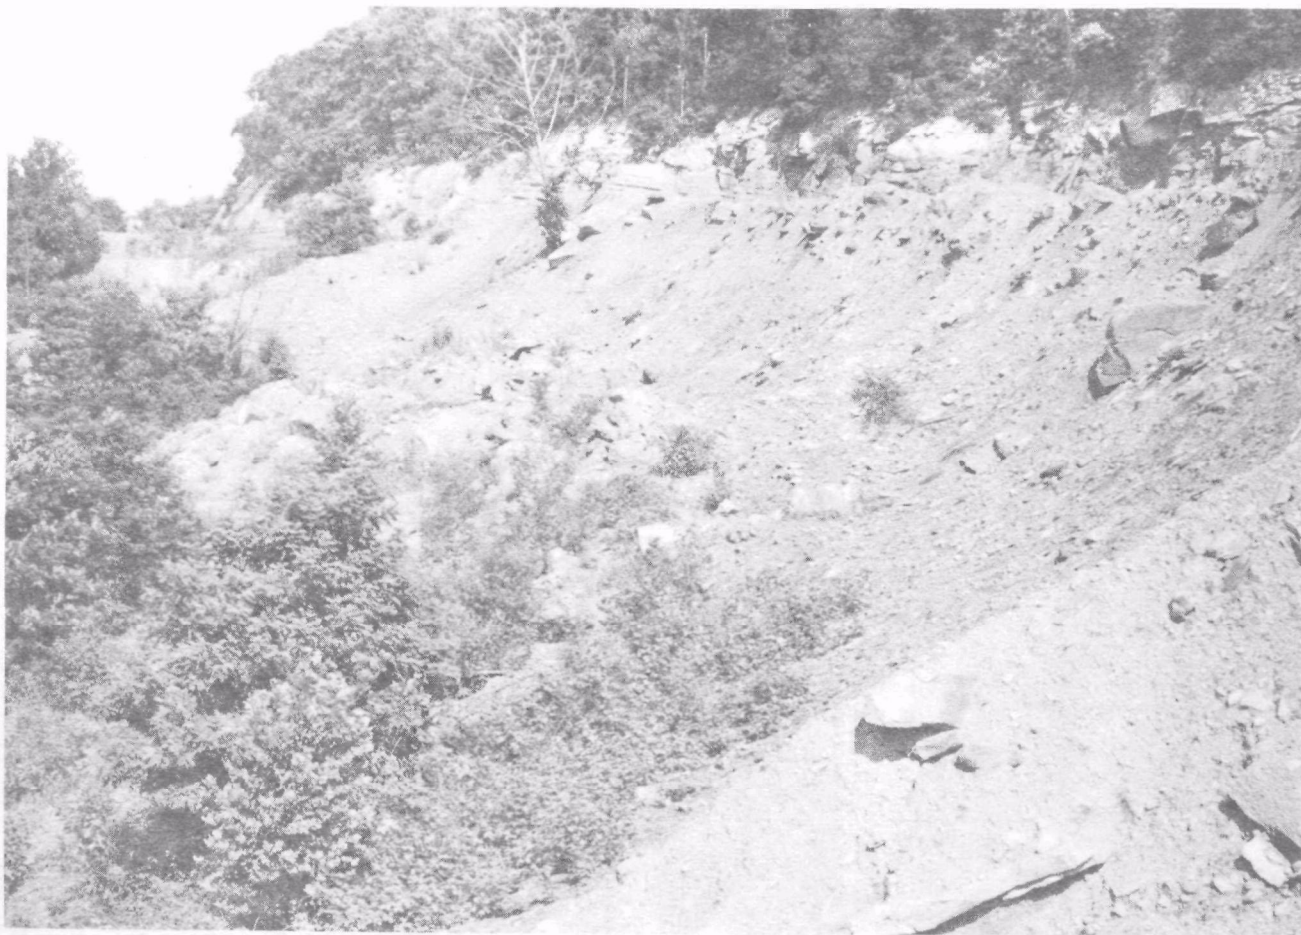
TYPICAL CONDITION OF "REGRADED" OUTSLOPE
SECTION G, STRIP AREA Q
FIGURE 31

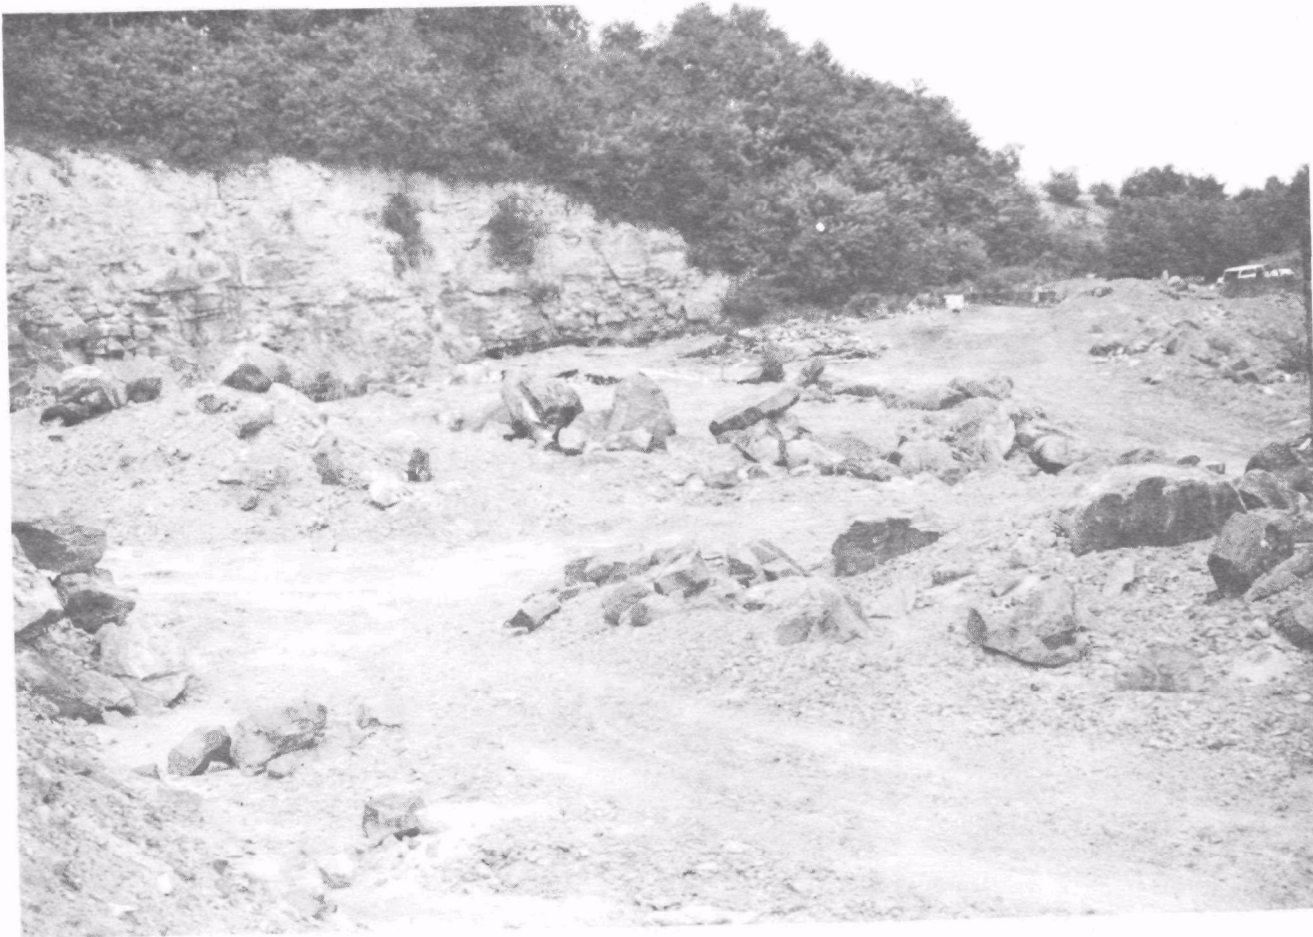
TYPICAL CONDITION OF BENCH AND HIGHWALL
SECTION G, STRIP AREA R
FIGURE 34

The highwall in the east section is forty to fifty feet high, the width of the bench is approximately two hundred fifty feet and the outslope is forty to fifty feet high. The strip mine has not been backfilled, and there is no vegetative cover on either the bench or the outslope in this area (see Figure 34). There is considerable solid waste in the area which could probably be buried in the highwall when the strip area is backfilled. The highwall is highly fractured in certain areas due to extensive auger mining. There are twenty visible auger openings (see Figure 35). It is estimated that there may be as

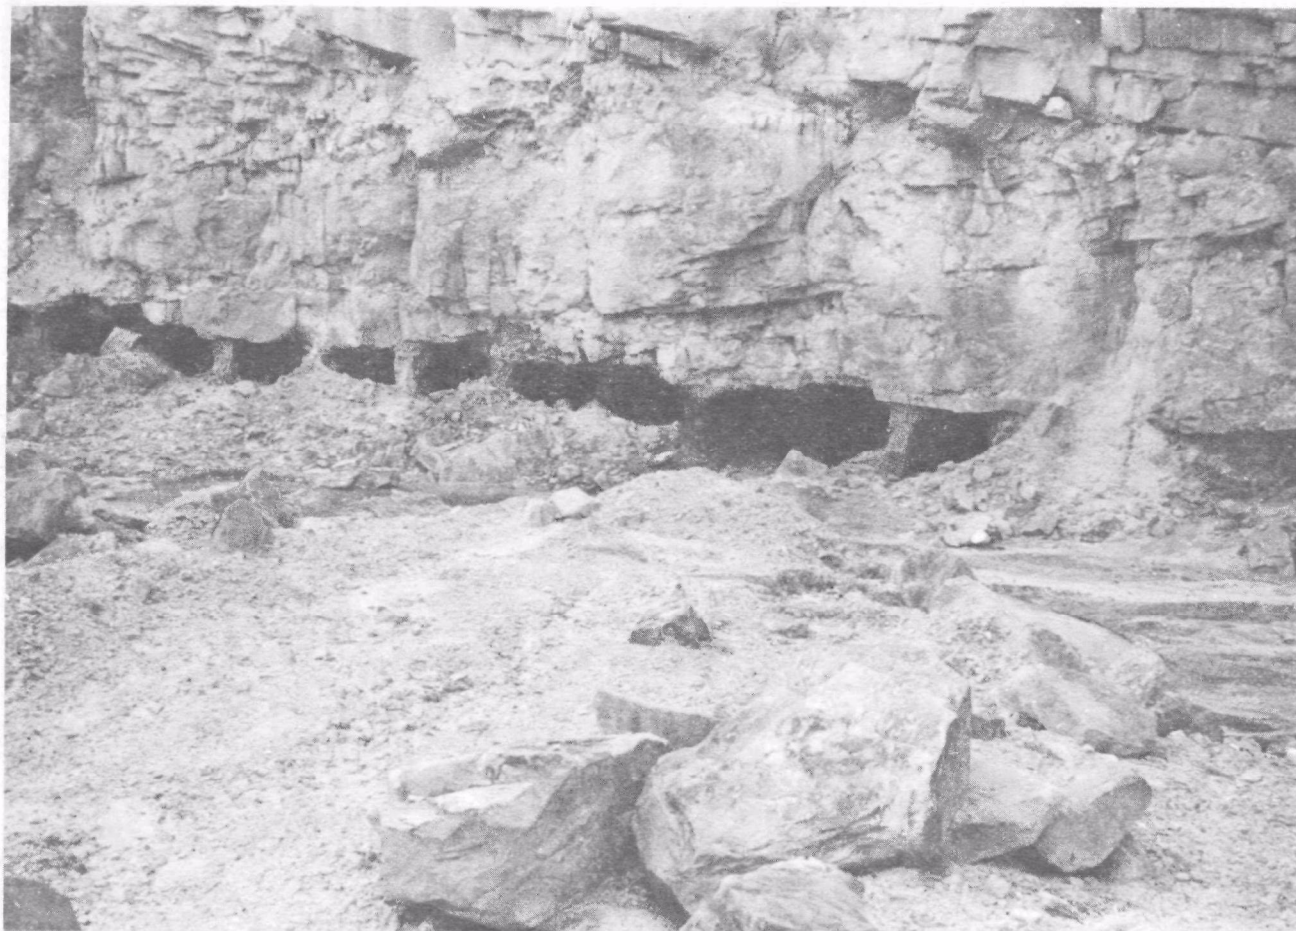
TYPICAL AUGER OPENINGS
SECTION G, STRIP AREA R
FIGURE 35

many as sixty additional openings; however, material has fallen from the highwall and partially covered most of these, making it impossible to determine the extent of auger mining in the area. There is evidence of water infiltration into the auger openings; however, no active drainage was observed at the time of this investigation.

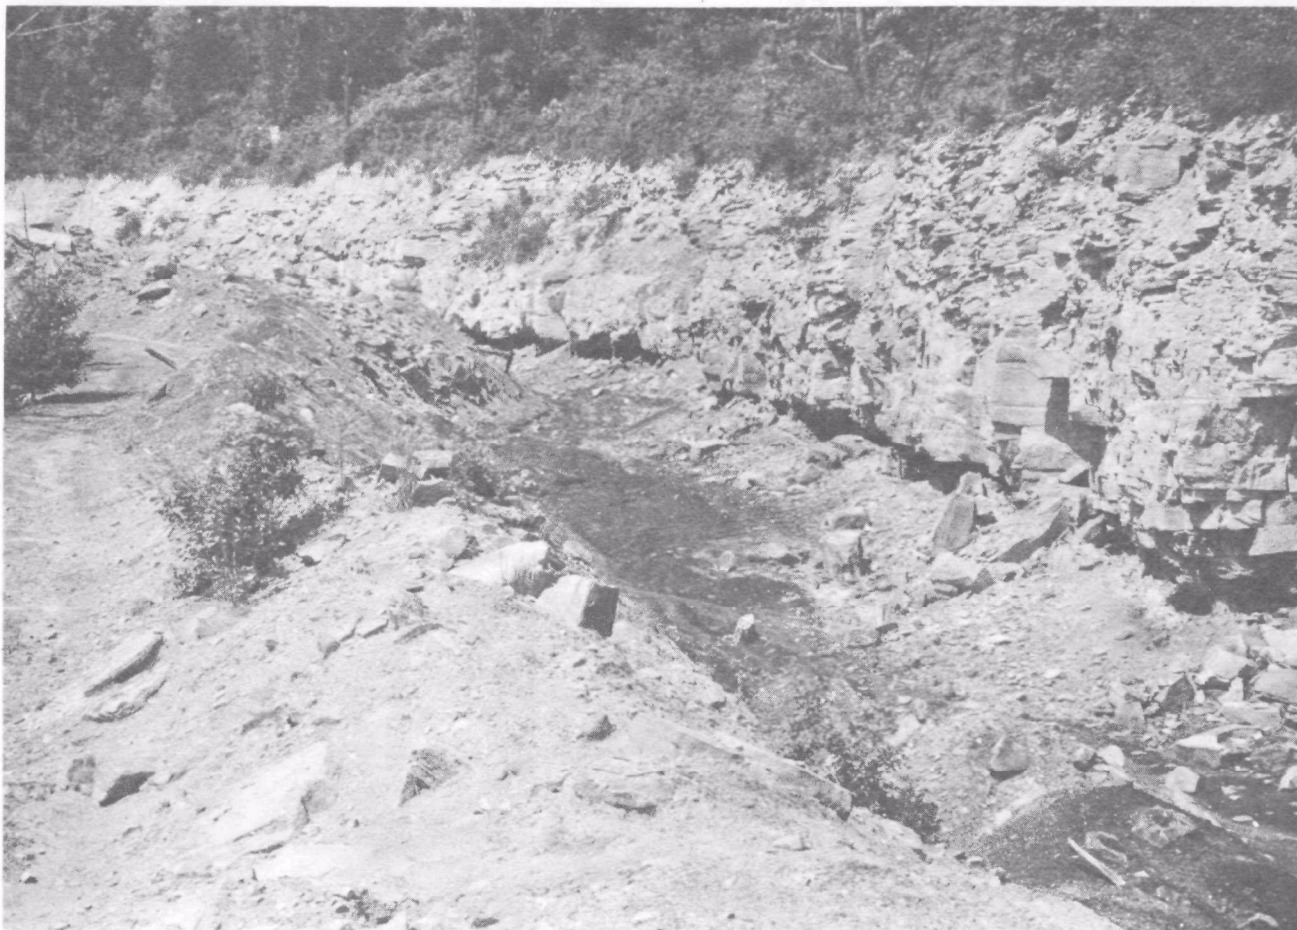
FRACTURED HIGHWALL RESULTING FROM EXTENSIVE AUGERING
SECTION G, STRIP AREA R
FIGURE 36
