SURFACE COAL MINING IN THE NORTHERN GREAT PLAINS OF THE WESTERN UNITED STATES

**AN INTRODUCTION AND INVENTORY UTILIZING AERIAL PHOTOGRAPHY
COLLECTED IN 1974-75**

**ENVIRONMENTAL PROTECTION
AGENCY**

June, 1976

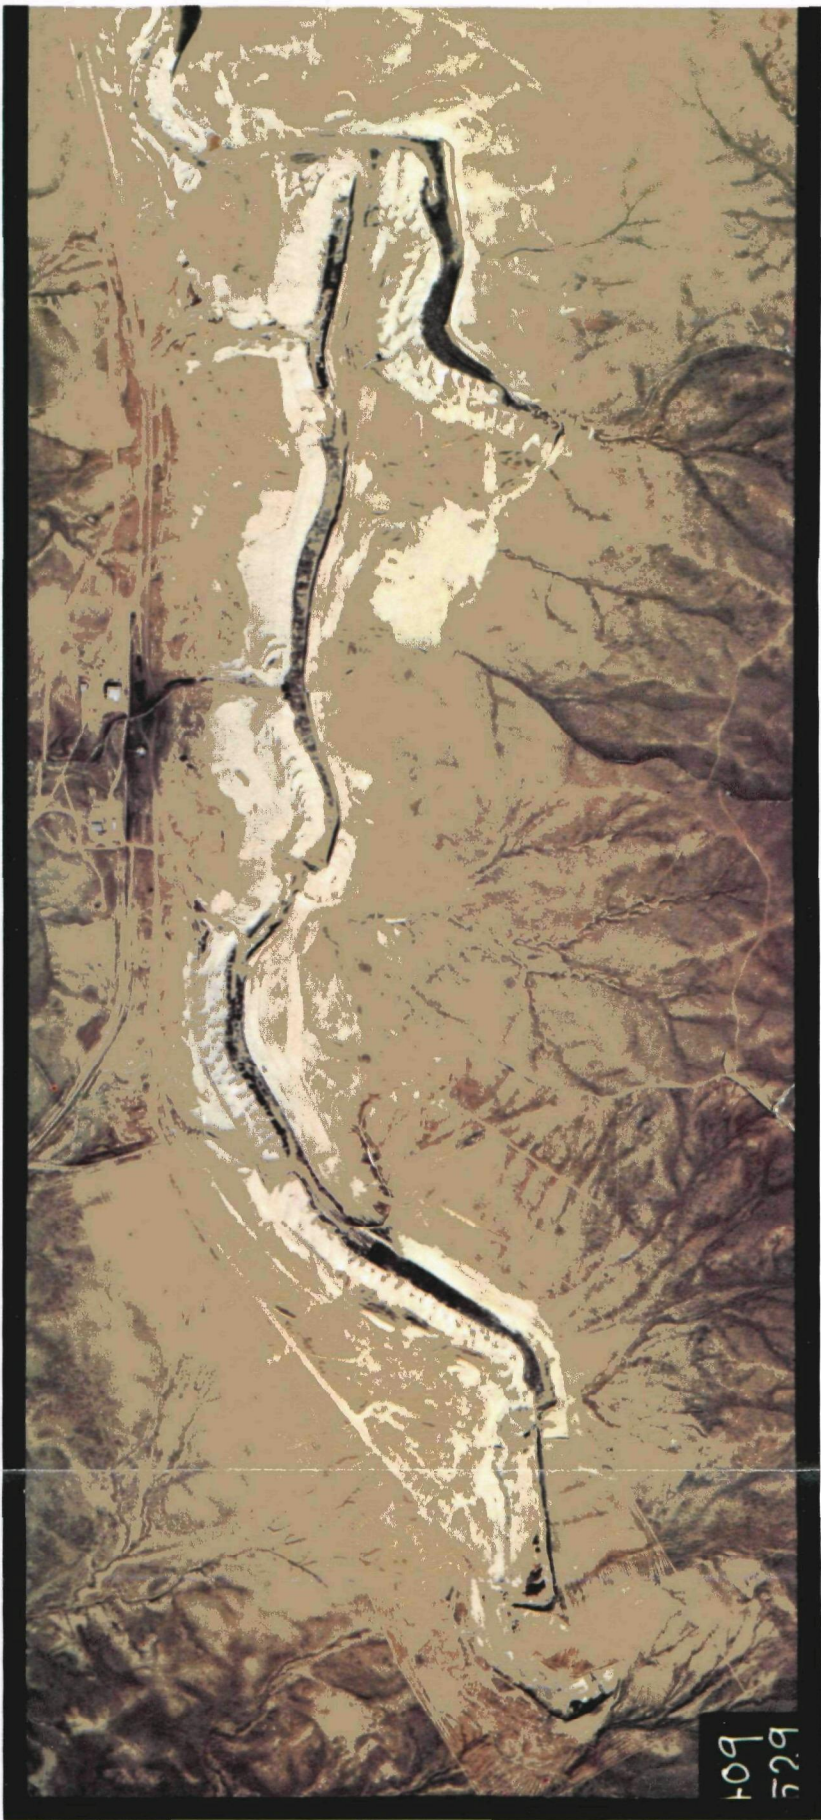
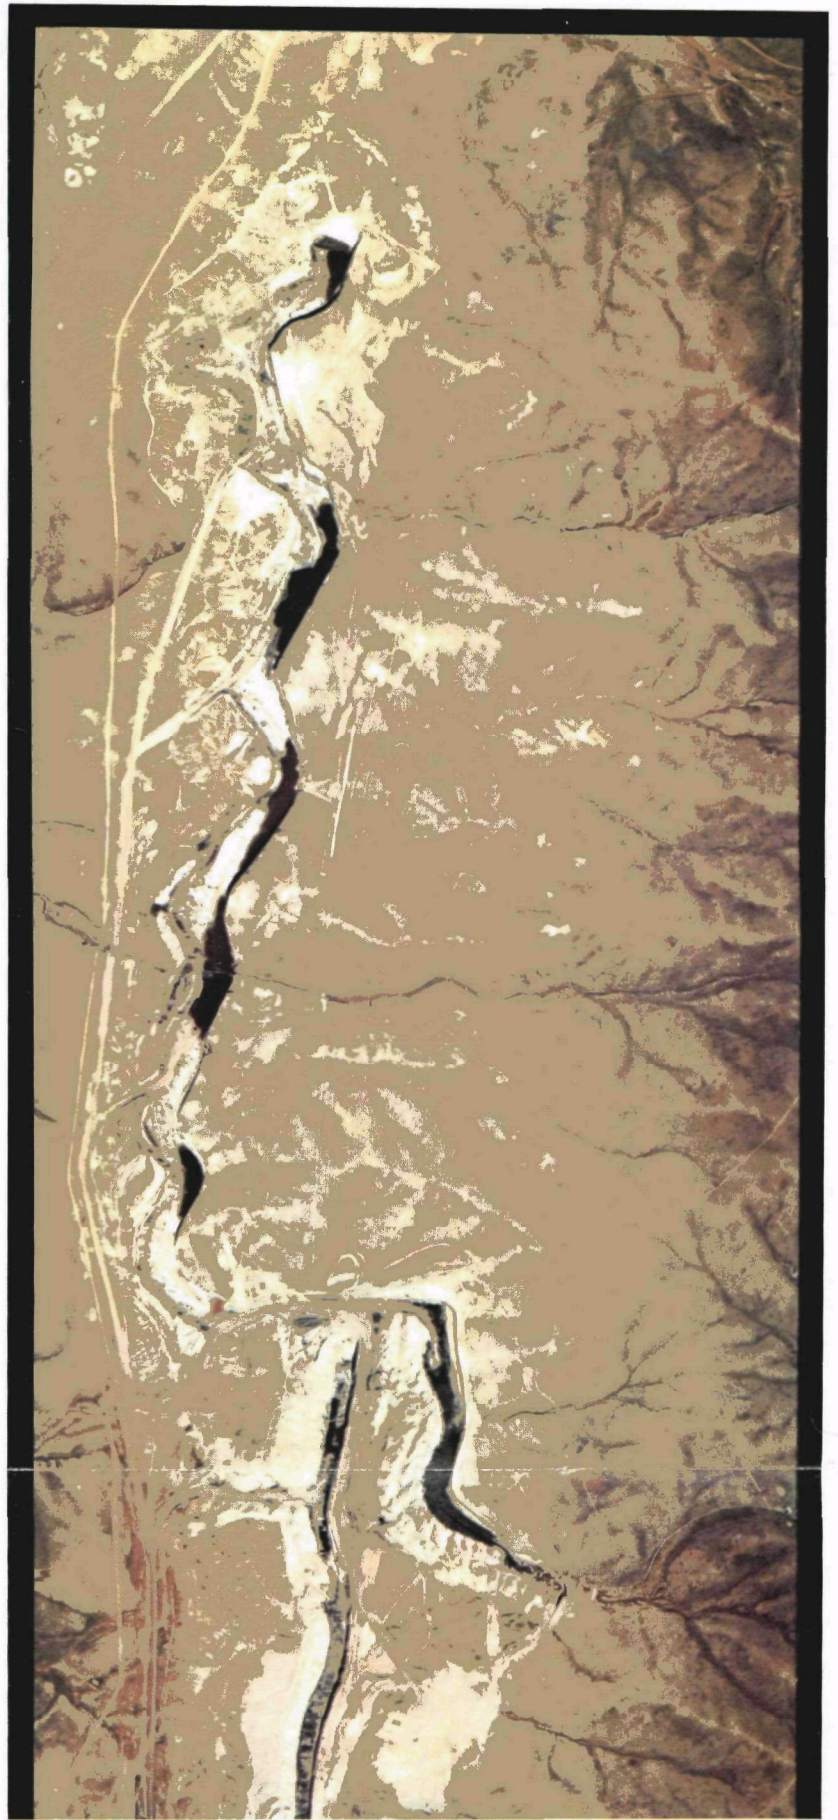
PLATE 2

DAVE JOHNSTON MINE
 Pacific Power and Light
 Converse County, Wyoming
 29Jul74

The Dave Johnston Mine, or "Dave Johnston Fuel Recovery Pit" as it is formally called, takes on the appearance of a snake and is represented here in both true color and color infrared photography. The true color photograph (Plate 2) is a low altitude mosaic collected on 29 July 1974. The color infrared film was exposed at an altitude of 17,450 meters (57,200 feet) on 28 January 1975. The mine is also the subject of an investigation of the applicability of satellite imagery (See Chapter 6). This mine is considered a "captive mine" and ships coal by rail to the Dave Johnston Power Plant nearby at Glenrock, Wyoming.

Comparison of the two photographs (Plates 2 and 3) facilitates an assessment of mining and reclamation progress. The separate pit on the northeast side of the mine has progressed north and east and additional excavation has been performed preparatory to mining the deeper bed. Grading activities east of the loading area have been extended toward the pit and emergent vegetation can be seen north of the loading area near the pit. In the newer pit area, spoil has been placed on the high-wall side (Plate 3).

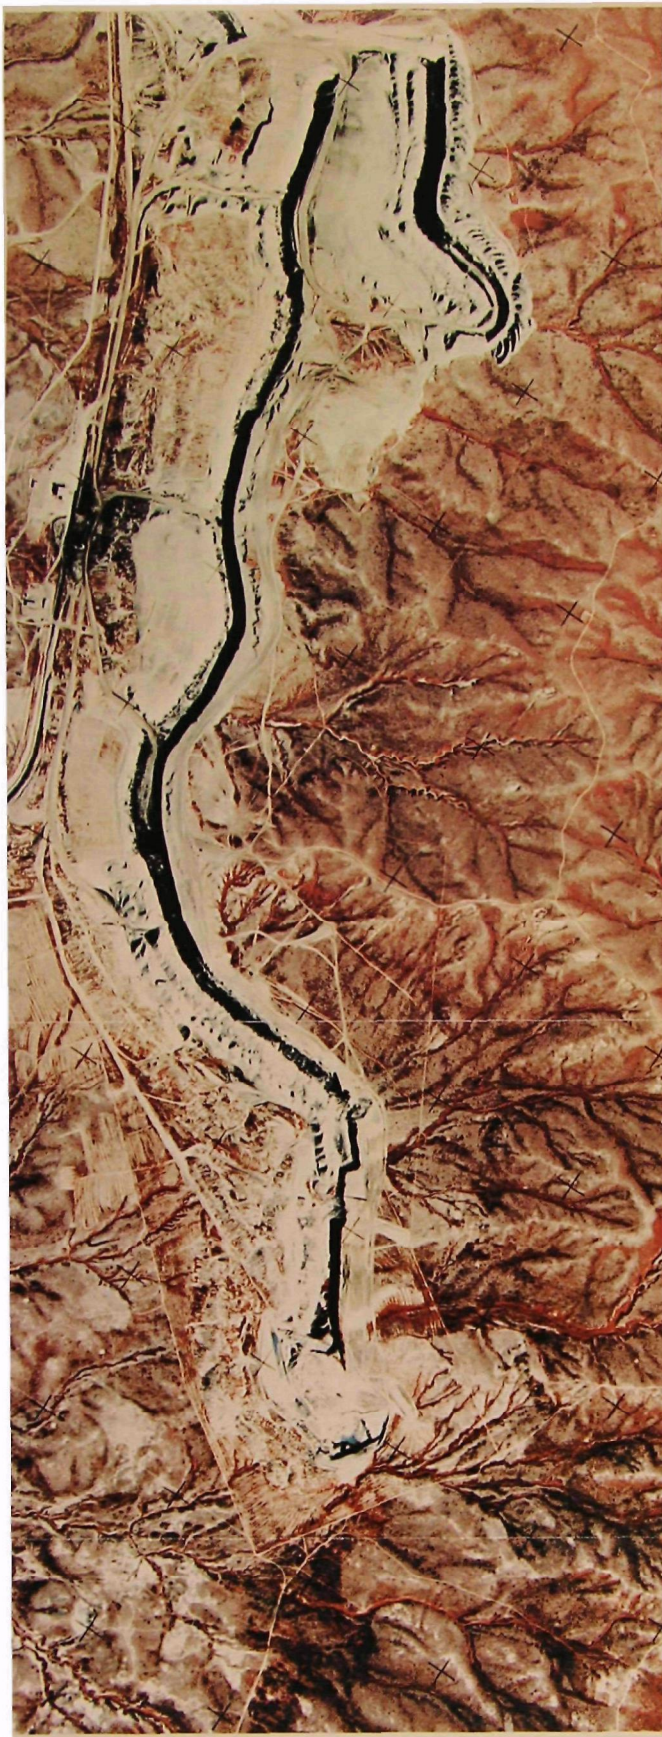
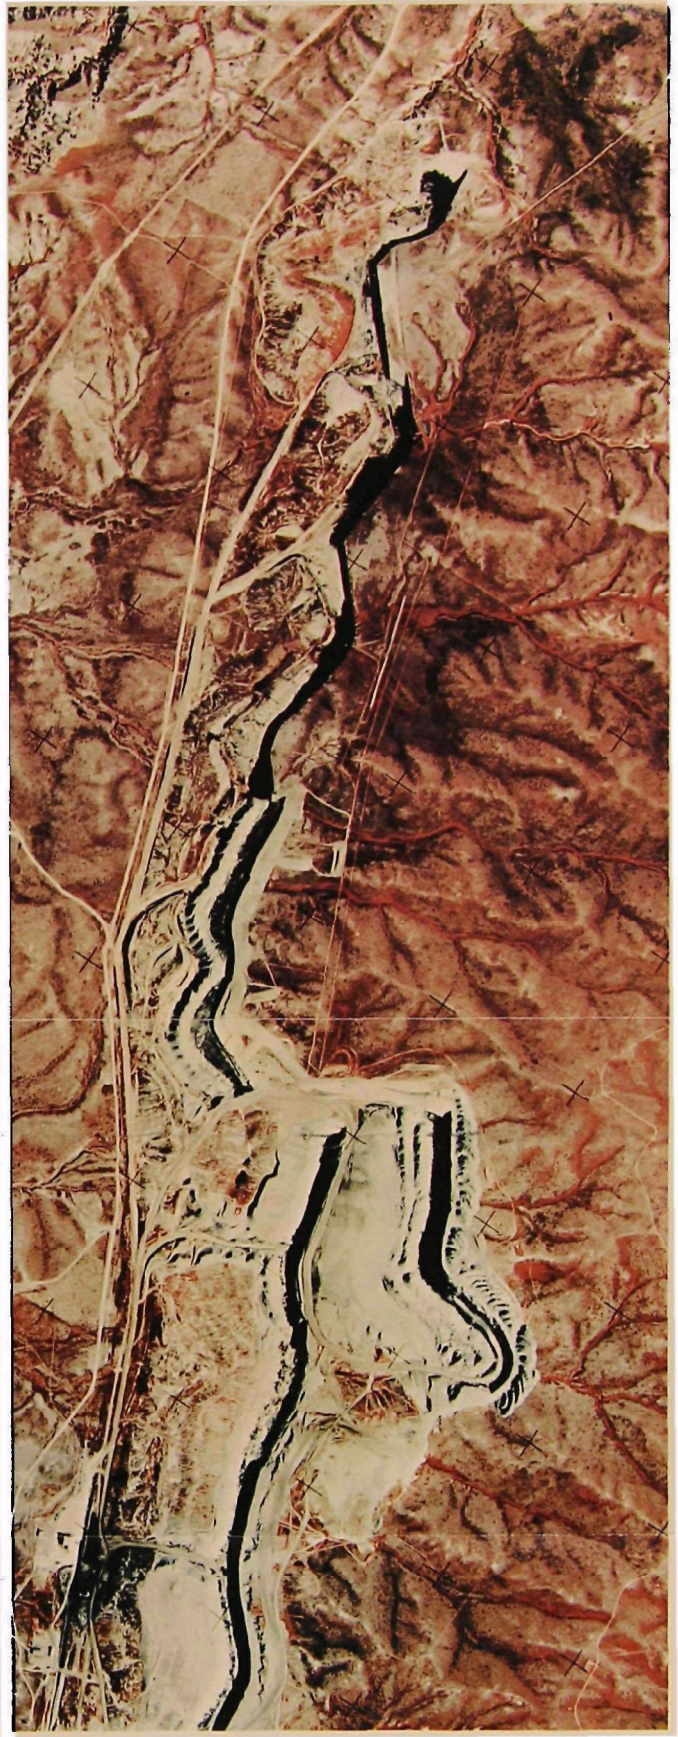
PLATE 3

DAVE JOHNSTON MINE
 Pacific Power and Light
 Converse County, Wyoming
 28Jun75 Color IR High Alt.

This mine is represented in two sets of aerial photography; true color flown on 29 July 1974 and color infrared collected from an altitude of 16,900 meters (55,500 feet) on 23 June 1975. The true color low altitude imagery is presented in mosaic form. The two imagery collection dates, almost one year apart, allow examination of the northward movement of the pit and the initial return of spoils to the southern part of the mine. Growth of perennial vegetation is evidenced in plots at the extreme southeast corner of the mine, but significant moisture availability to vegetation on disturbed lands is not evidenced elsewhere except along the haul road. The area east of the coal load silos has been seeded in the past and vegetative growth of annuals is visible in the 1974 photography, but not in the 1975 photography.

The soil patterns shown in both sets of photography are noteworthy. The yellowish area of the 1975 photography extending south-southeast from the mine is most likely related to the burn line of the coal bed and shows as a reddish tinge at the bottom of the 1974 imagery.

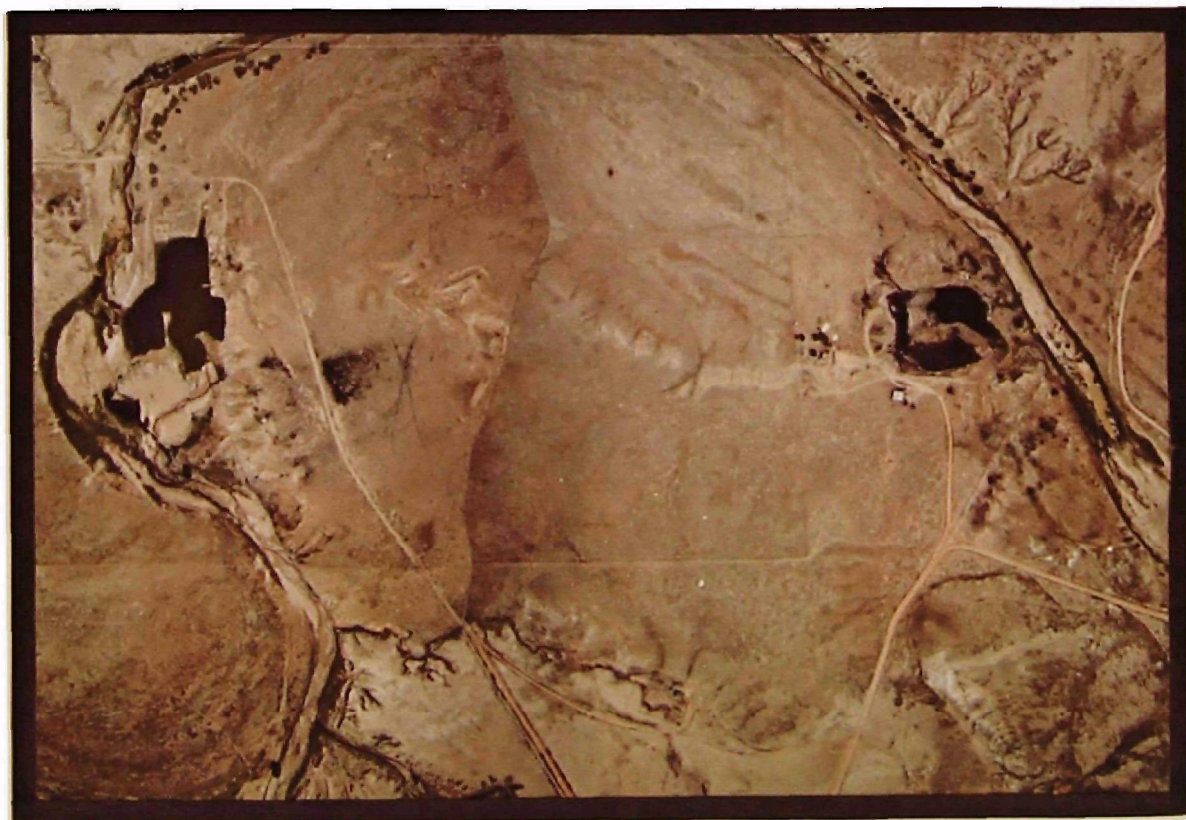
PLATE 4

EAST ANTELOPE MINE
Best Coal Company
Converse County, Wyoming
19Jul74 1201-1202 hrs

This mine is the small operation shown on the right of Plate 4, which is a mosaic of low altitude, true color photography collected on 19 July 1974. The water-filled pit to the west (left) is an abandoned coal mine. Obviously, the East Antelope operation is one of the smaller surface coal mines in the Northern Great Plains.

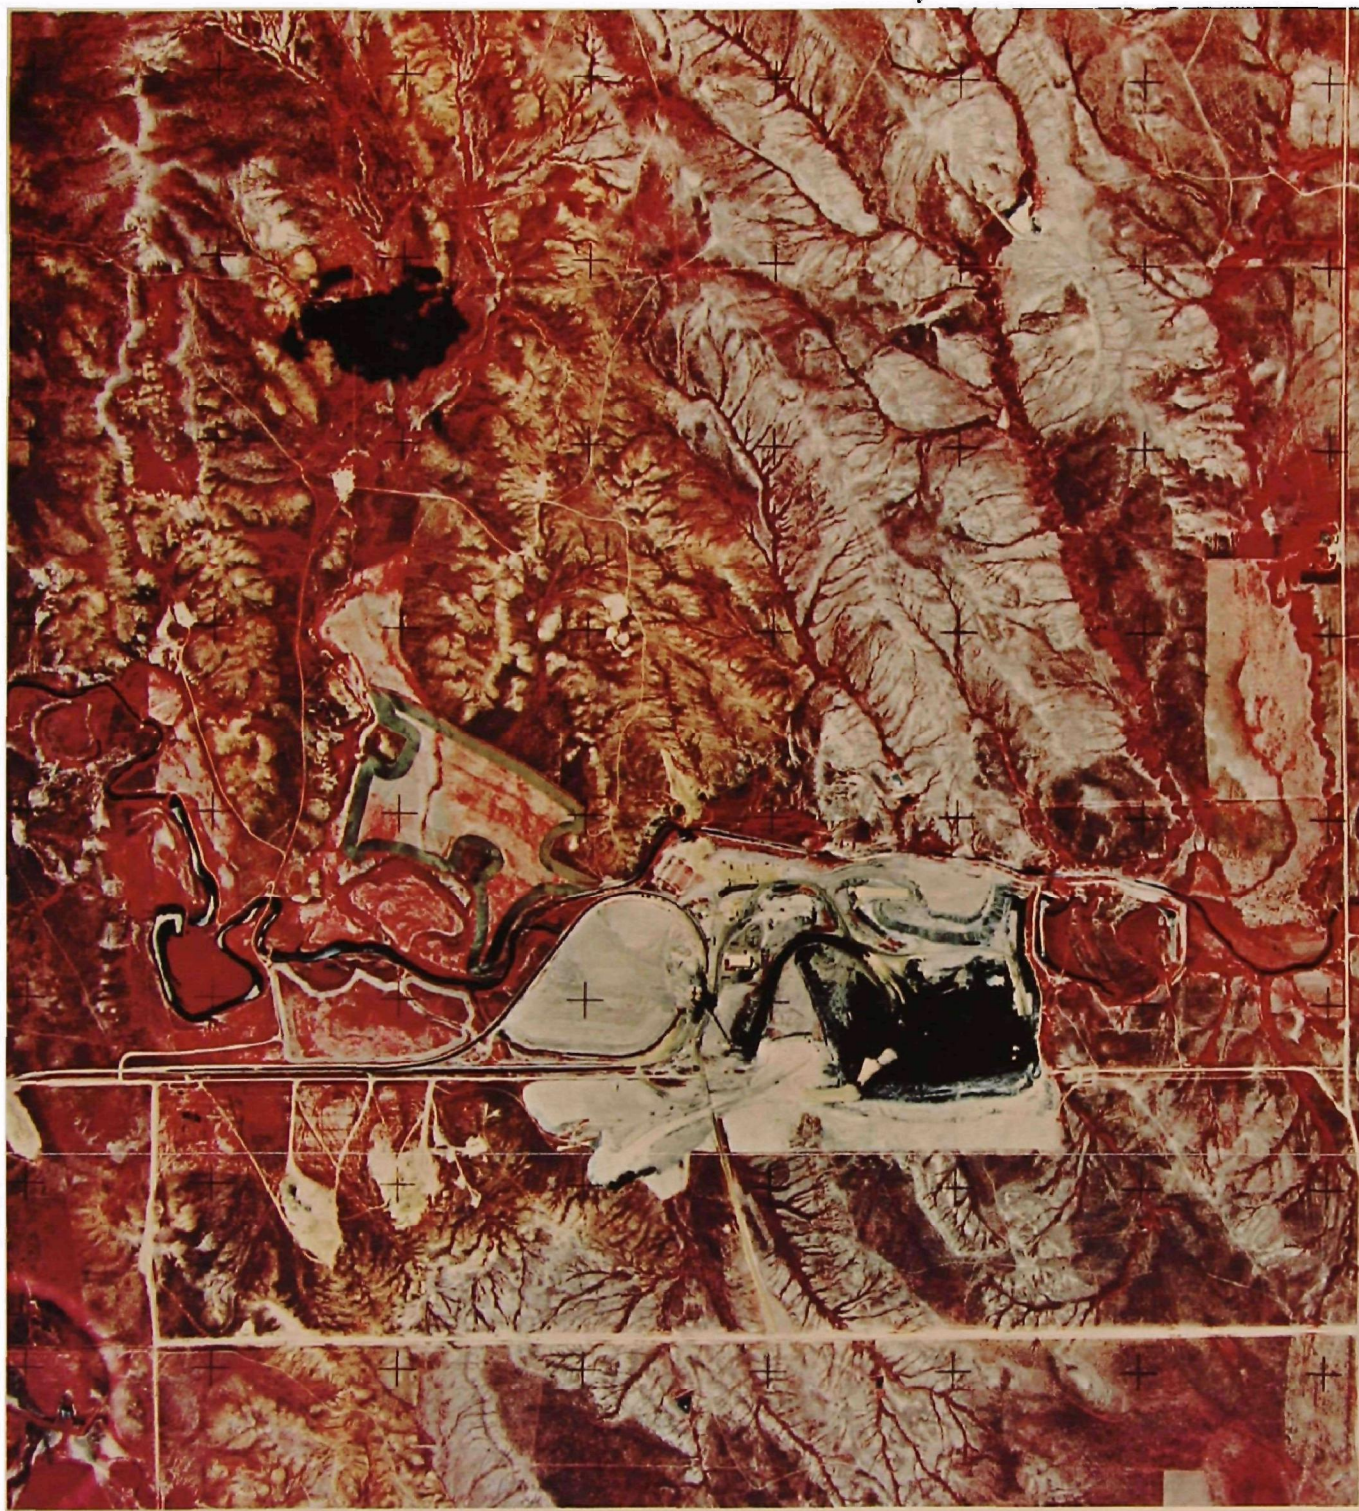
PLATE 6

BELLE AYR MINE
 AMAX Coal Company
 Campbell County, Wyoming
 23Jun75 Color IR High Alt.

The green color of Donkey Creek is related to algae nourished by sewage effluent from the town of Gillette. Seepage into the Wyodak Pit from the diverted creek has been noted.

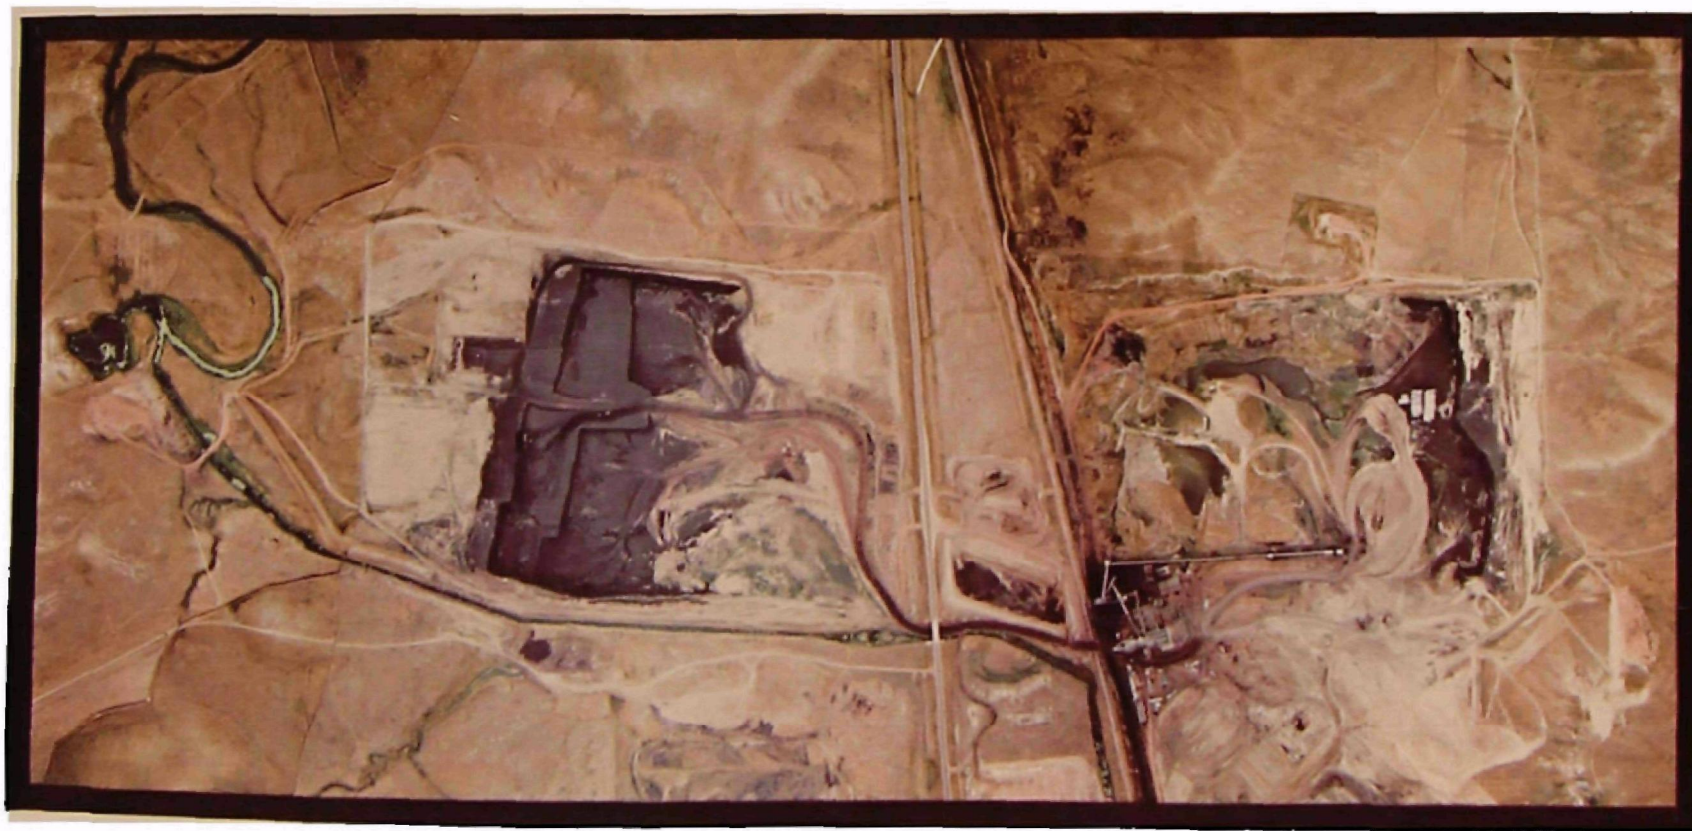
PLATE 7

WYODAK MINE
Wyodak Resource Develop-
ment Company
Campbell County, Wyoming
19Jul74 1526-1527 hrs

This mine is represented in low altitude photography collected on 19 July 1974 (Plate 7). The active pit is that lying south of the highway. Obviously, the coal is thick and mining equipment requirements are minimal to date. The mine is also shown in low-level oblique color photography flown on the same day (Plate 8).

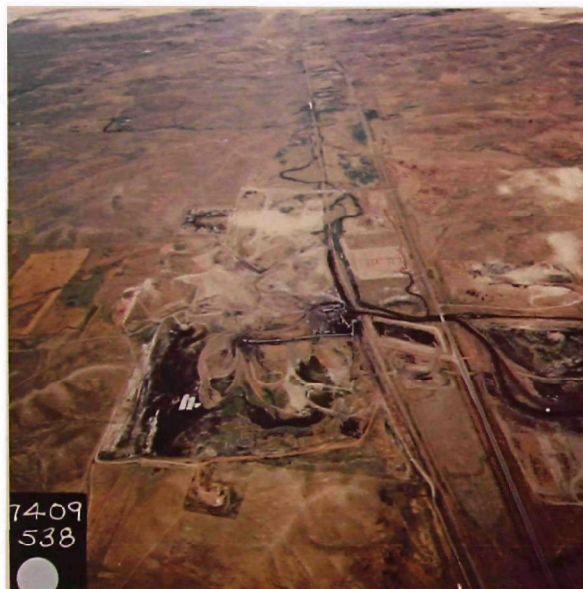
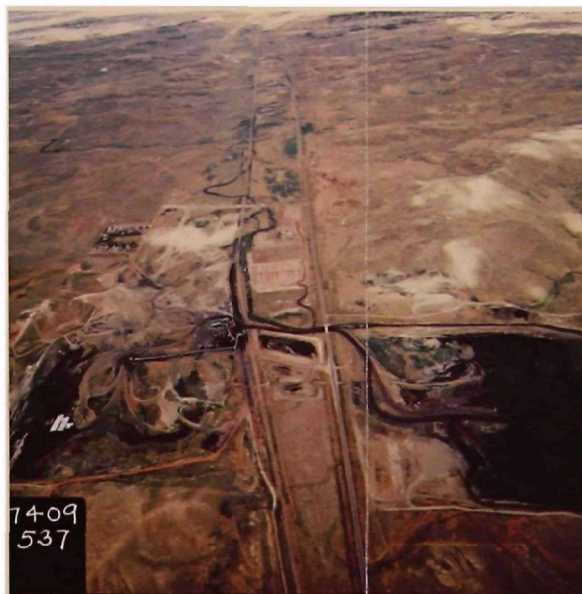
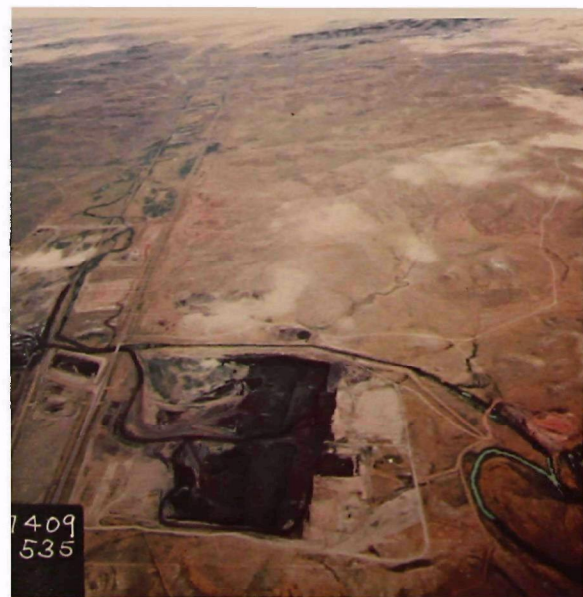
PLATE 8

Photographs collected along south to north flight line. Horizon of photograph is west.

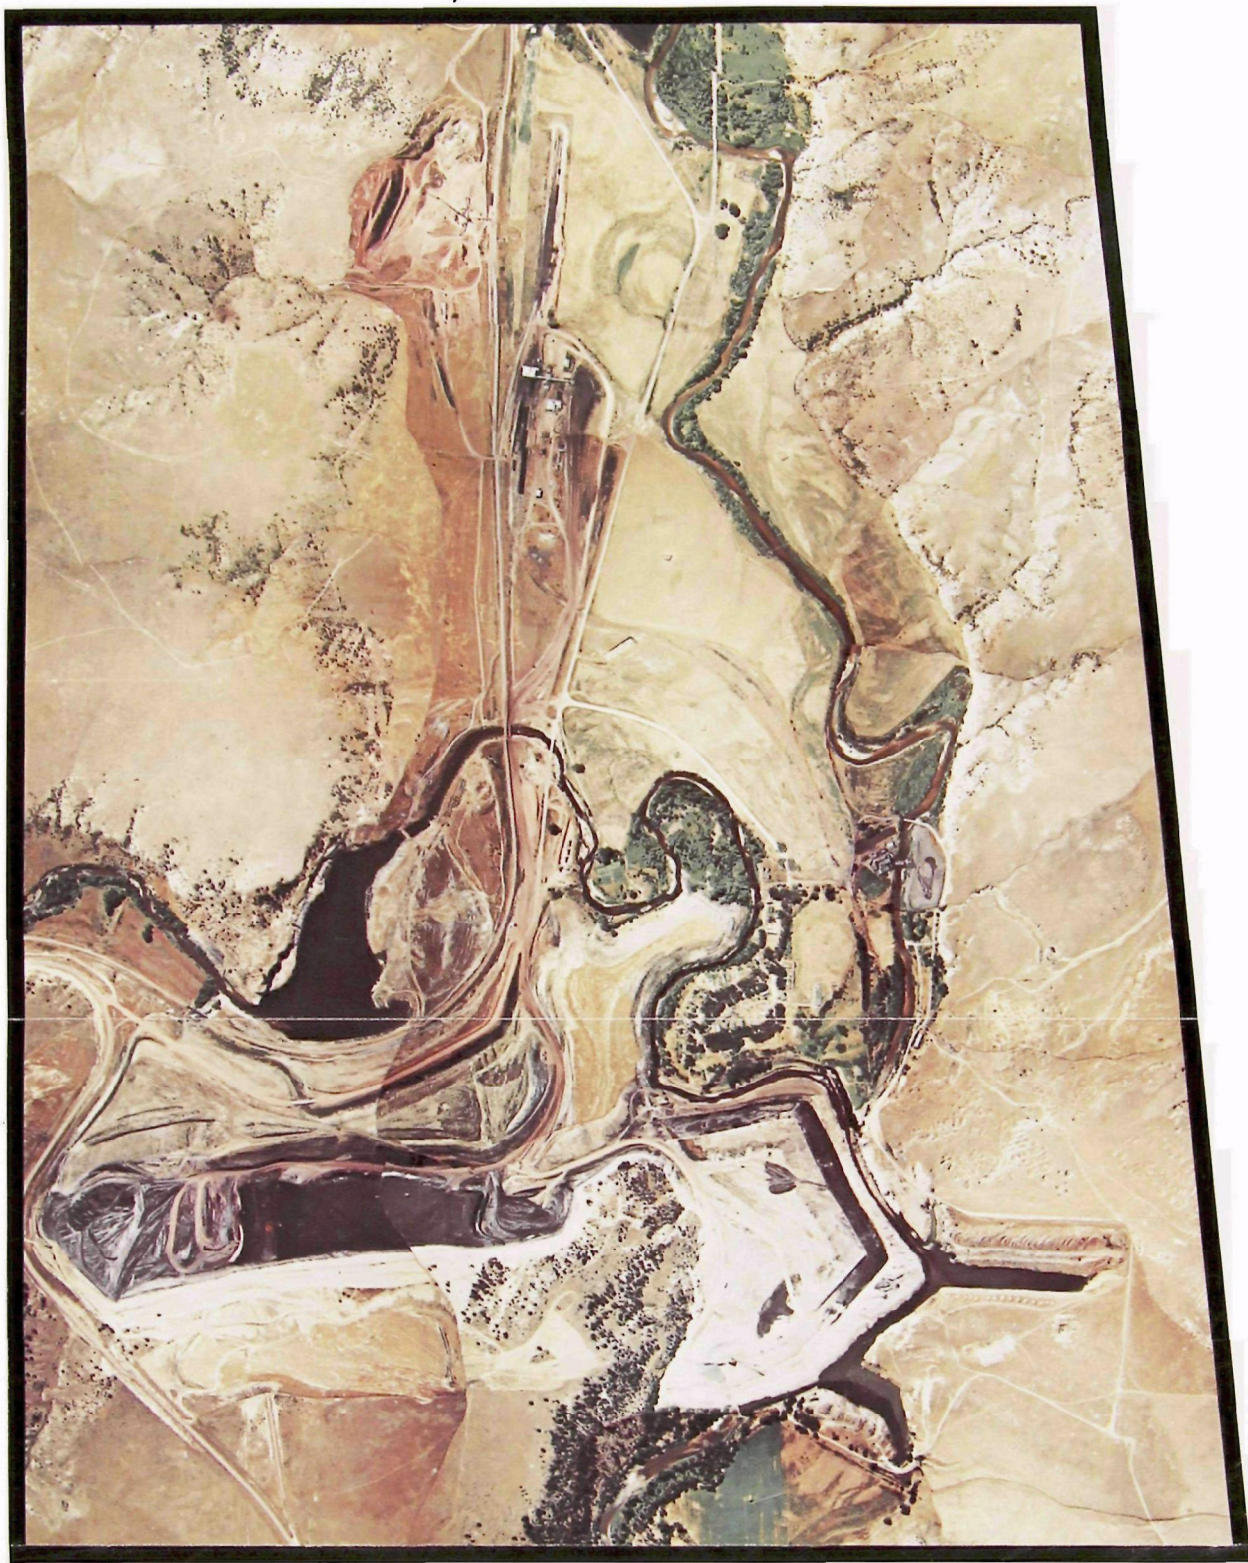
PLATE 10

BIG HORN NO. 1 MINE
Big Horn Coal Company
Sheridan County, Wyoming
28Jul74 1440-1516 hrs

In portions of the area currently mined and to the north of the area shown in Plate 10, extensive underground mining has been conducted. Subsidence features exist over hundreds of acres. Various areas of that coal are presently burning. Impressive columns of smoke are sometimes evident for short periods when portions of the old underground mines collapse up to the land surface.

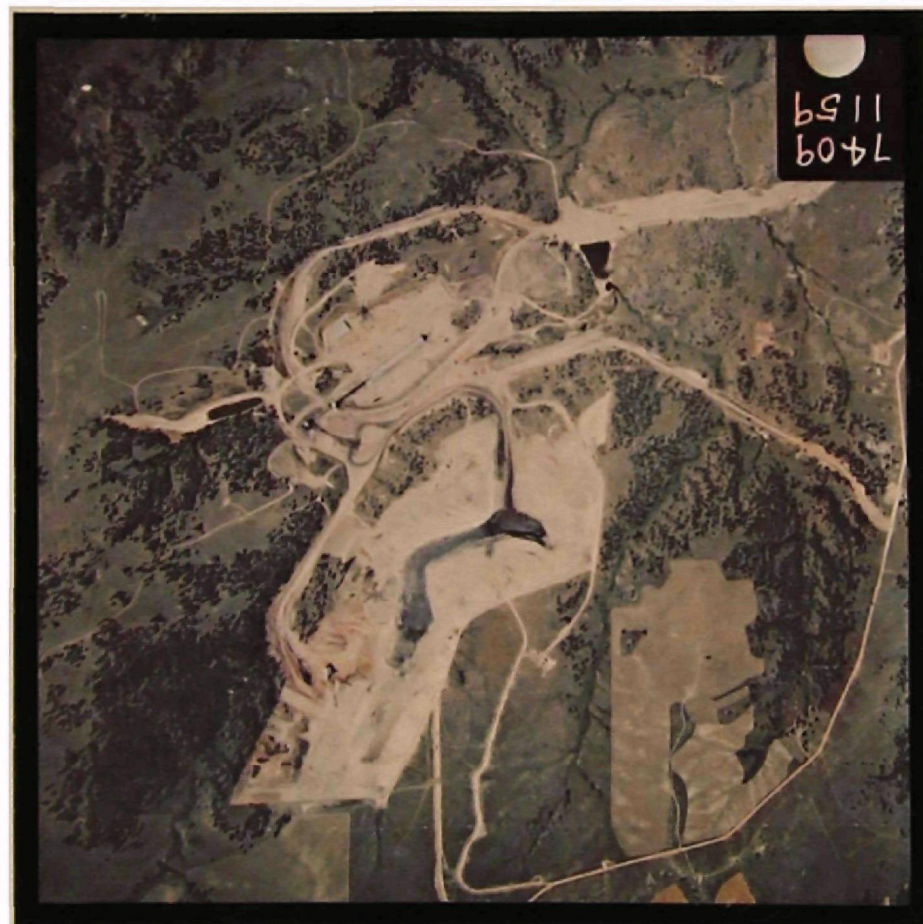
PLATE 14

**ABSALOKA MINE
(SARPY CREEK)**
Westmoreland Coal Company
Big Horn County, Montana
21Jul74 1130-1132 hrs

This mine is one of the newest in the Northern Great Plains. It is represented in this report by low-level aerial photography flown on 21 July 1974 presented in Plate 14 in true color. The area is characteristic of biological ecosystems at the moderate altitudes of eastern Montana as evidenced by the higher density of evergreen trees and shrubs.

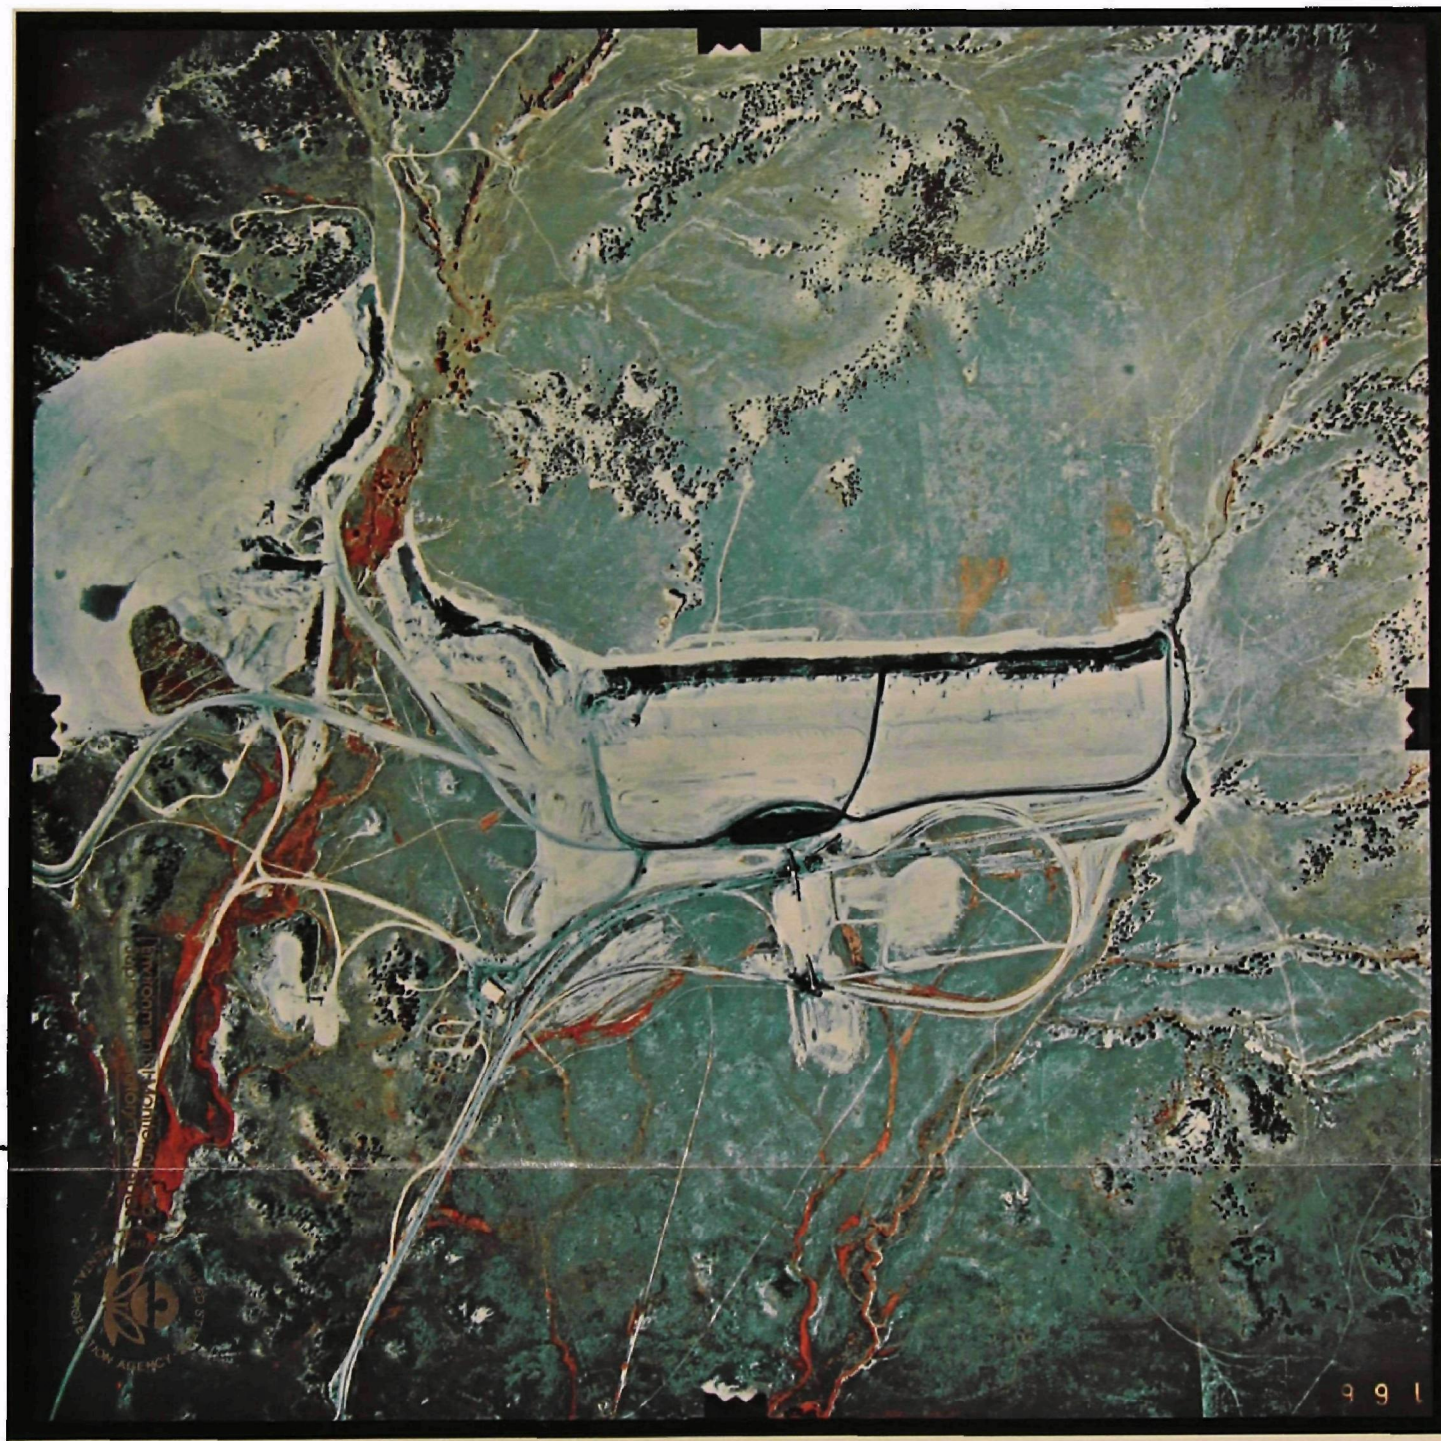
PLATE 15

BIG SKY MINE
 Peabody Coal Company
 Rosebud County, Montana
 11Jul75

This mine was missed during the 1974 data gathering exercise and is therefore represented by color infrared imagery collected on 23 June 1975 from an altitude of 17,450 meters (57,300 feet) (Plate 16) and by color infrared imagery collected on 11 July 1975 from an altitude of 1,830 meters (6,000 feet) (Plate 15). The mine is relatively small in comparison to the nearby Rosebud Mine and is located south of Colstrip, Montana and west-southwest of the lower portion of the Rosebud Mine (See Section 5-10). The railroad loop is evident on the right-hand (east) side of the upper pit. The magenta tones of the color infrared photograph trace the principal drainages of the area while contrasting with the whites of the gravel roads and mined areas, and with the black of the exposed coal (along the left side of the upper pit) and coal in the coal preparation area. The color infrared imagery has not identified much vegetation growth over the disturbed areas except at the right bottom of the lower disturbed area in Plate 15 where some extremely vigorous vegetation is mixed in with more barren material. A portion of this is also represented in the 1975 photography of Plate 16. The light blue areas show accumulation of water. Greyish spoil and some less vigorous vegetative growth also appear across the disturbed areas.

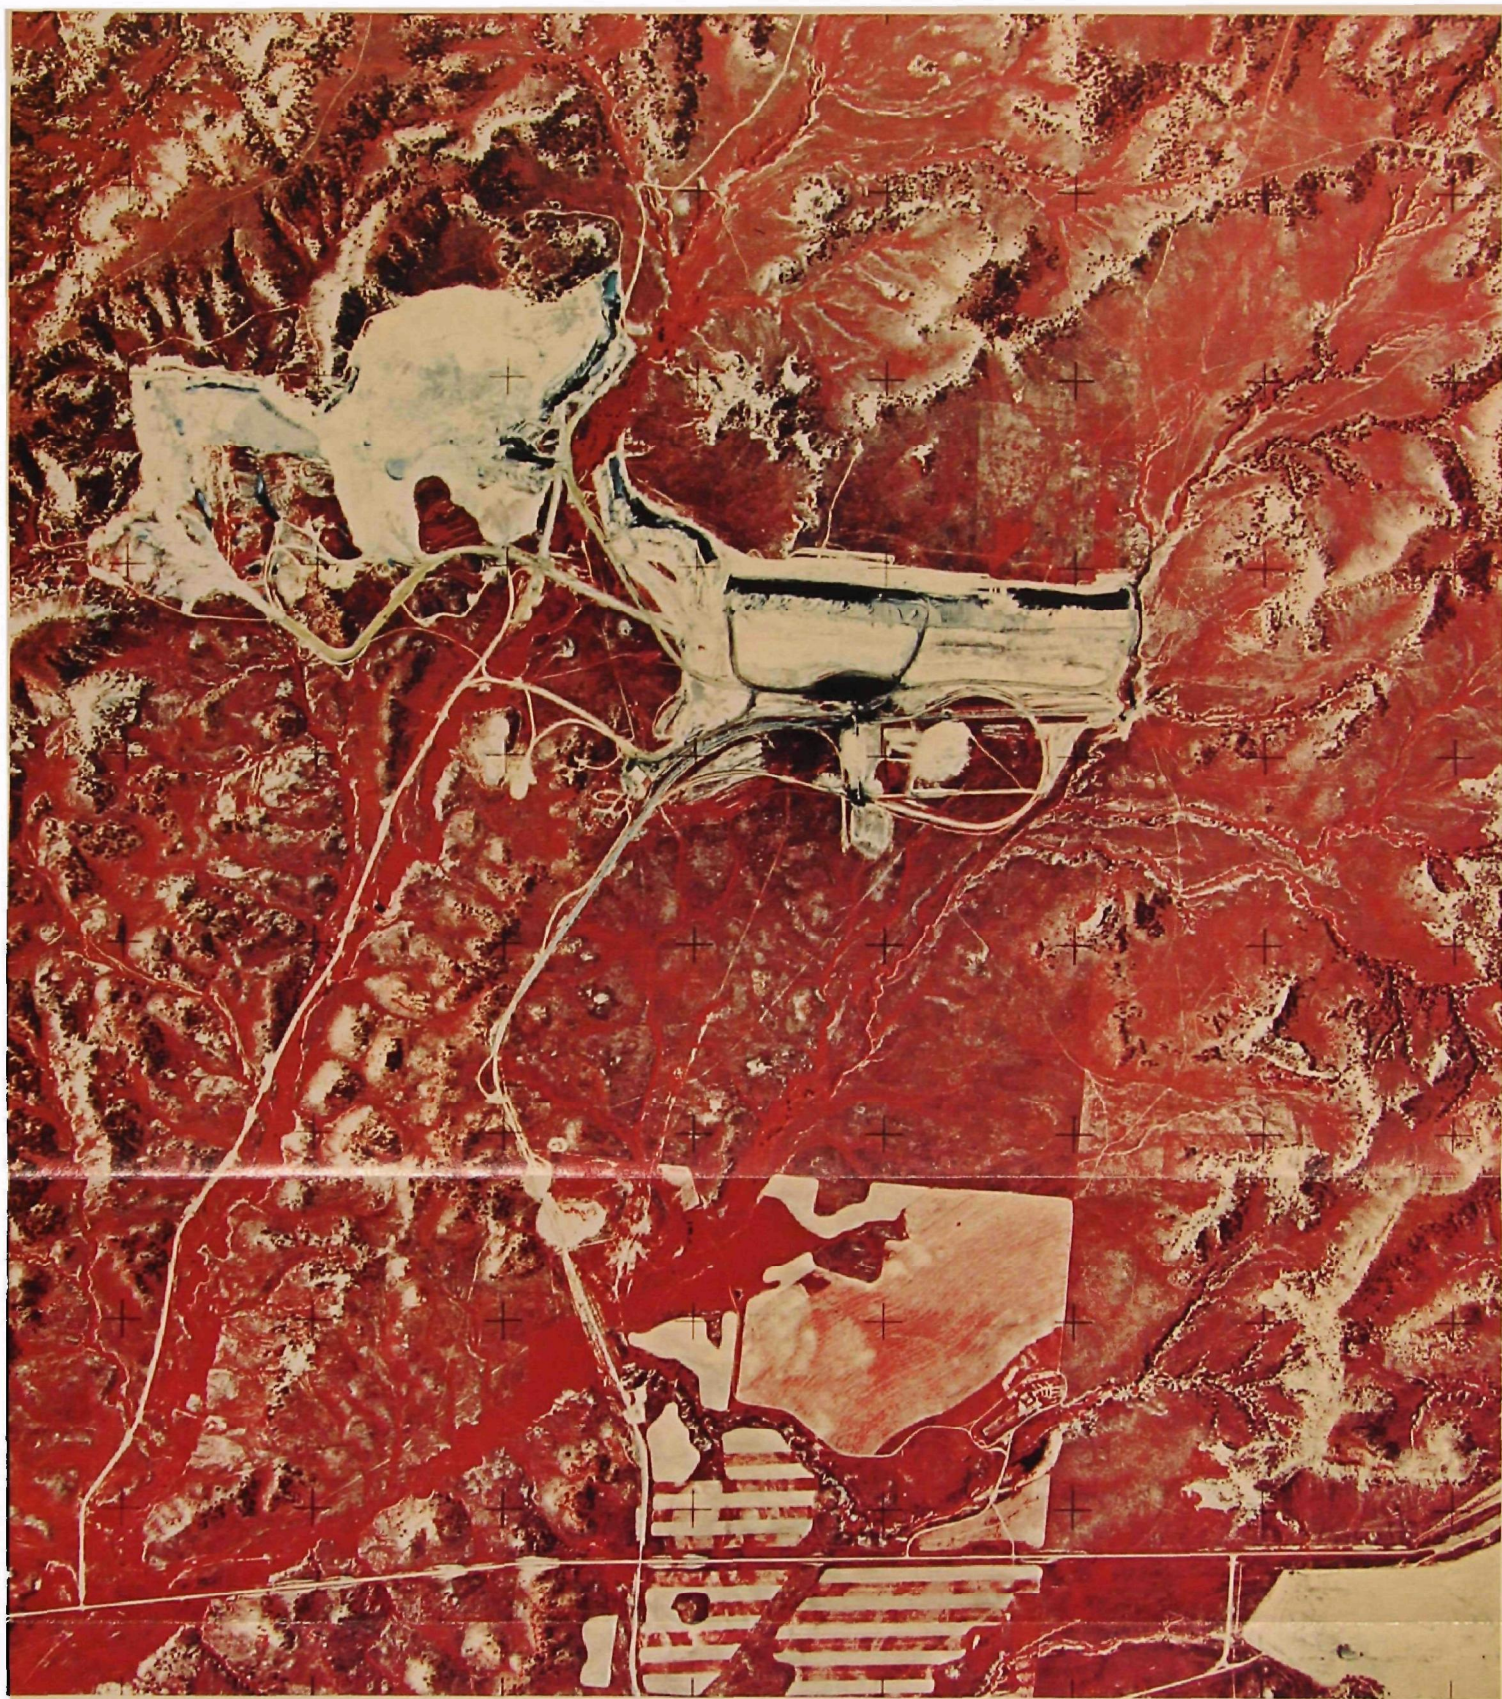
PLATE 16

BIG SKY MINE
Peabody Coal Company
Rosebud County, Montana
23Jun75 Color IR High Alt.

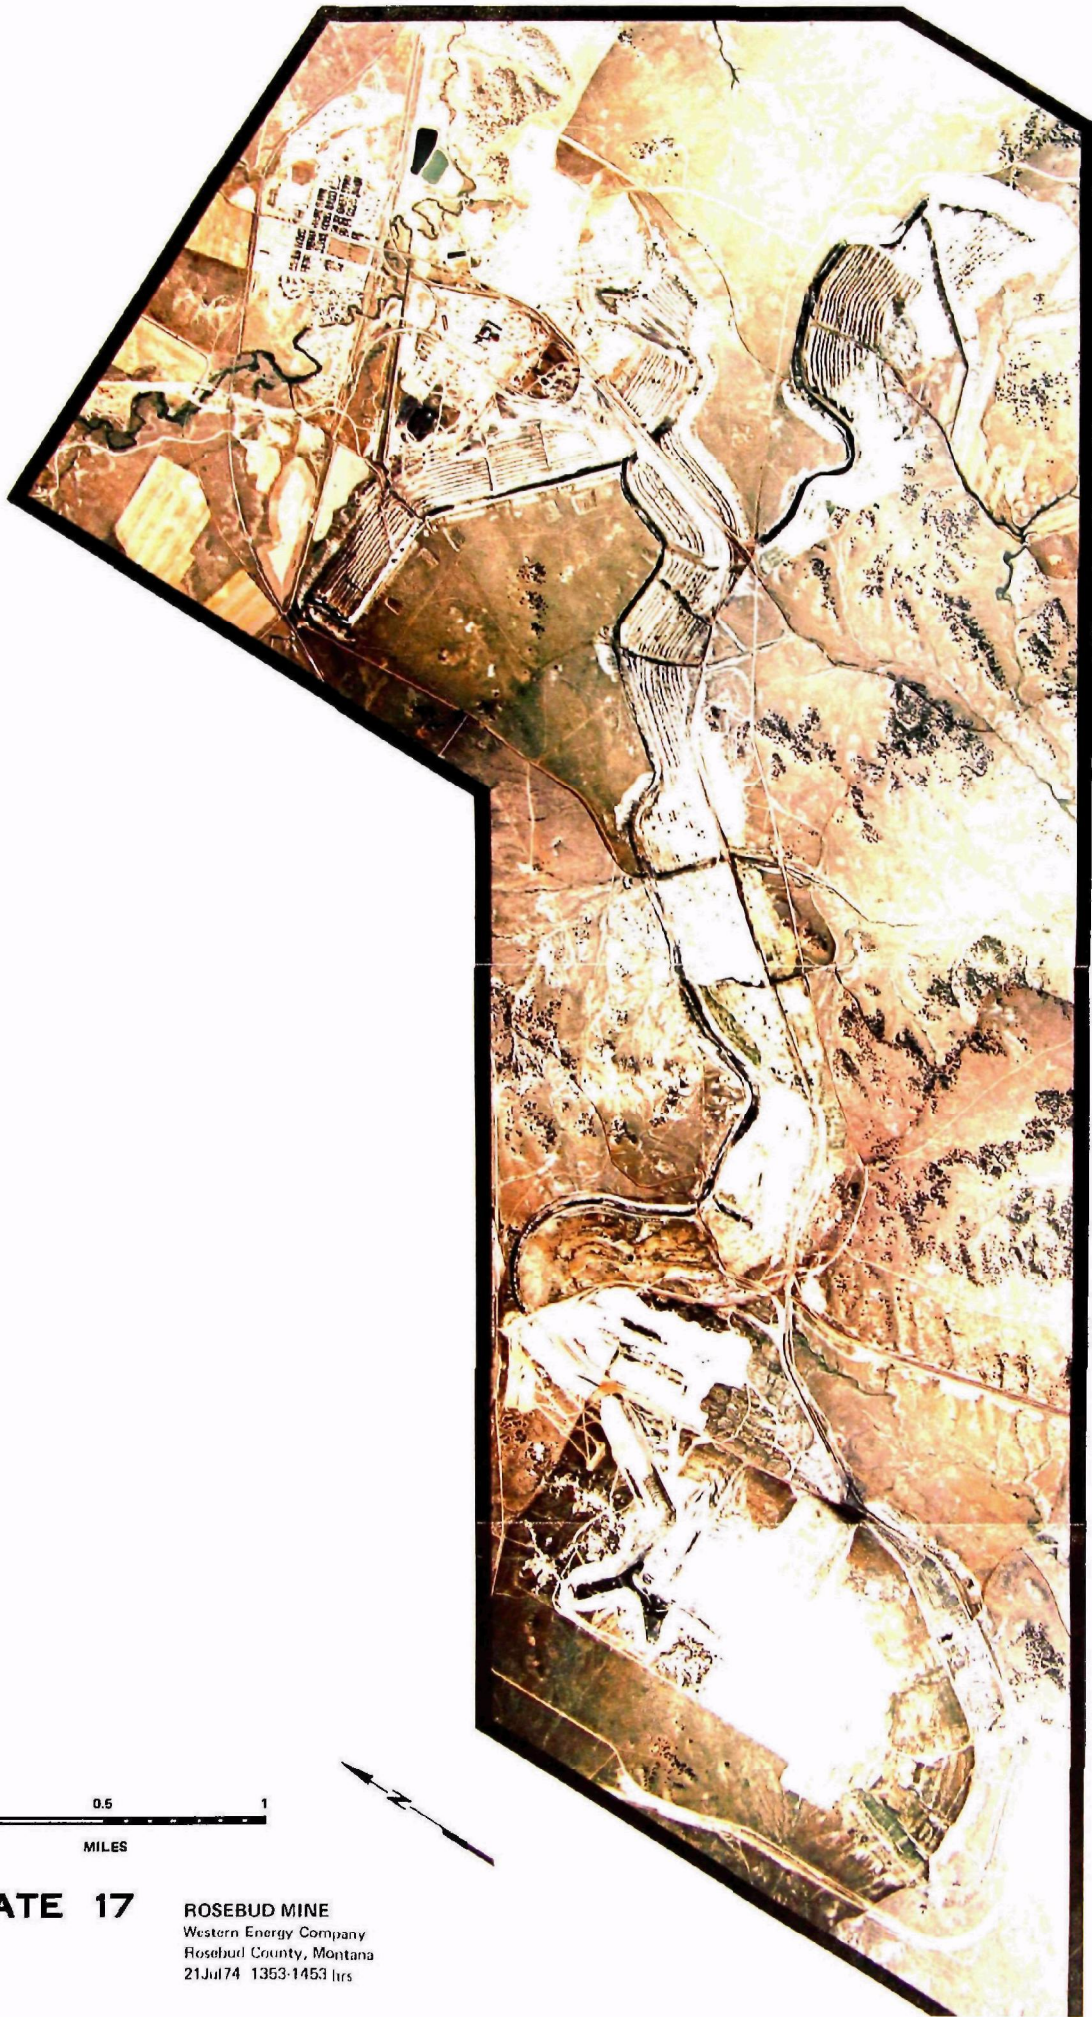
PLATE 17

ROSEBUD MINE
Western Energy Company
Rosebud County, Montana
21Jul74 1353-1453 hrs

This mine was photographed in July 1974 and again in June 1975. Imagery from the first flight, on 21 July 1974, is presented in true color (see Plate 17). The imagery for 23 June 1975 is color infrared. The true color is a mosaic of low altitude photography while the color infrared was obtained at an altitude of 17,450 meters (57,330 feet). We are afforded then the opportunity to again compare types of imagery and changes in time. Plate 19 provides an oblique view of the operation which includes the power plant, also collected on 28 July 1974.
