SURFACE COAL MINING IN THE NORTHERN GREAT PLAINS OF THE WESTERN UNITED STATES

**AN INTRODUCTION AND INVENTORY UTILIZING AERIAL PHOTOGRAPHY
COLLECTED IN 1974-75**

**ENVIRONMENTAL PROTECTION
AGENCY**

June, 1976

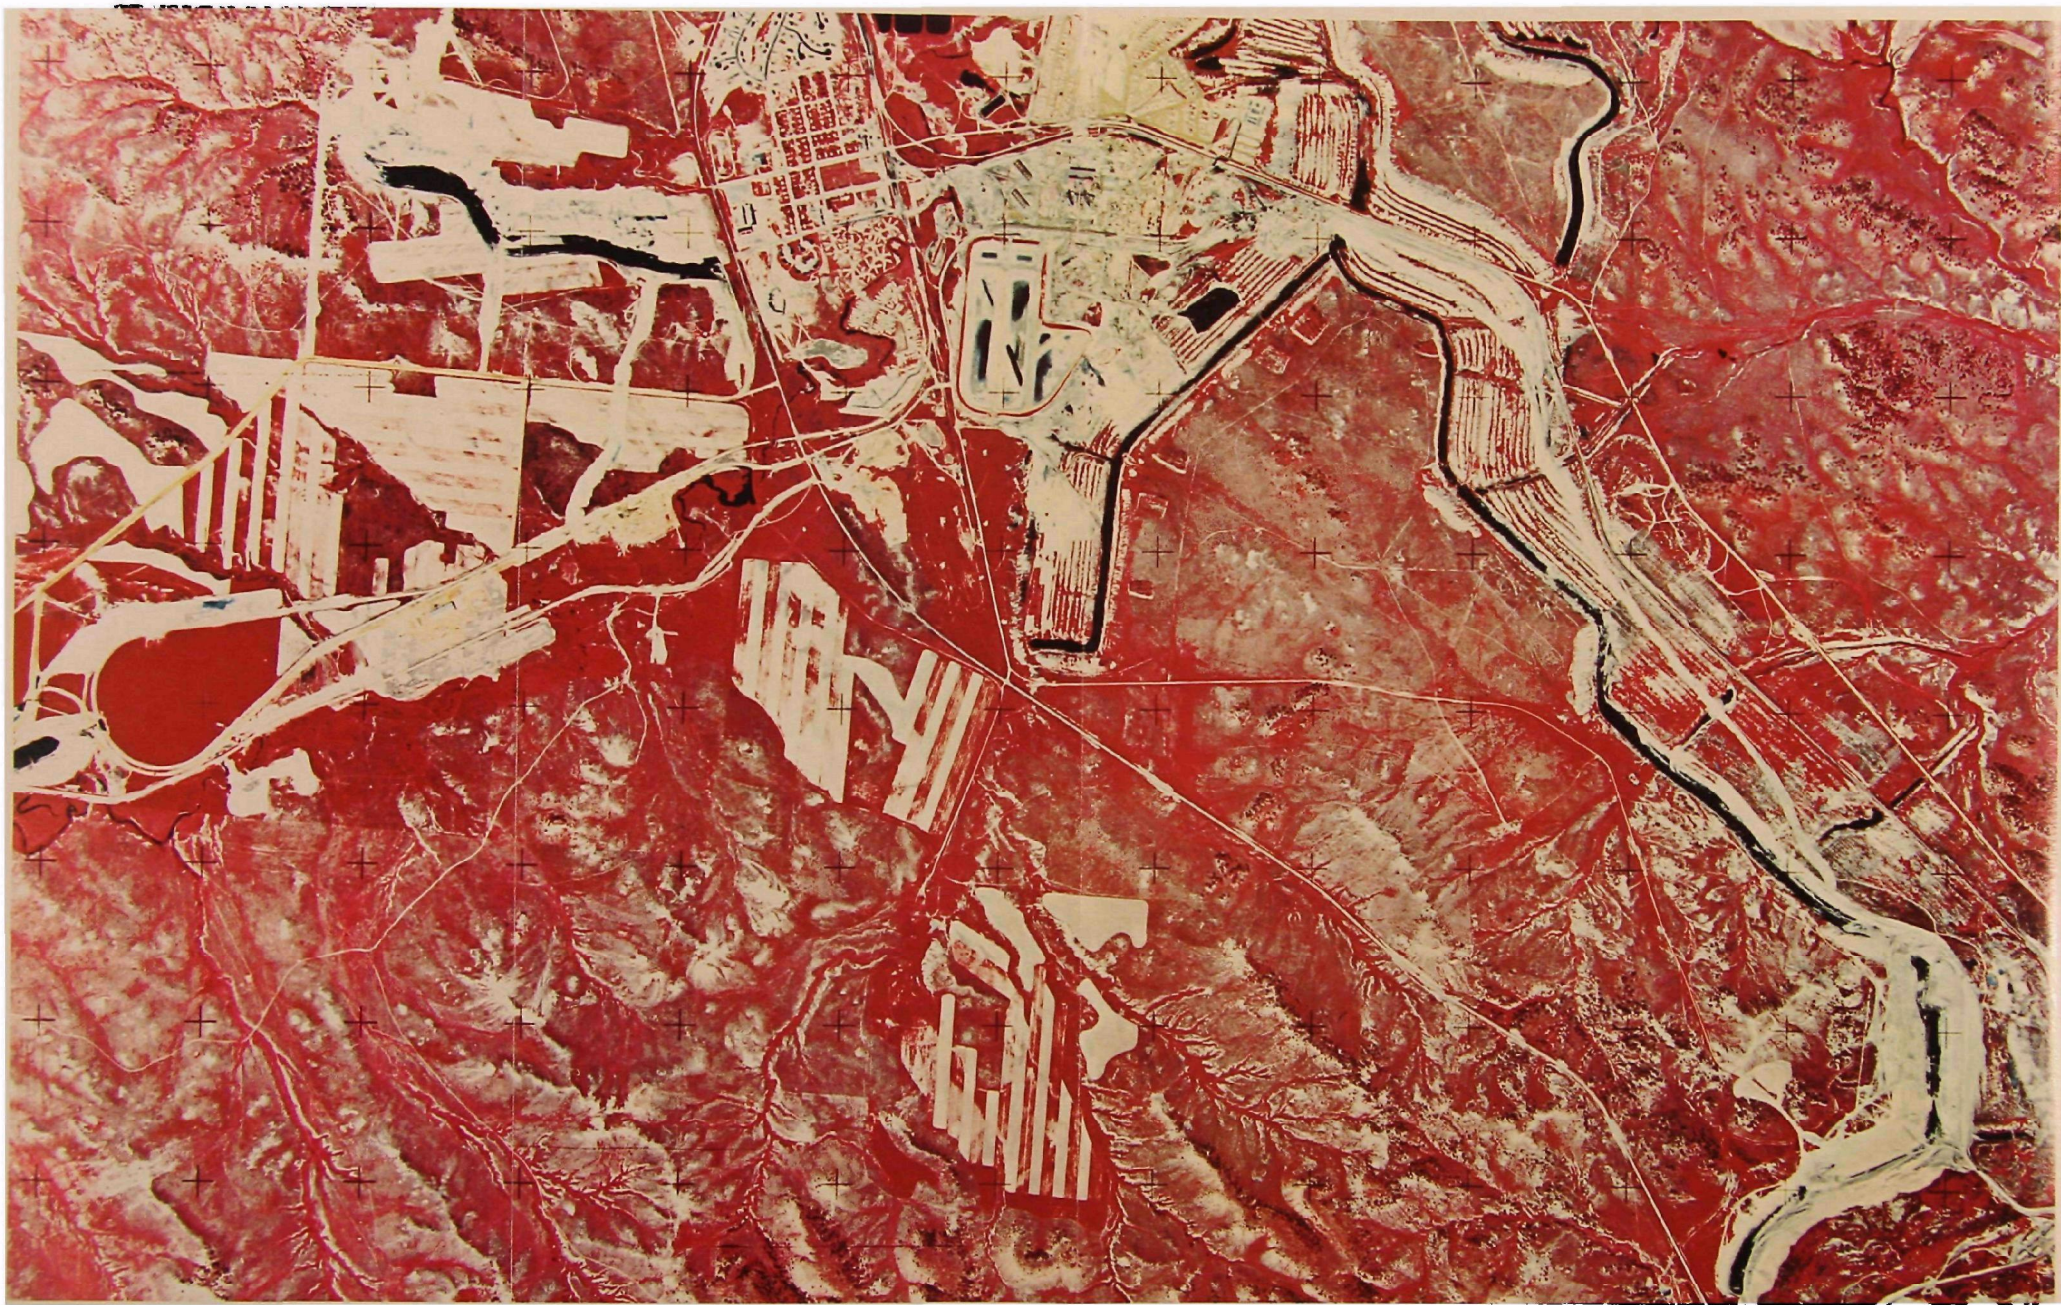
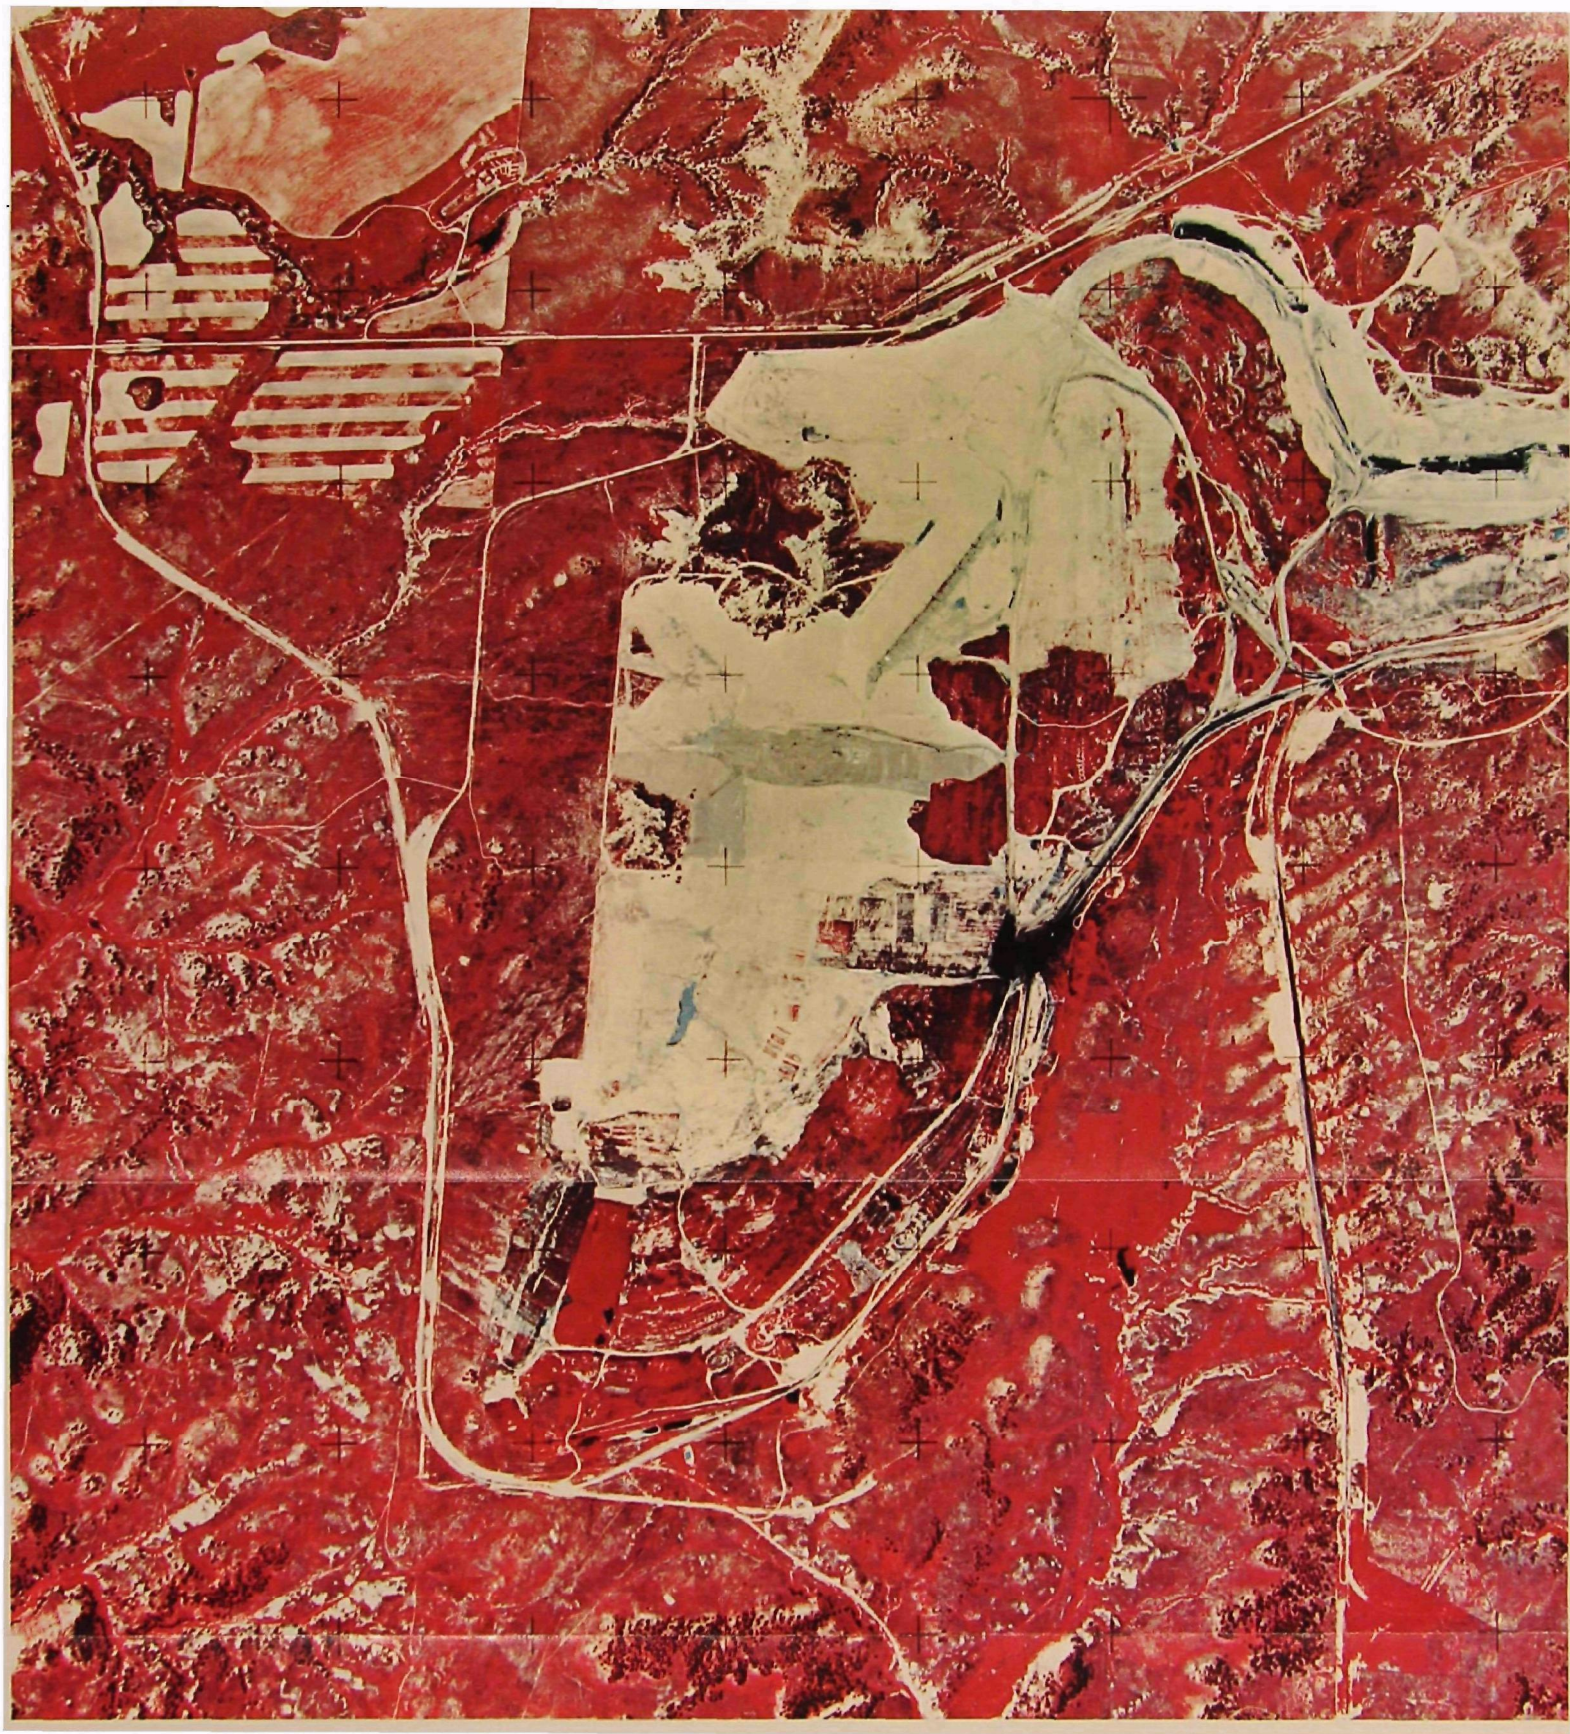
PLATE 18

ROSEBUD MINE

Most assuredly this site offers a full spectrum of examples of energy development activities. Note also the new activities being conducted in the creek valley to the west of Colstrip (Plate 18).

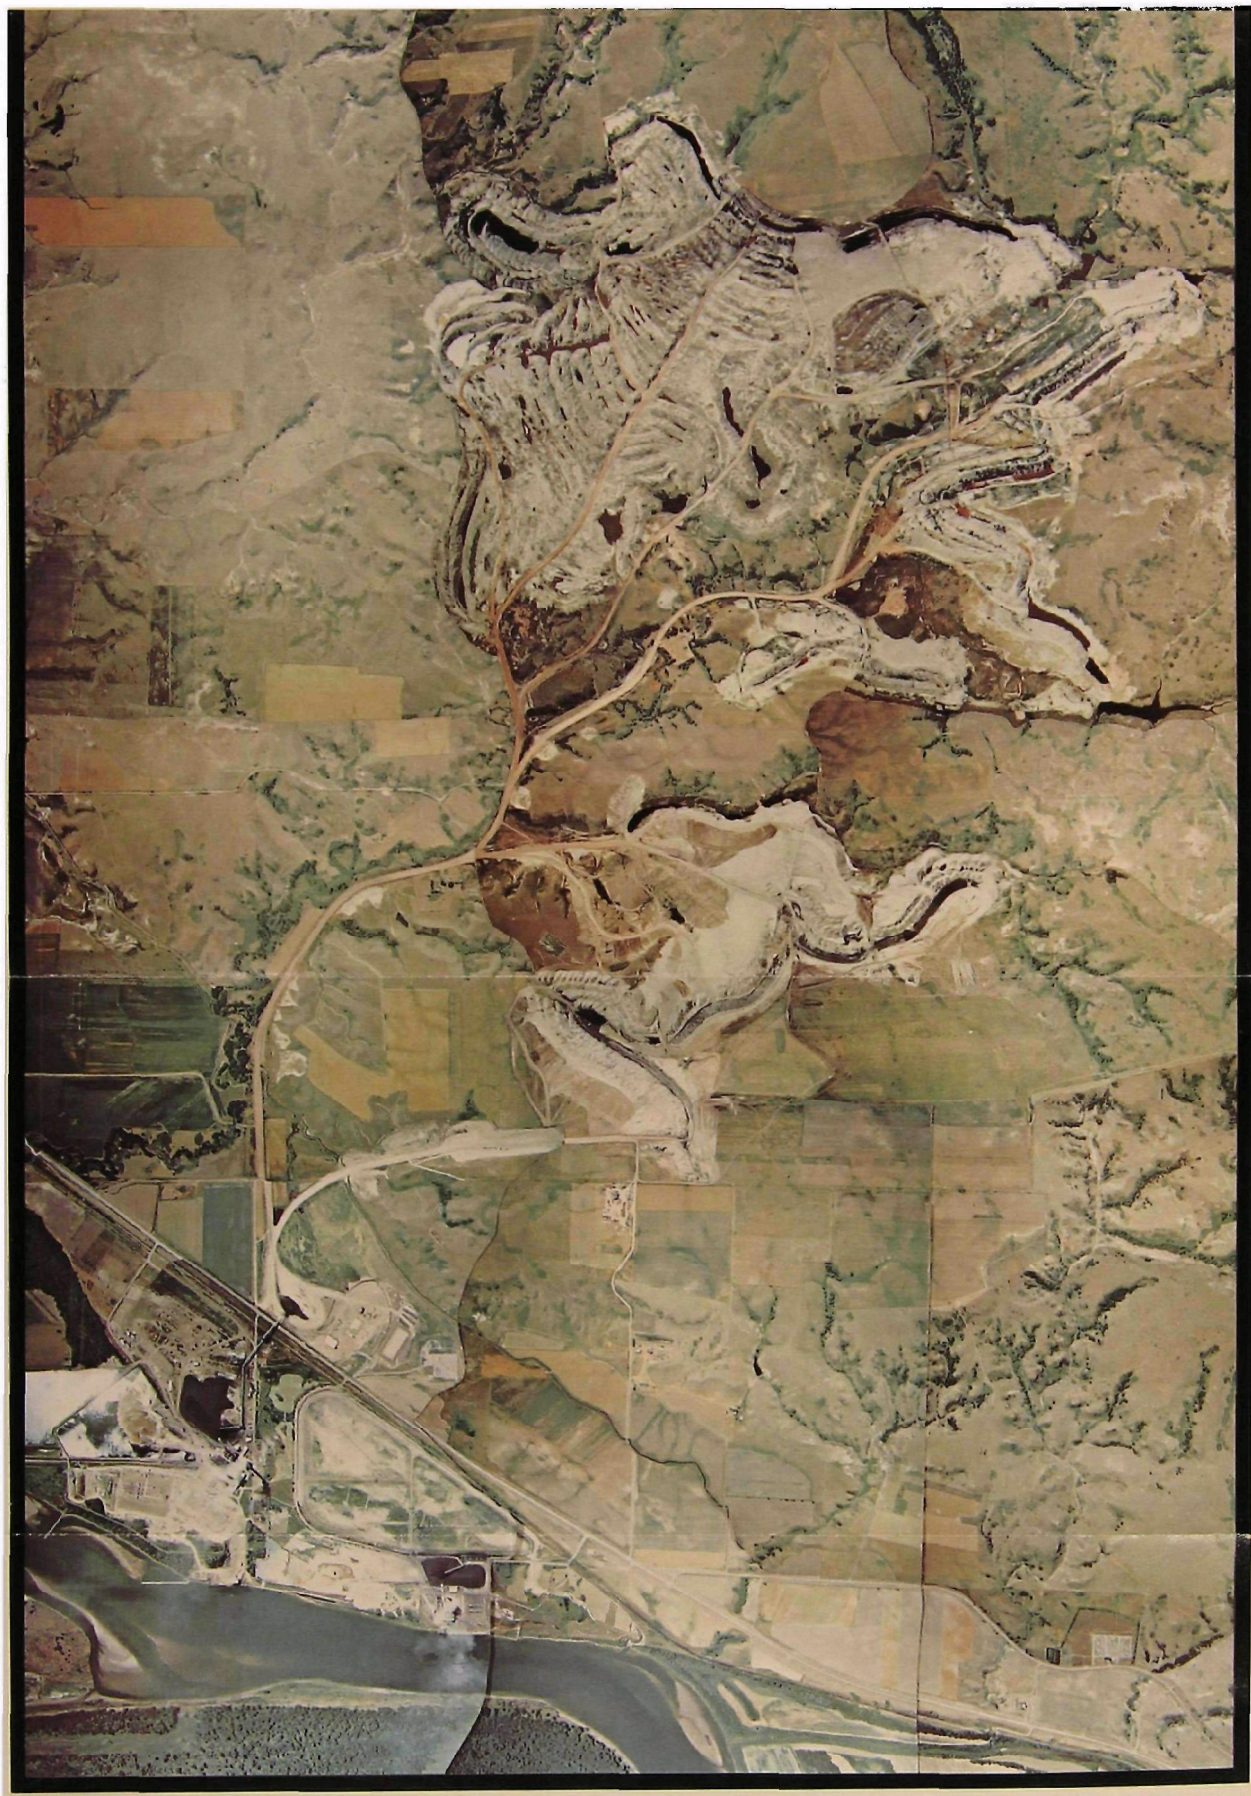
PLATE 25

GLENHAROLD MINE
Consolidation Coal Company
Oliver, Mercer Counties,
North Dakota
27Jul74 1135-1202 hrs

The Glenharold Mine, a mine of moderate size supplying a nearby power plant, is represented by low-level true color imagery collected on 27 July 1974. Color oblique photography collected at the same time is presented in Plate 25. The Missouri River is visible at the upper right corner of the mosaic as are two power plants. The unit on the right is supplied from this mine; the unit on the left is the United Power Association Stanton Plant and is supplied with coal from the Indian Head mine near Beulah, North Dakota, using unit trains (see Plate 27 in the Indian Head Mine).

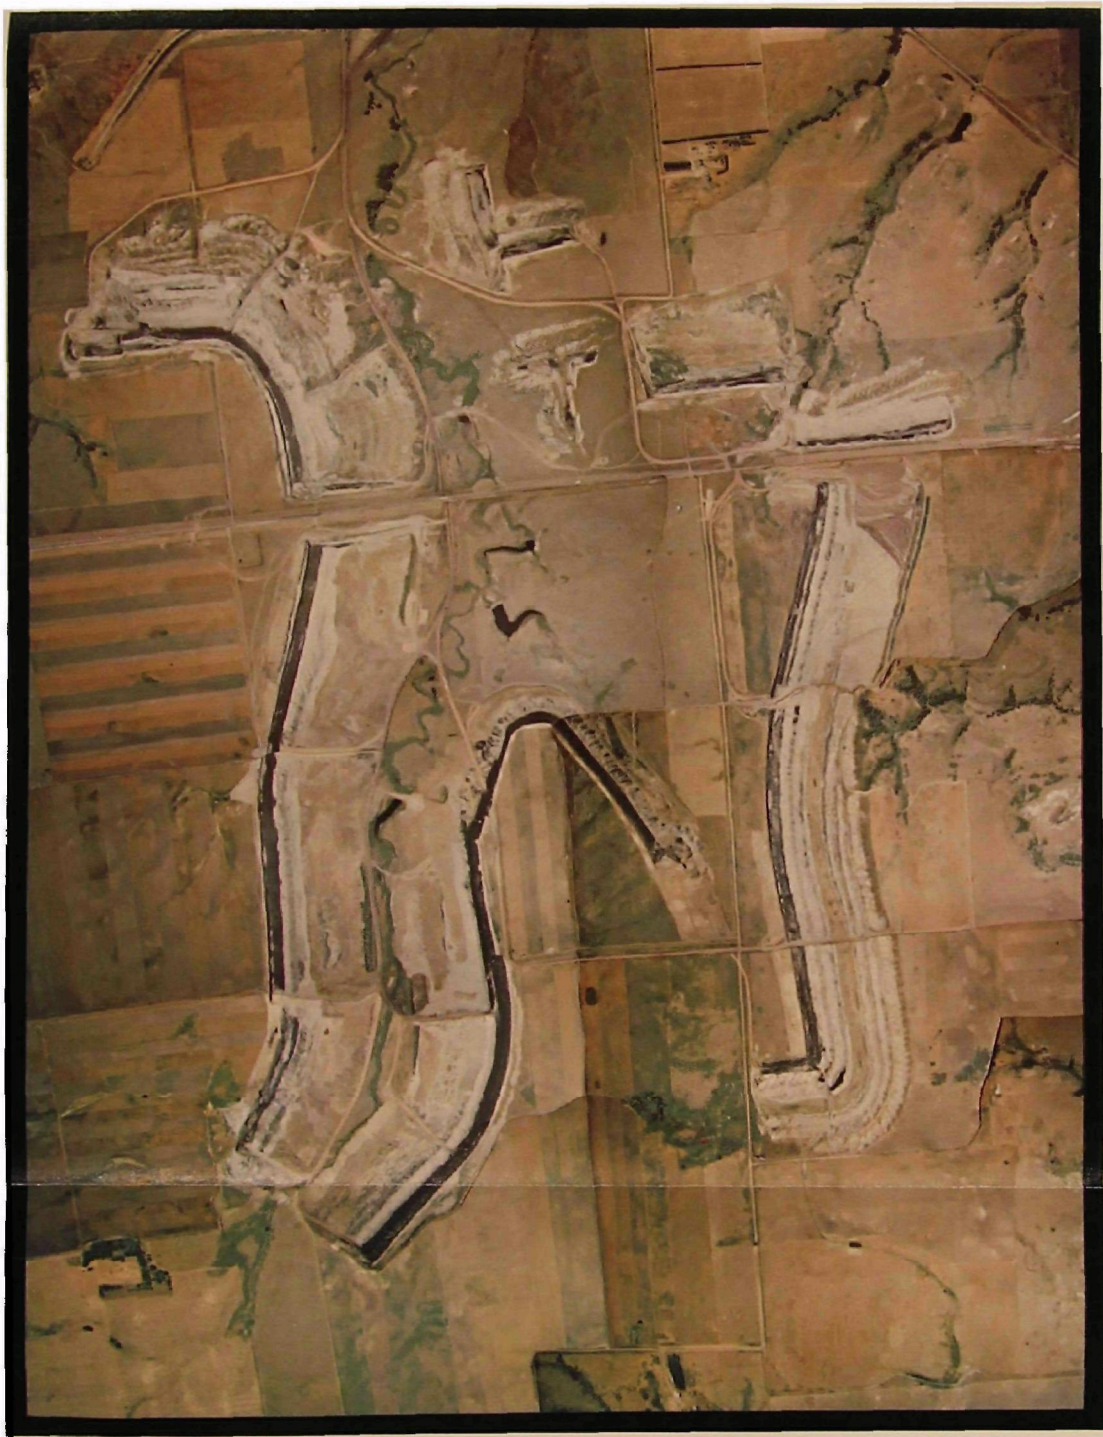
PLATE 27a

The southern portion of this mine is also represented by true color photography collected on 23 July 1974 at low altitude. Plate 27a, a mosaic, presents this imagery and shows a relatively regular mining pattern which is generally followed rather closely by grading and it would appear, "top-soiling". There are some signs of emerging vegetation on the graded and "top-soiled" areas along the south strip of the mine. A few areas along the edges of the mined strips are not graded.

BEULAH SOUTH MINE
Knife River Coal Company
Mercer County, North Dakota
23Jul74 1457-1515 hrs

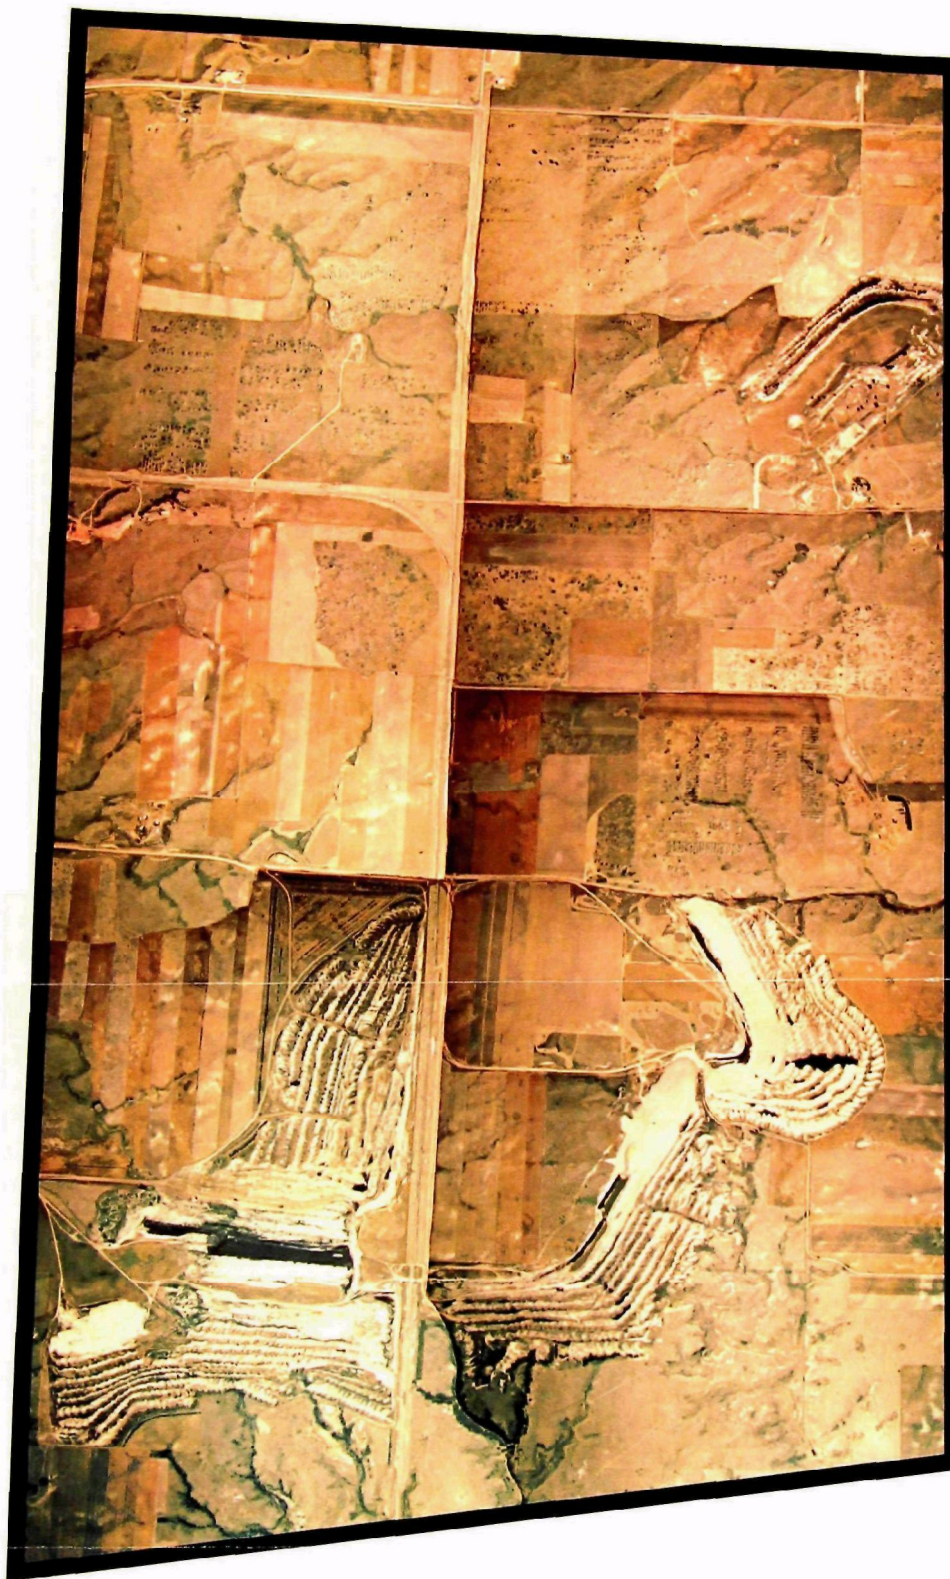
PLATE 27b

The northern portion of this mine is represented on true color collected on 23 July 1974 at low altitude and mosaicked. Plate 27b presents not only the visible remnants of surface mining, at the left top (north) and right (east), but also, the perhaps more impressive remnants of underground mining of the shallow coals. Note throughout the area west of the Beulah North Mine, the regular pattern of depressions caused by subsidence into the drifts extending perpendicular from the main underground haulage ways. In the case of the subsidence shown in the north-central part of the mosaic, even the main haulage ways appear to have collapsed.

BEULAH NORTH MINE
Knife River Coal Company
Mercer County, North Dakota
23Jul74 1520-1528 hrs

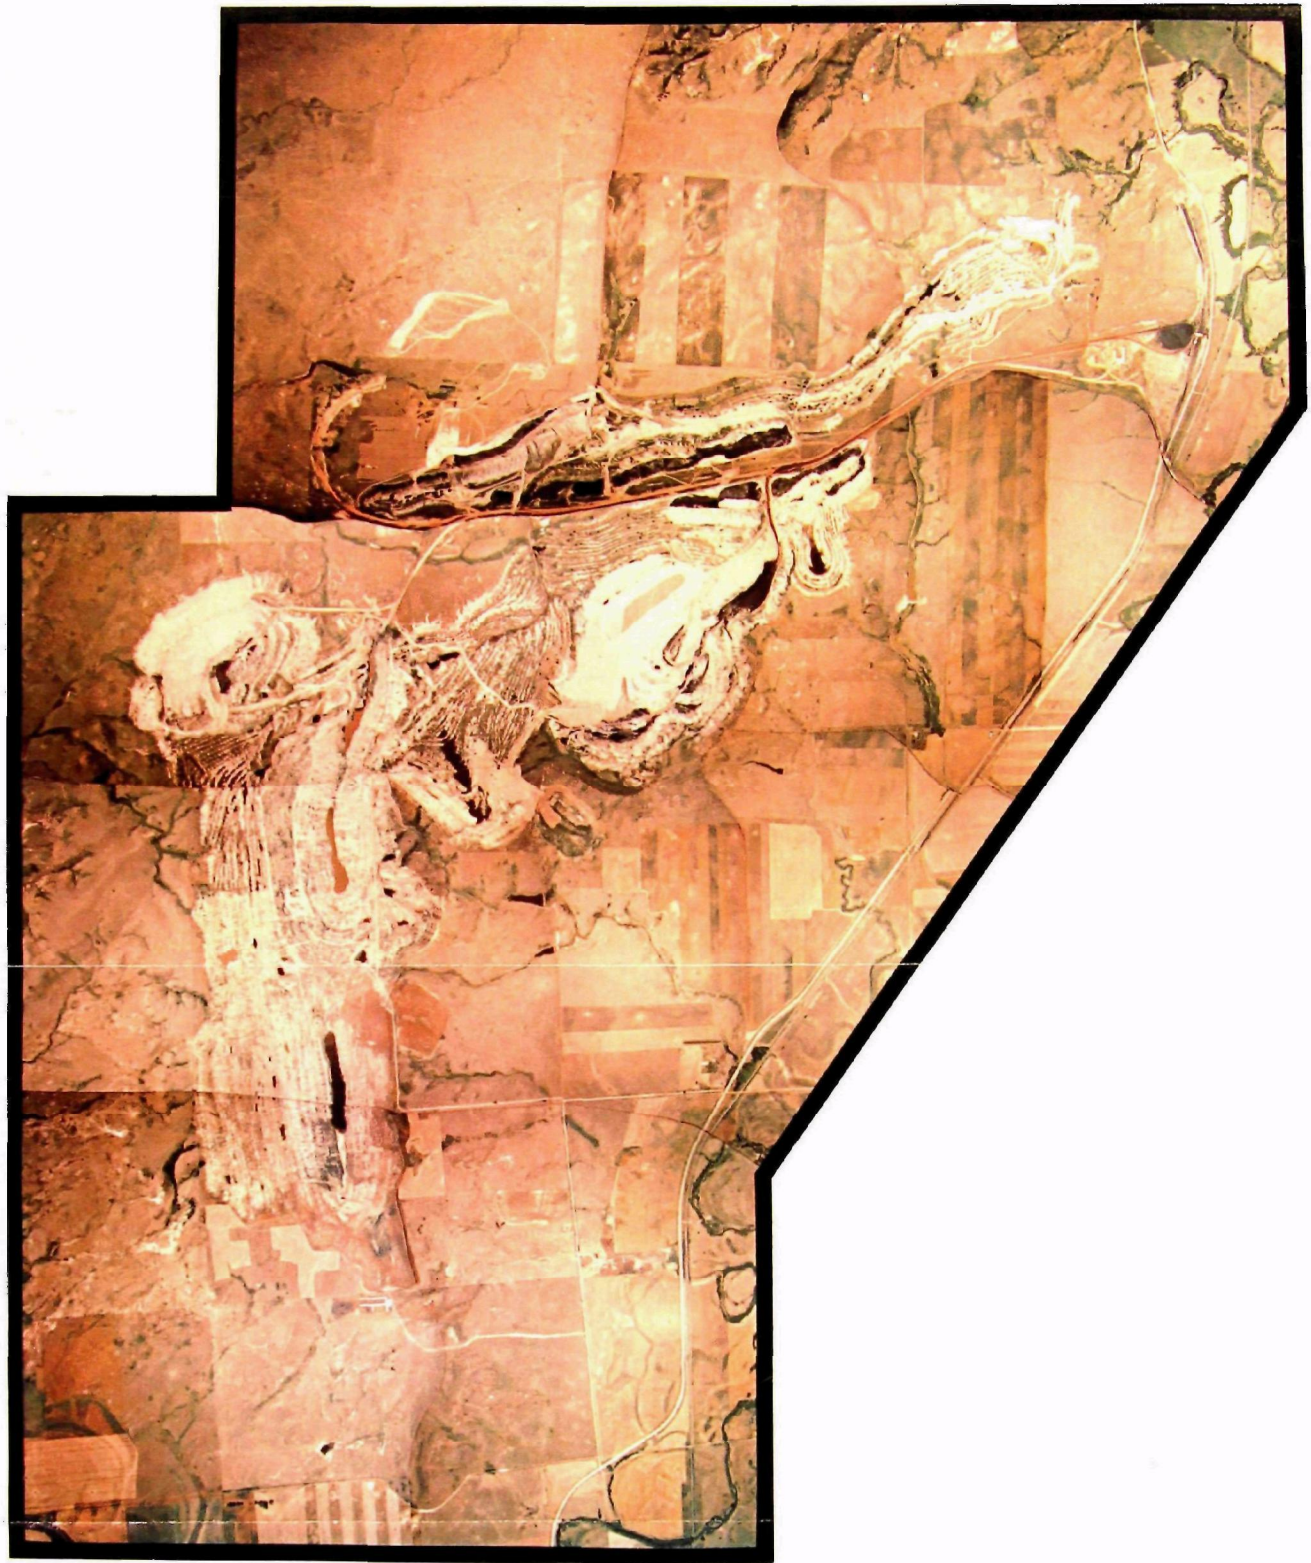
PLATE 28

Reserves estimated 200,000,000 tons.
Blasting Coal AN-FO and 60% dynamite, 10' spacing.
Pit Width: 100' to 120'
Minor water inflow to pit requiring periodic pumping.

INDIAN HEAD MINE
North American Coal Company
Mercer County, North Dakota
23Jul74 1322-1414 hrs

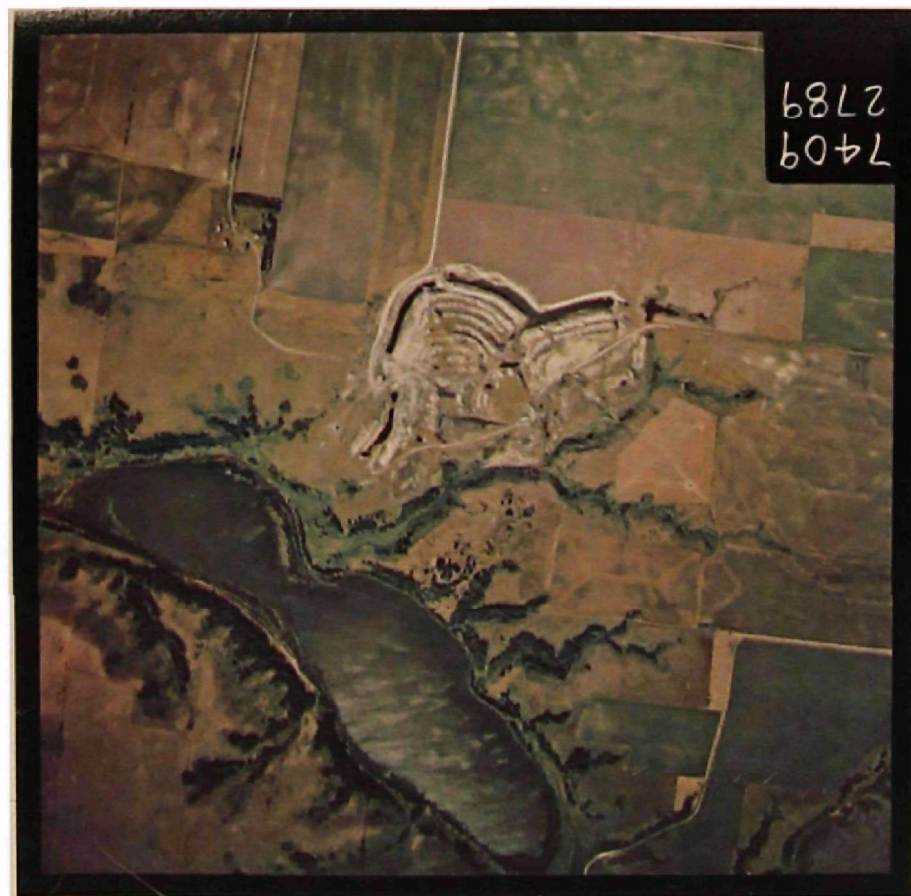
PLATE 29

This mine, in the past a relatively small operation and closed in 1973, is represented in true color, low altitude photography collected on 27 July 1974. Extensive reclamation is not apparent, but vegetative growth has migrated into the disturbed lands, especially where the spoil piles are somewhat leveled. The area shows signs of a relatively shallow ground water table and water is standing in the open pit areas.

UNDERWOOD MINE
Underwood Coal Company
McClain County, North Dakota
27Jul74 1230-1232 hrs

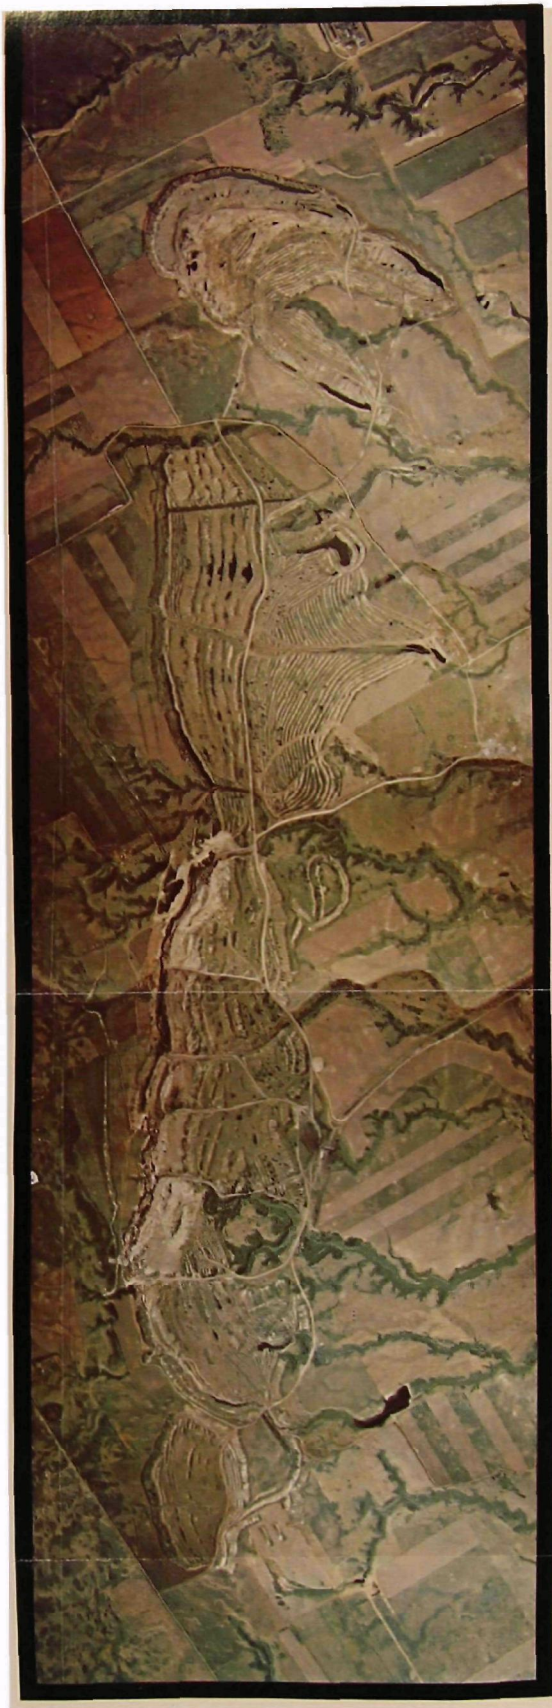
PLATE 30

This mine has been a relatively extensive one as is shown by the low altitude photography presented as a mosaic in Plate 30. The imagery was collected on 22 July 1974. The northeastern area of the mined land shows vegetative growth on the north and east sides of spoil ridges. The southern portion of the mined area shows the effect of leveling the top of larger spoil ridges. There, vegetation occurs in a relatively even pattern over much of the area. Along the extreme western area of the disturbed lands, the vegetation shown in the imagery appears to simulate the vegetation and biological ecosystem south of the mined area.

Highwall instability has resulted in slides.
No blasting.
Pit width 100 - 110'.

VELVA MINE
Consolidation Coal Company
Ward County, North Dakota
22Jul74 1455-1457 hrs

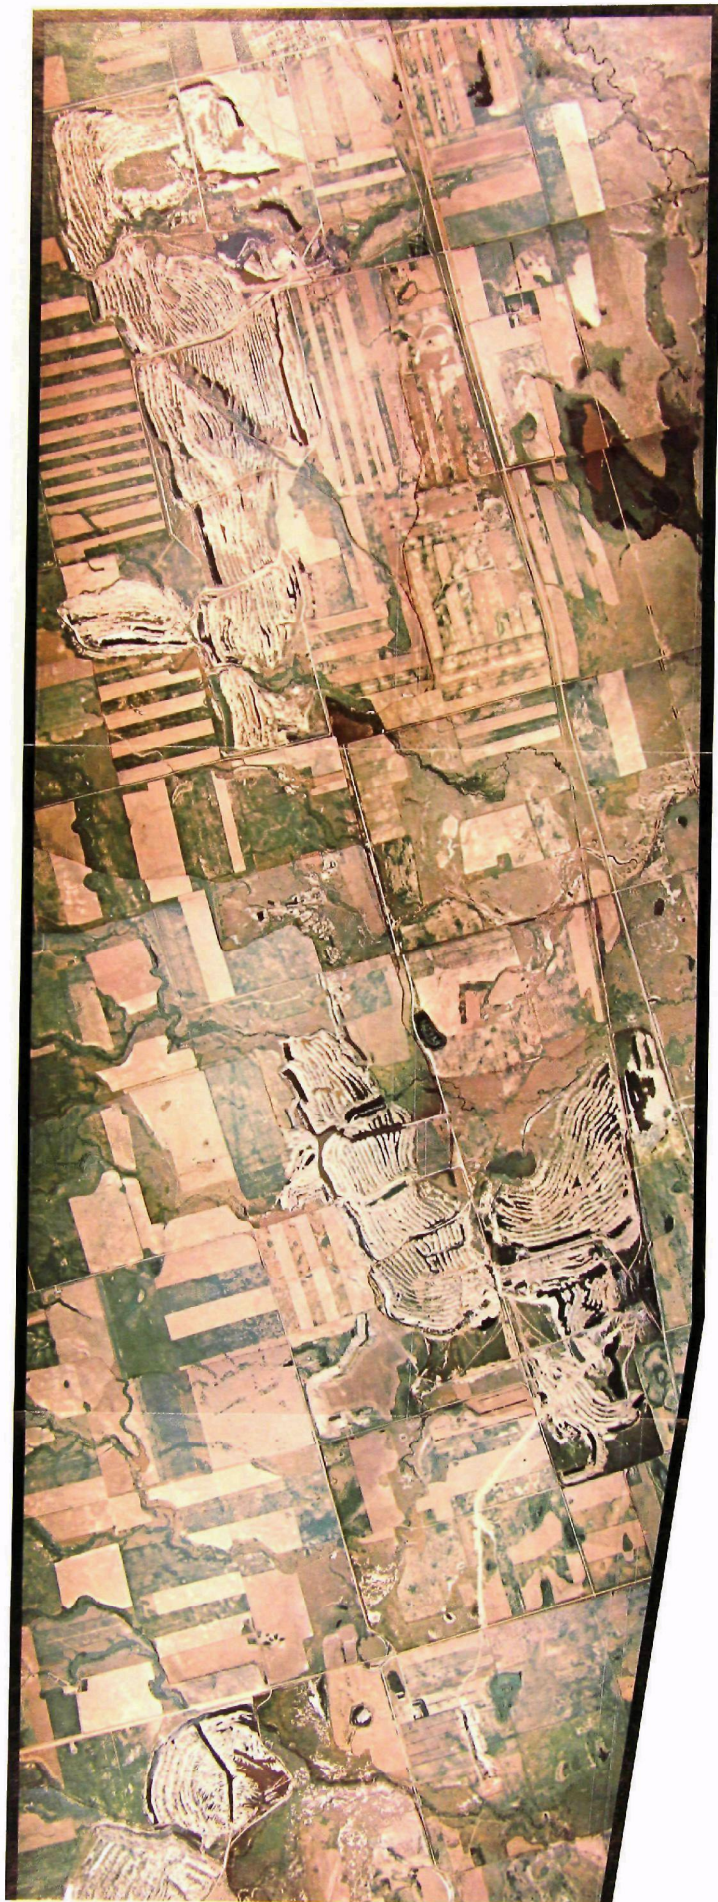
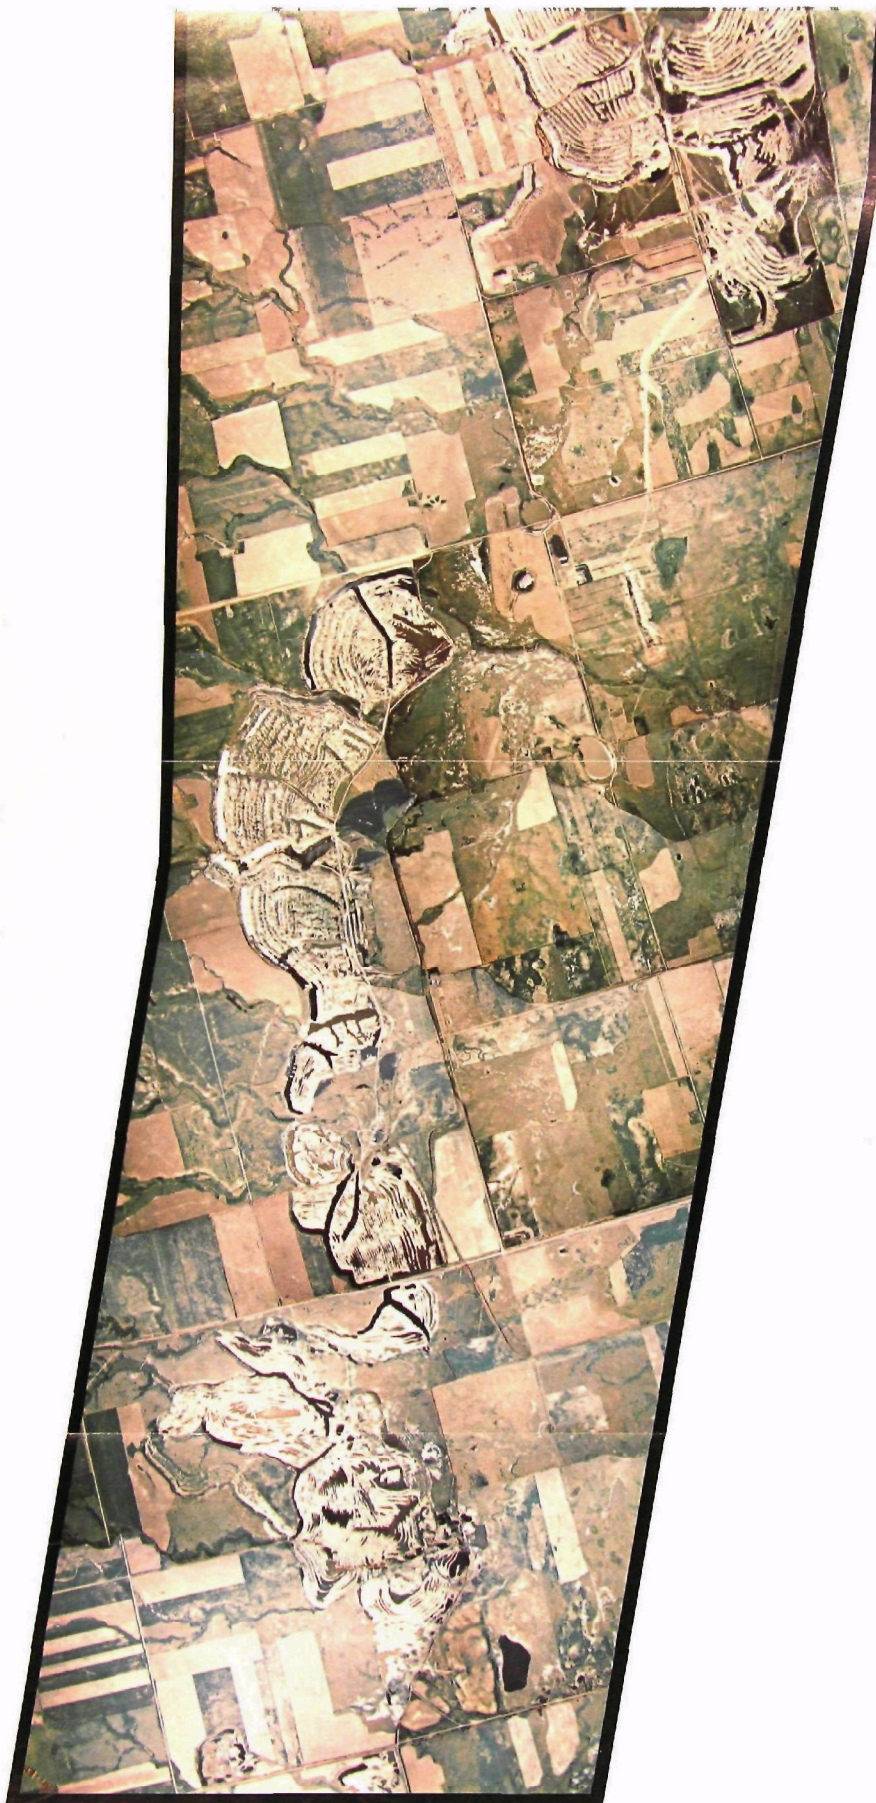
PLATE 31

This mine, which has extended over a very large area, is represented on Plate 31. This true color photography was collected at low altitude on 22 July 1974. The area shows numerous areas of standing water and the imagery suggests a shallow water table. This is a region of thick glacial deposits.

See following page
for title. Photo-
graph presented in
two parts with cen-
ter repeated.

NOONAN MINE
 Baukol Noonan Inc.
 Burke County, North Dakota
 22Jul74 1150-1224 hrs
 (Two pages including pre-
 ceding page)

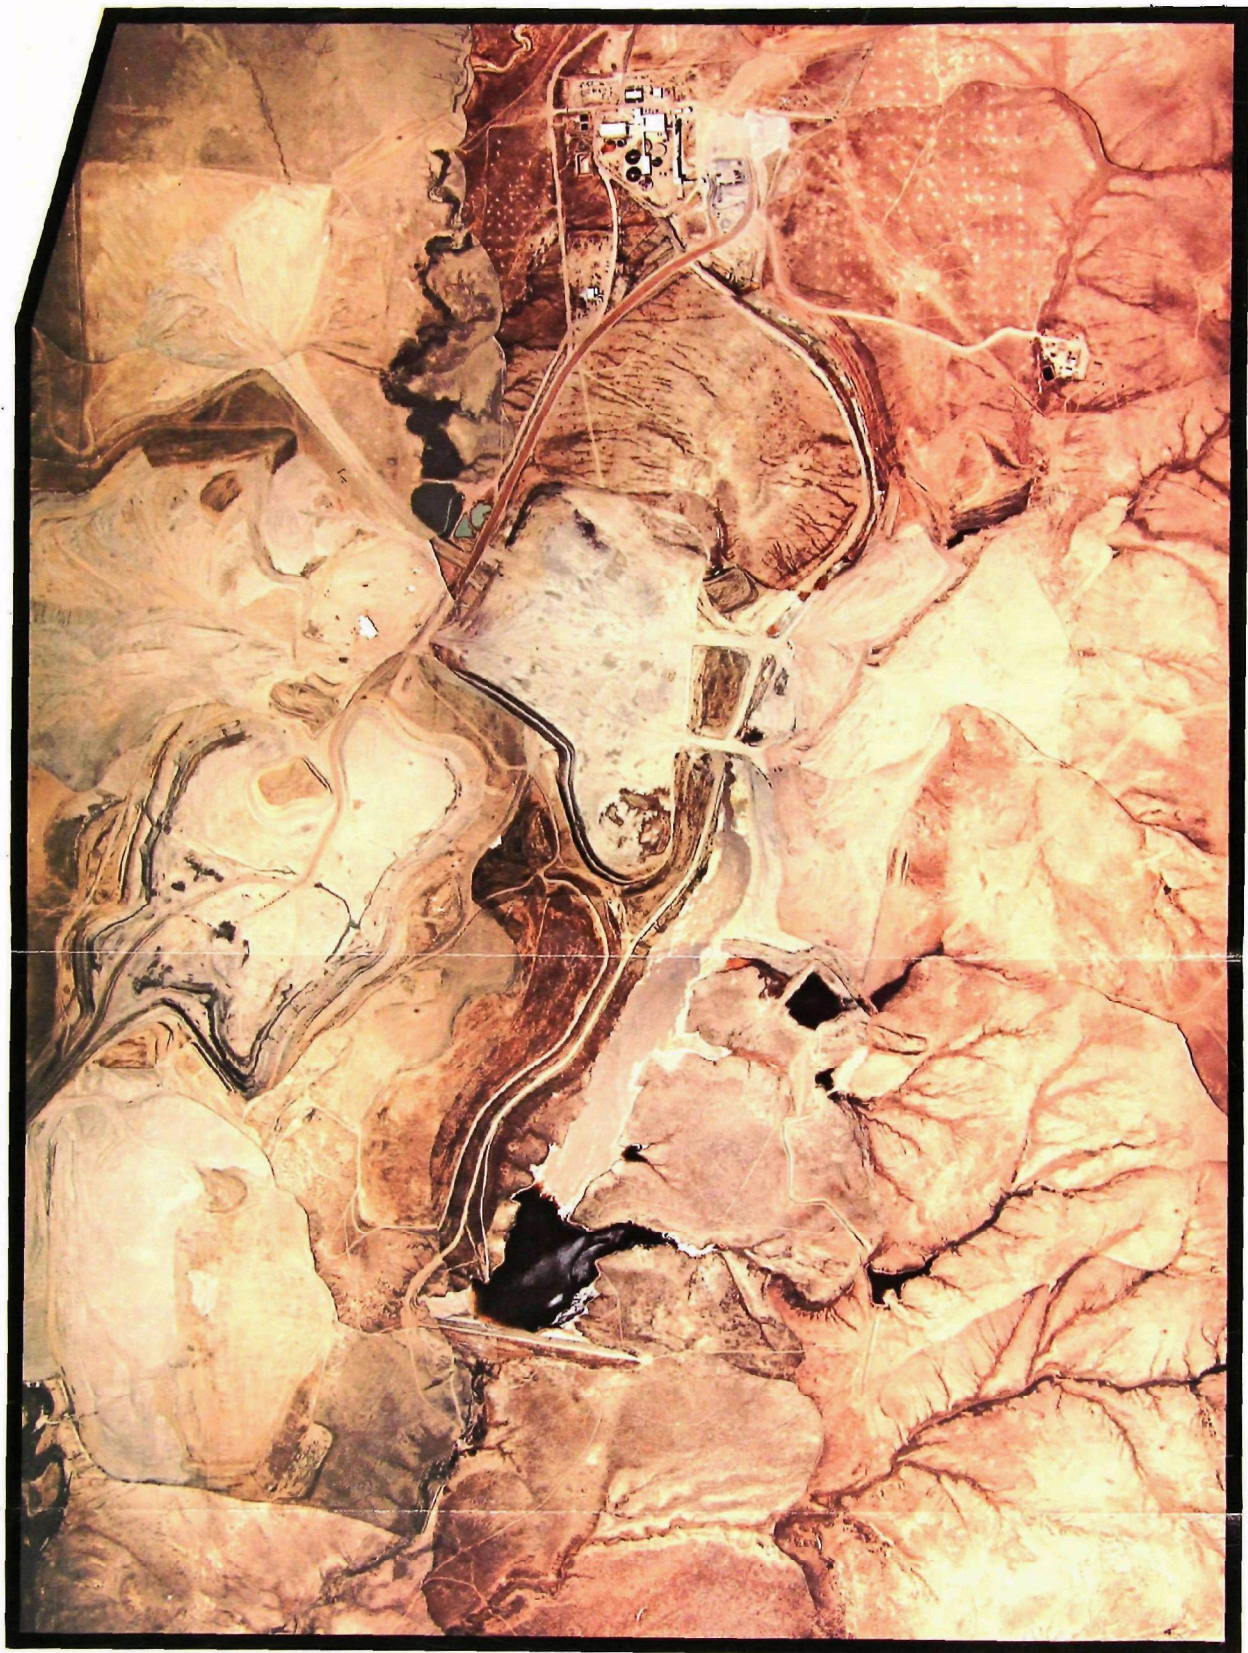
PLATE 32

HIGHLAND MINE (URANIUM)
Exxon
Converse County, Wyoming
19&29Jul74 1107-1139/1123-1124

Vertical aerial imagery makes it somewhat difficult to "see" the open pit of this uranium mine located along the southern boundary of the mosaic. Therefore, we have provided an aerial oblique view of the mine area (Plate 33) and a ground-level view of the mine for perspective. The aerial oblique was collected on 19 July 1974 while the ground-level view was photographed in early June 1974.

"Statistical information" is not provided for this operation. Exploratory drilling is evident along the left (west) side of the mosaic. A north-south fracture pattern is also shown by striations in the area east of the mill. The area to the northeast of the mine pit is an overburden dump and shows vegetative growth. Diversion dams and ditches are located along the northern border of the tailings pond area. Seepage is evident downstream of the tailings pond dam.

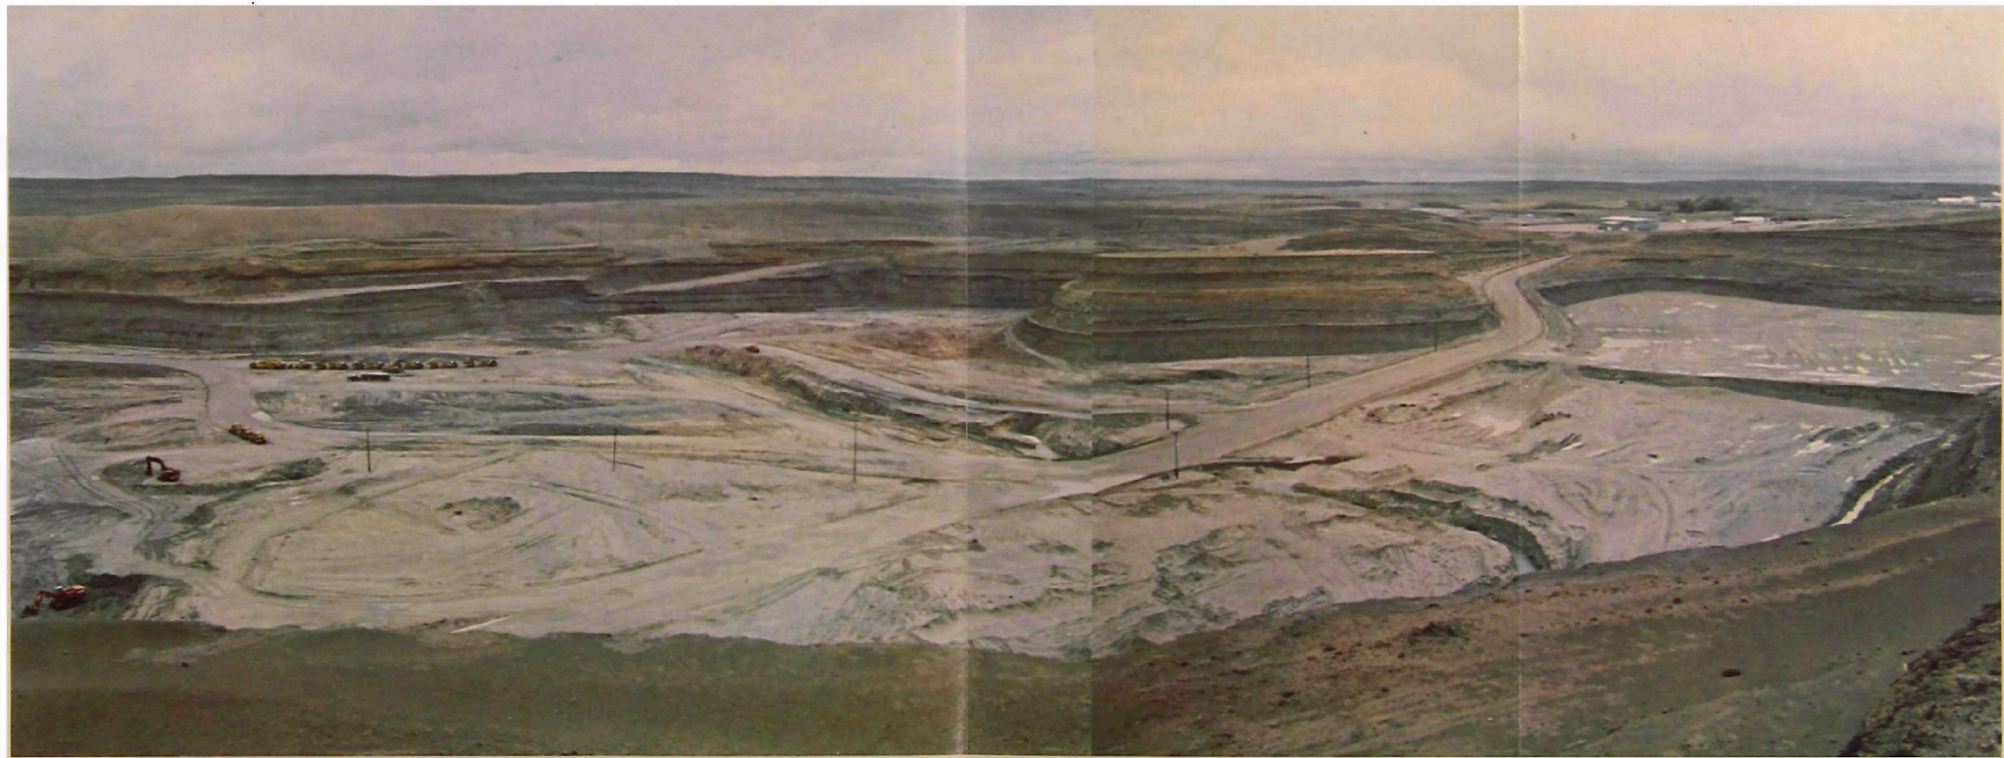
Ground Panorama
Horizon of picture is to the southwest.

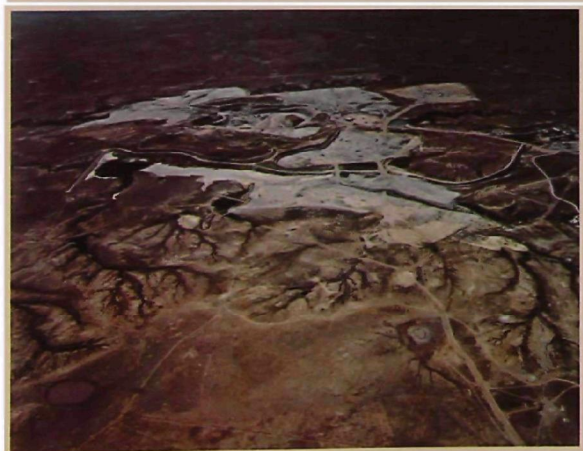
Oblique Aerial
Horizon of picture is to the south.
