SURFACE COAL MINING IN THE NORTHERN GREAT PLAINS OF THE WESTERN UNITED STATES

**AN INTRODUCTION AND INVENTORY UTILIZING AERIAL PHOTOGRAPHY
COLLECTED IN 1974-75**

**ENVIRONMENTAL PROTECTION
AGENCY**

June, 1976

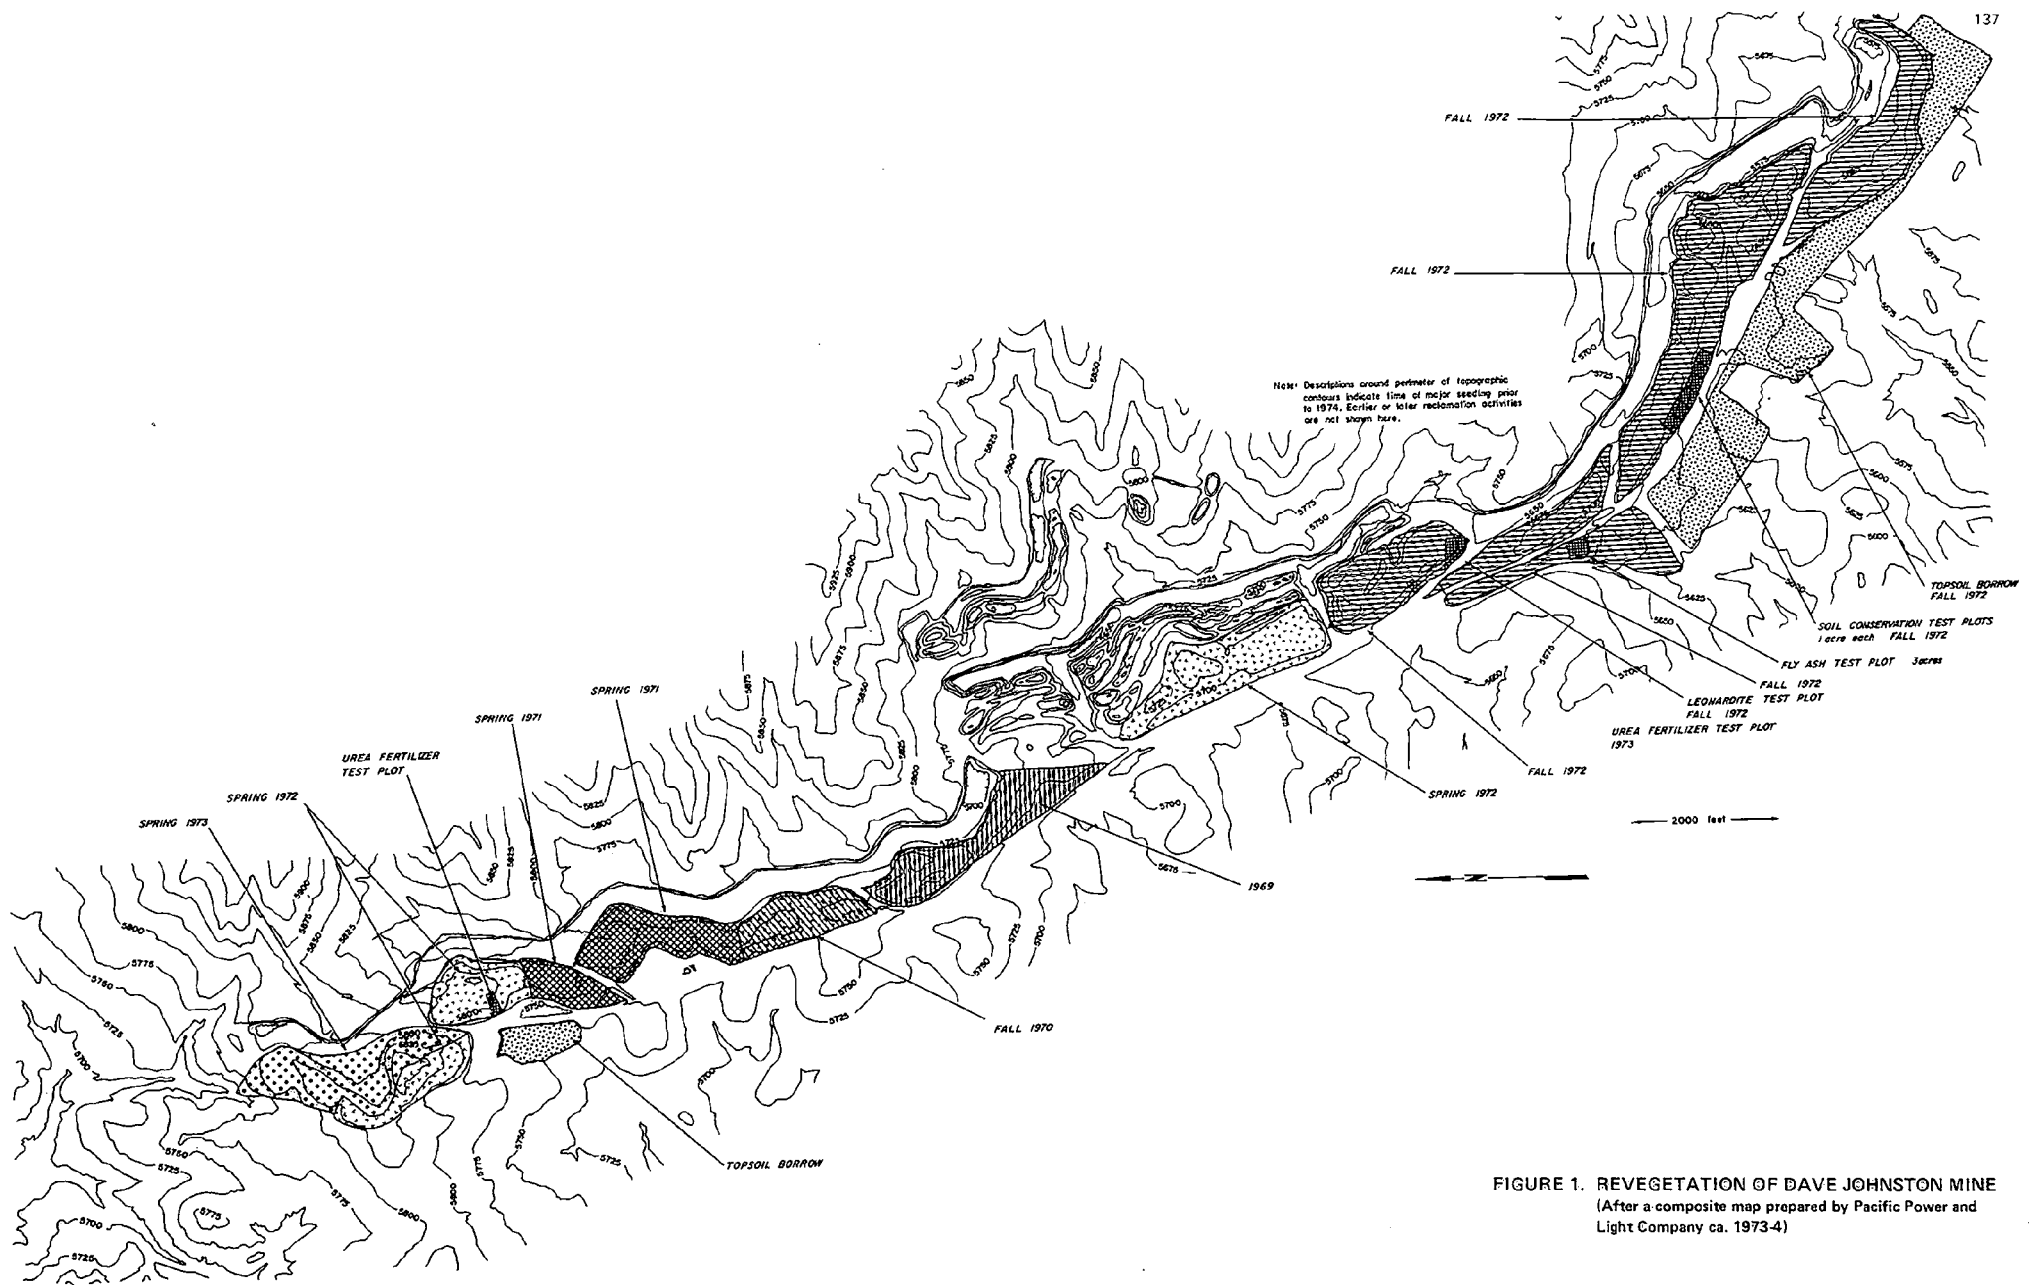
FIGURE 1. REVEGETATION OF DAVE JOHNSTON MINE
(After a composite map prepared by Pacific Power and Light Company ca. 1973-4)

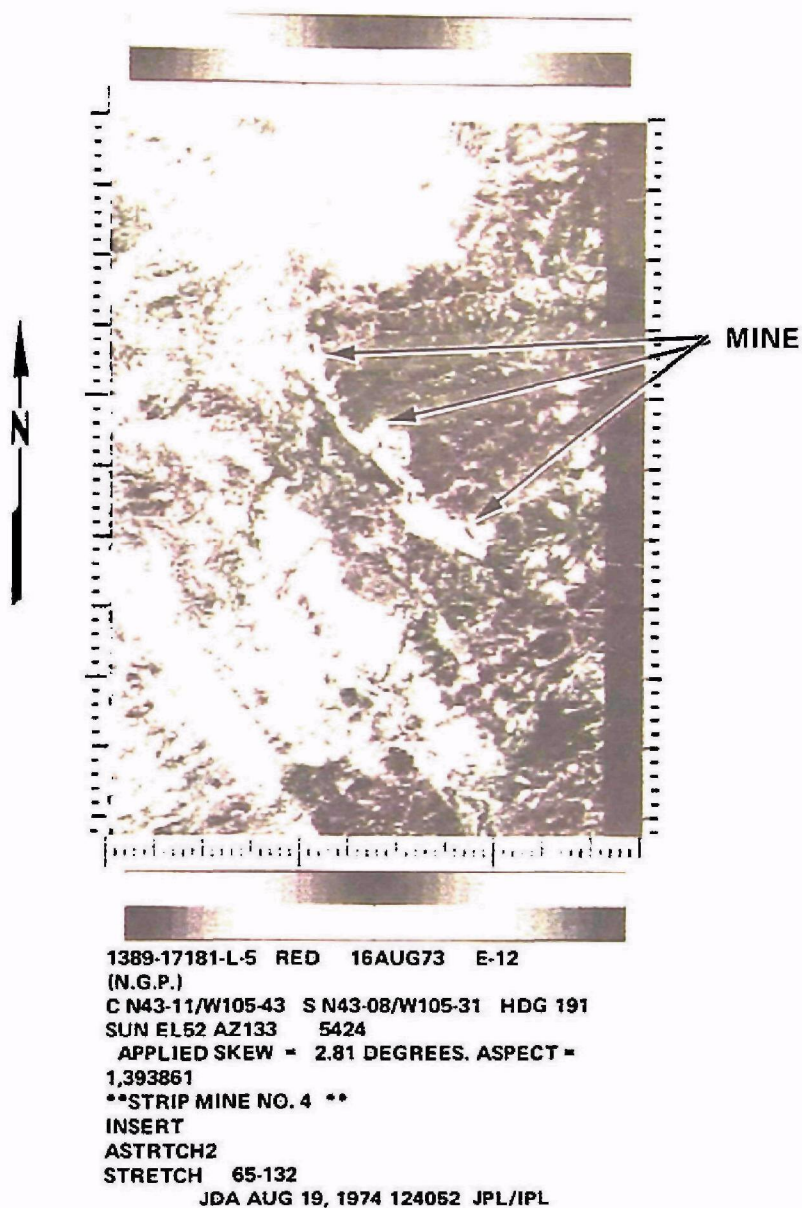
FIGURE 2. SATELLITE IMAGE OF DAVE JOHNSTON MINE

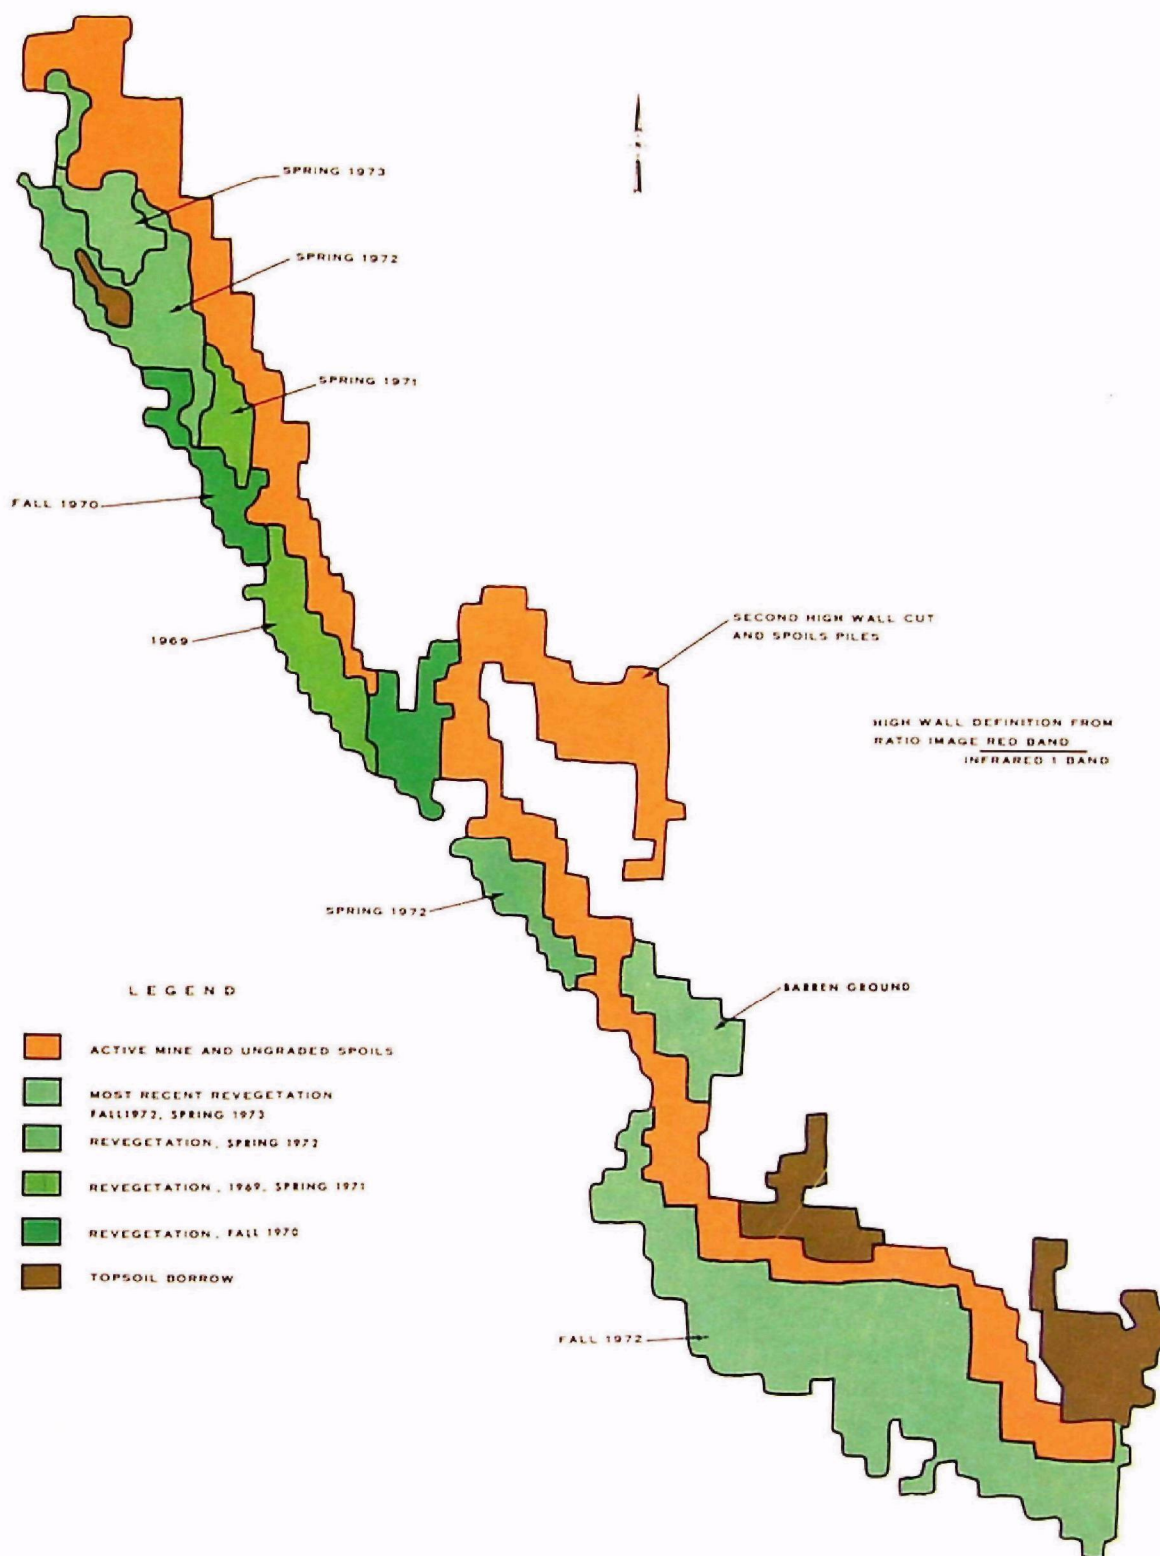
**FIGURE 3. CLASSIFICATION MAP OF DAVE JOHNSTON MINE
GLENROCK, WYOMING
PACIFIC POWER AND LIGHT COMPANY**

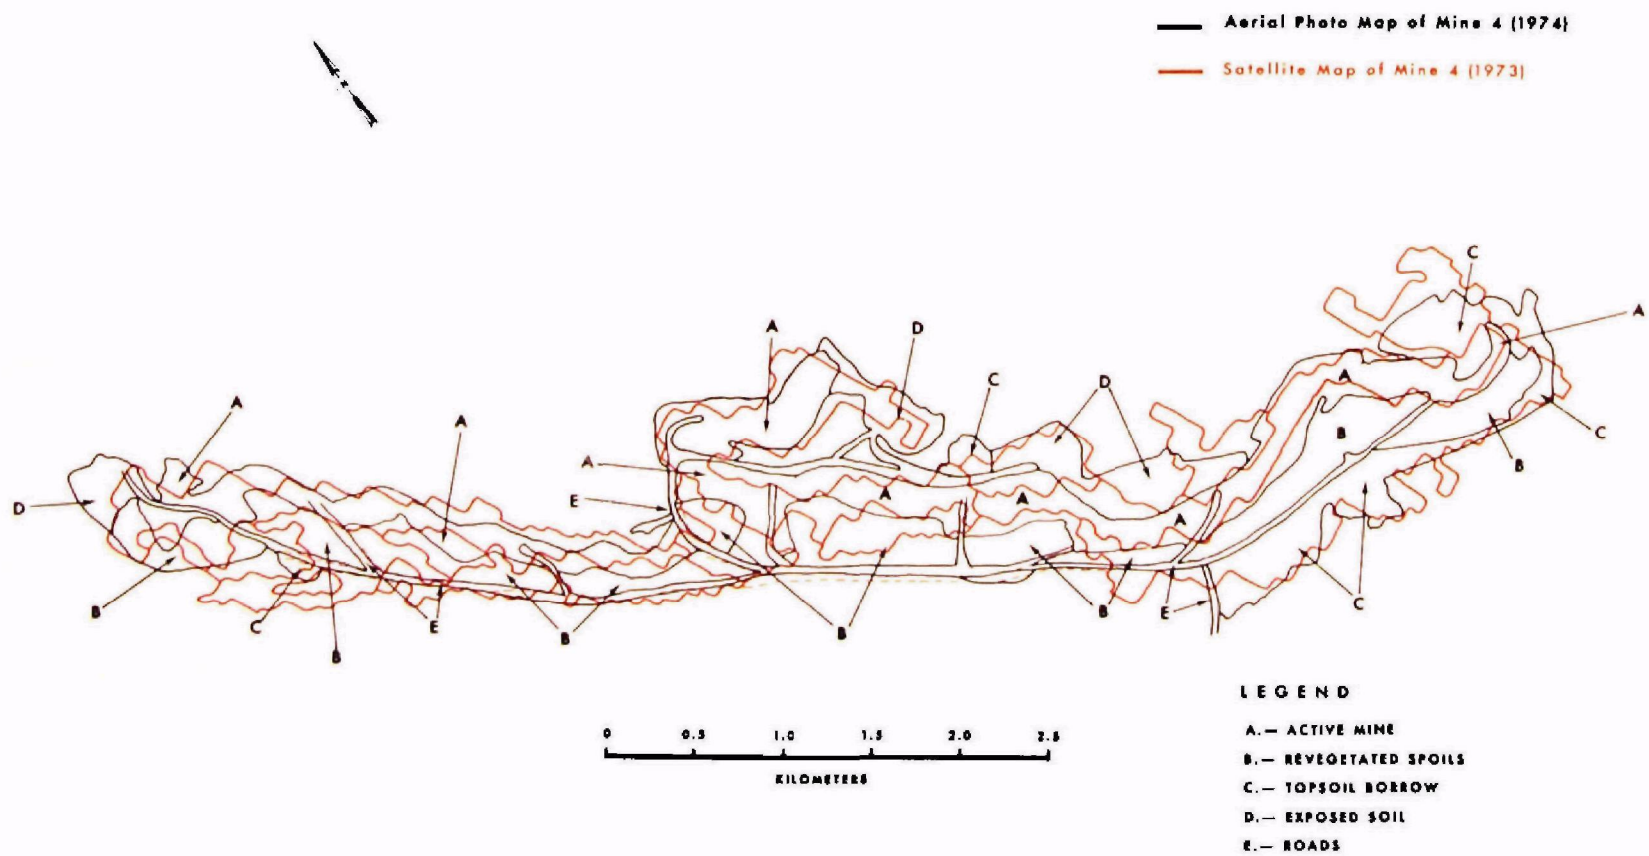
FIGURE 4. A COMPARISON OF DAVE JOHNSTON CLASSIFICATION MAPS

In the northwestern corner of the mine, land revegetated in Spring 1973 was discernible from grass in an adjacent area planted one year earlier. A topsoil borrow area on the west side was also identified. Proceeding to the southeast, revegetated areas planted in 1969, 1970, and 1971 as designated on the map produced spectral signatures the same as undisturbed native vegetation thus indicating that a comparable density of vegetation had been achieved.
