SURFACE COAL MINING IN THE NORTHERN GREAT PLAINS OF THE WESTERN UNITED STATES

**AN INTRODUCTION AND INVENTORY UTILIZING AERIAL PHOTOGRAPHY
COLLECTED IN 1974-75**

**ENVIRONMENTAL PROTECTION
AGENCY**

June, 1976

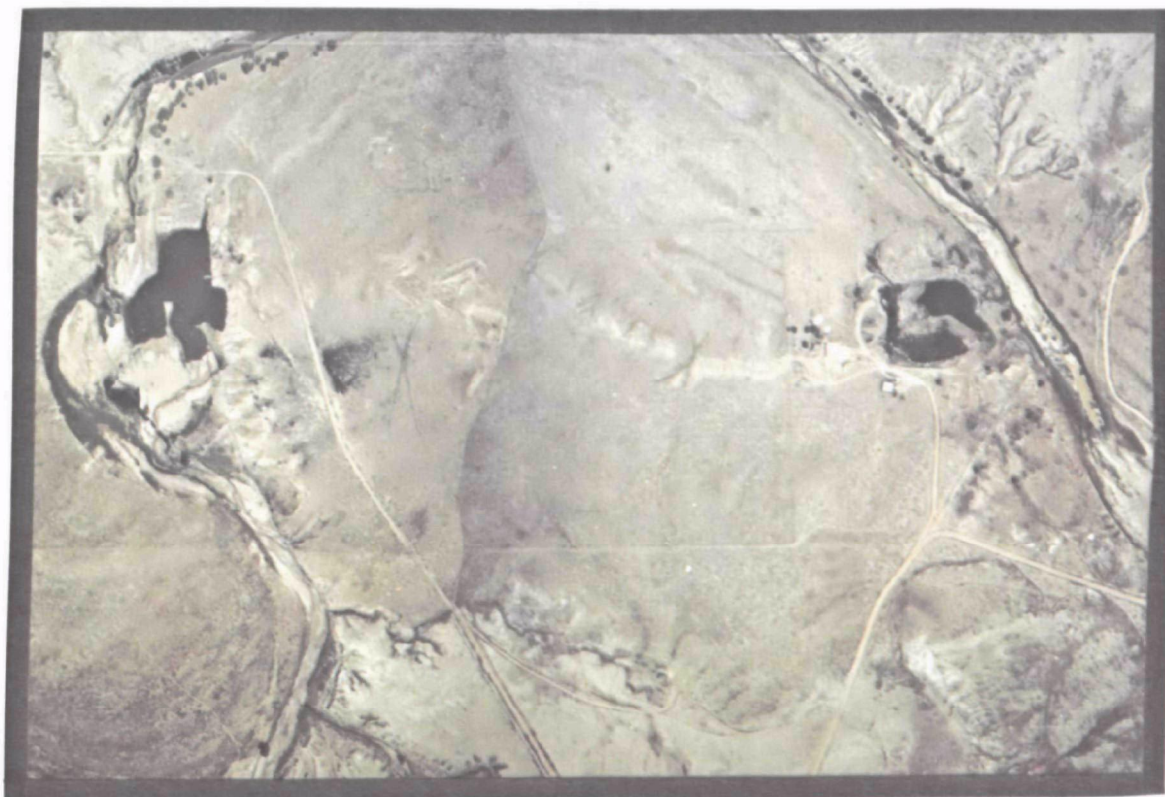
PLATE 4

EAST ANTELOPE MINE
Best Coal Company
Converse County, Wyoming
19Jul74 1201-1202 hrs

This mine is represented in two sets of aerial photography; true color flown on 29 July 1974 and color infrared collected from an altitude of 16,900 meters (55,500 feet) on 23 June 1975. The true color low altitude imagery is presented in mosaic form. The two imagery collection dates, almost one year apart, allow examination of the northward movement of the pit and the initial return of spoils to the southern part of the mine. Growth of perennial vegetation is evidenced in plots at the extreme southeast corner of the mine, but significant moisture availability to vegetation on disturbed lands is not evidenced elsewhere except along the haul road. The area east of the coal load silos has been seeded in the past and vegetative growth of annuals is visible in the 1974 photography, but not in the 1975 photography.

The soil patterns shown in both sets of photography are noteworthy. The yellowish area of the 1975 photography extending south-southeast from the mine is most likely related to the burn line of the coal bed and shows as a reddish tinge at the bottom of the 1974 imagery.

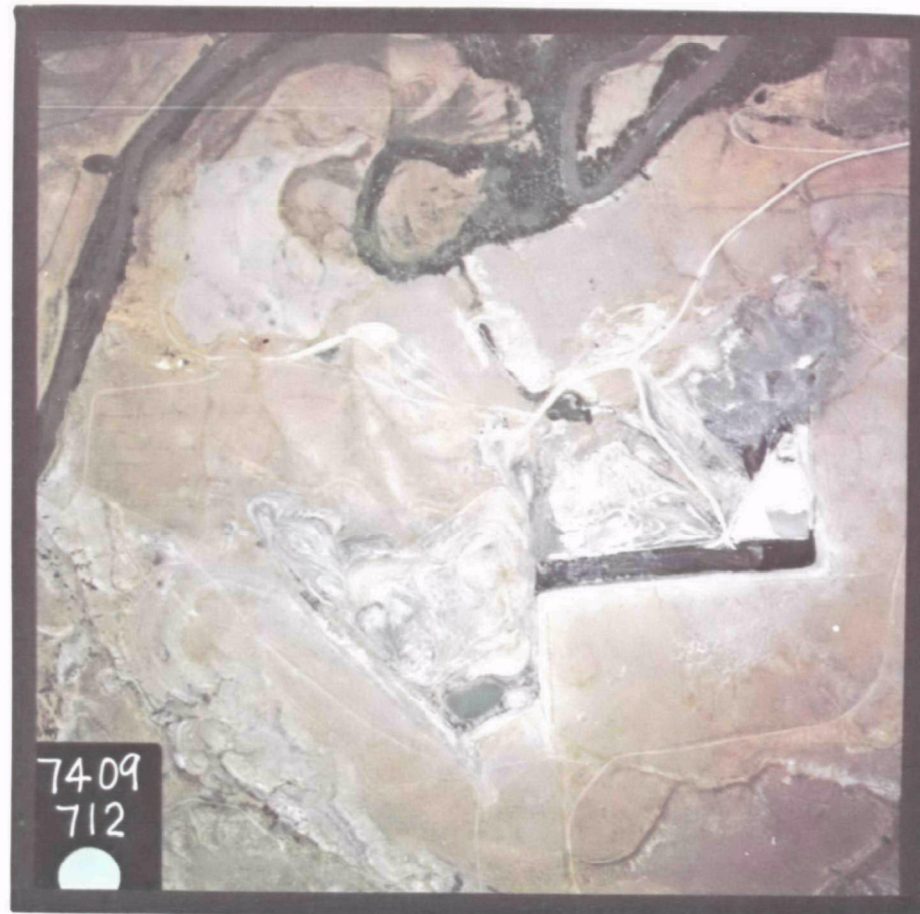
PLATE 9

WELCH STRIP MINE
Welch Coal Company
Sheridan County, Wyoming
20Jul74 1110 hrs

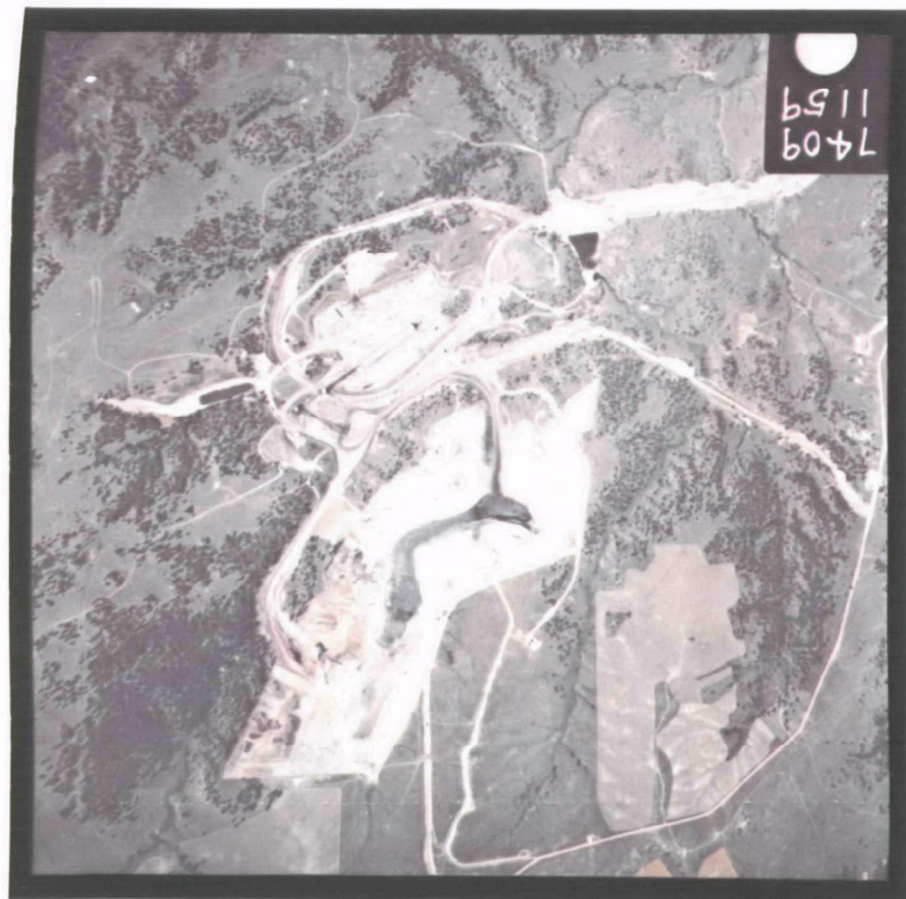
PLATE 14

ABSALOKA MINE (SARPY CREEK)

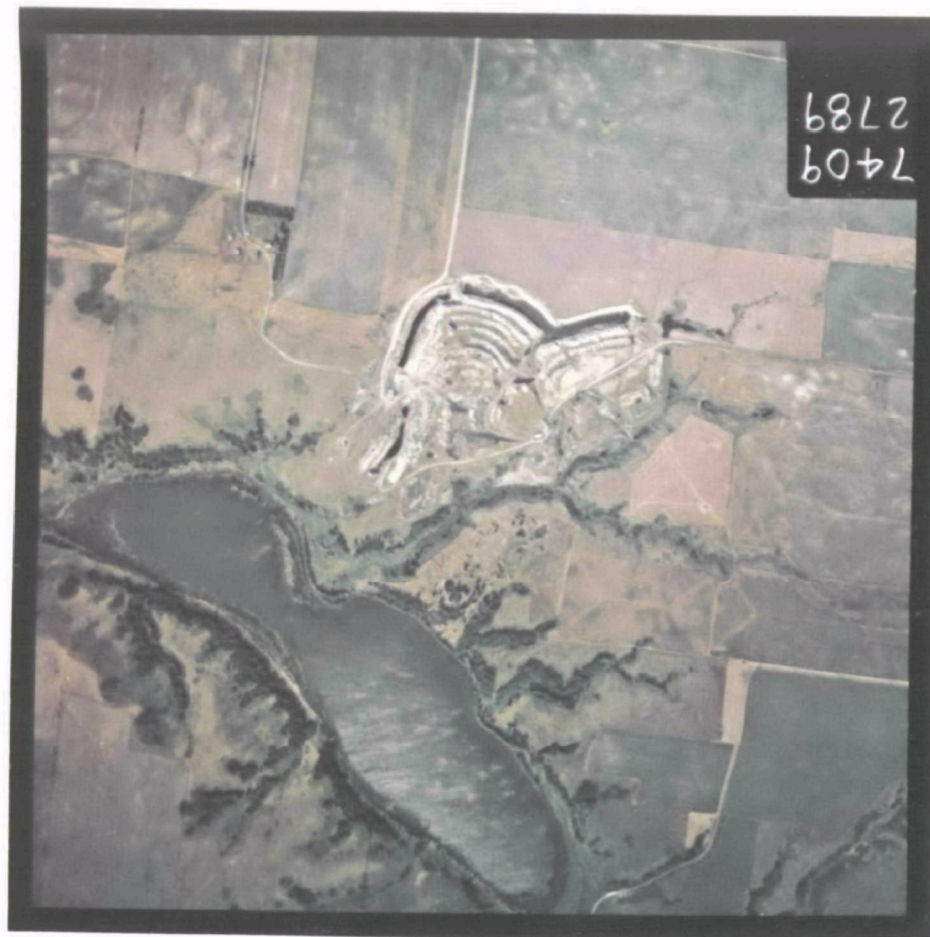
PLATE 29

UNDERWOOD MINE
Underwood Coal Company
McClain County, North Dakota
27Jul74 1230-1232 hrs

This mine, in the past a relatively small operation and closed in 1973, is represented in true color, low altitude photography collected on 27 July 1974. Extensive reclamation is not apparent, but vegetative growth has migrated into the disturbed lands, especially where the spoil piles are somewhat leveled. The area shows signs of a relatively shallow ground water table and water is standing in the open pit areas.

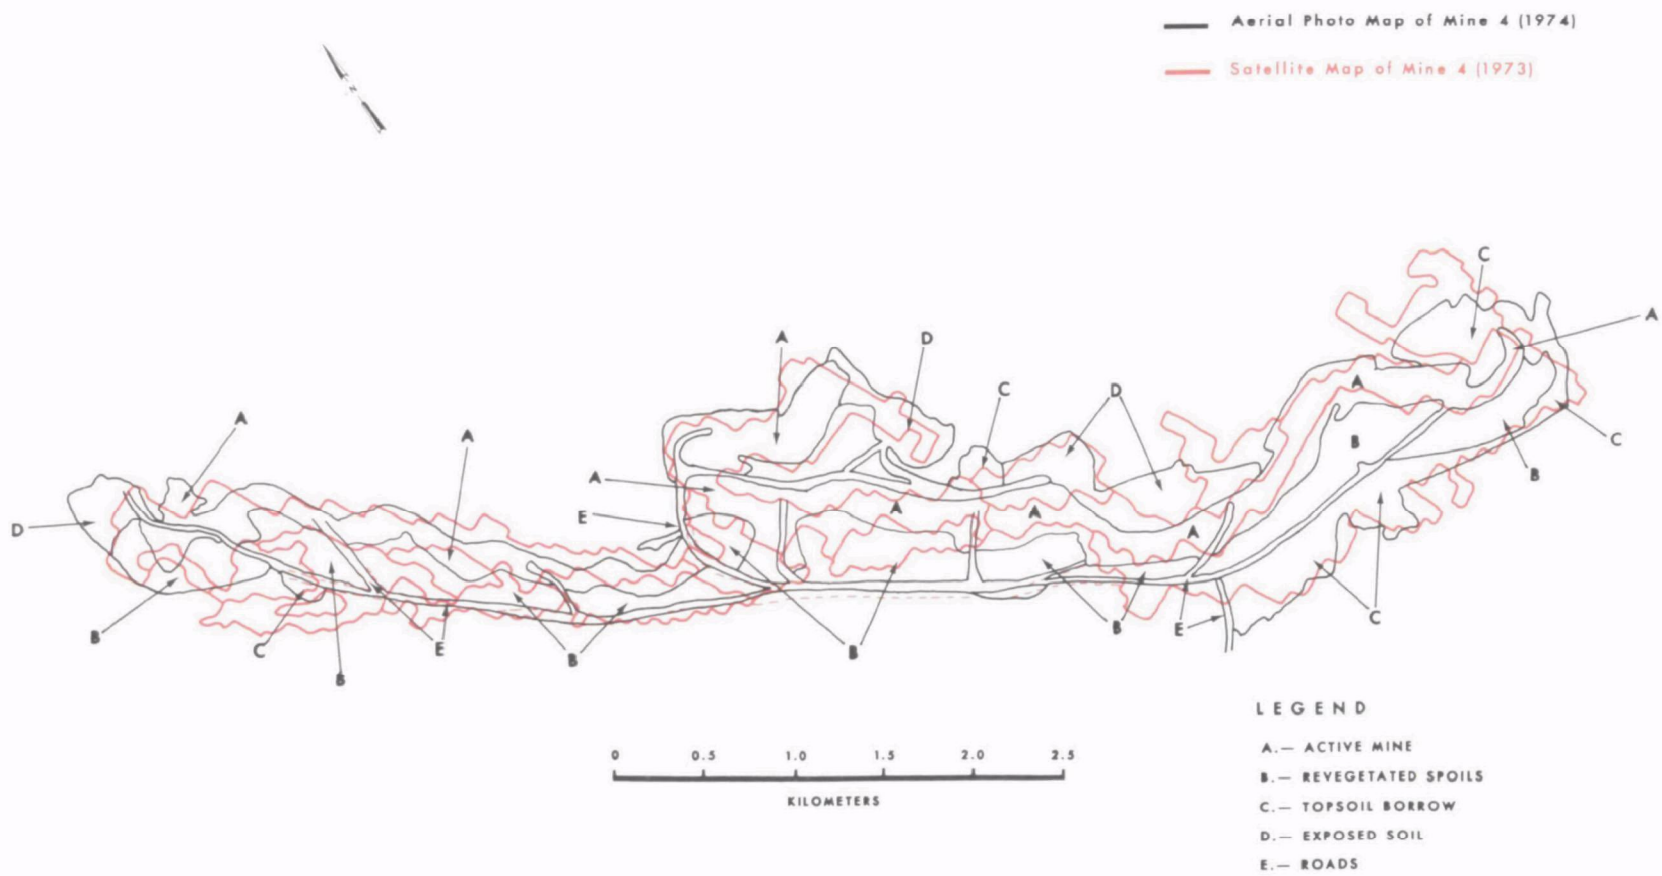
FIGURE 4. A COMPARISON OF DAVE JOHNSTON CLASSIFICATION MAPS

In the northwestern corner of the mine, land revegetated in Spring 1973 was discernible from grass in an adjacent area planted one year earlier. A topsoil borrow area on the west side was also identified. Proceeding to the southeast, revegetated areas planted in 1969, 1970, and 1971 as designated on the map produced spectral signatures the same as undisturbed native vegetation thus indicating that a comparable density of vegetation had been achieved.
