# TECHNOLOGY

Issue 38

October 2008

### Innovative Dredging Technology Accelerates Removal of Residual Contamination in Ashtabula River

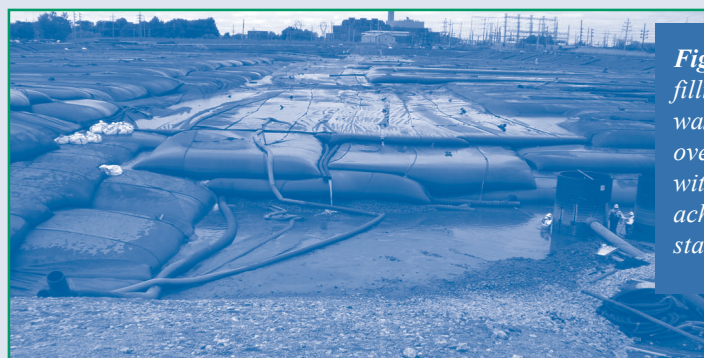
**Figure 1.** Prior to filling, each tube was placed in an overlaying pattern within the landfill to achieve a 10-layer stack.

Partnership, submitted a request to the GLNPO requesting funds under the newly authorized Great Lakes Legacy Act (GLLA). After extended technical, legal, and financial discussions, active remediation on the \$58 million river project began in 2006, with the GLLA providing \$29 million in funding. The final design called for hydraulic excavation of sediments; hydraulic transport of the dredged slurry to the landfill through a 2.5-mile long, double-walled pipeline; dewatering of the sediment slurry using geotubes; and treatment of the water through a 5,000-gpm water treatment plant. Dewatering was designed to occur at the 1,000,000-yd<sup>3</sup> TSCA-permitted landfill, with geo-textile tubes (geotubes) left in place for final disposal (Figure 1).

At the landfill, the sediment slurry was pumped into geotubes that were approximately 300 feet long and 75 feet in diameter. As slurry moved into each tube, a polymer was added to increase coagulation of sediment particles. Coagulated particles remained inside the geotubes while slurry water exited by gravity through pores of the geotube's woven material. Filled tubes were allowed to air dry for approximately 15 days in order to achieve a solids content of approximately 40% before additional tubes were placed on them. The 13.5-acre TSCA-permitted landfill was constructed with two 60-mil synthetic liners, a geosynthetic clay liner, and several drainage layers along with a leachate collection system.

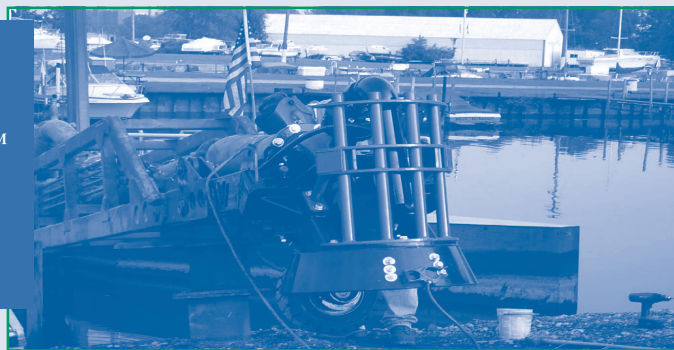
**Figure 2.** The 8-inch hydraulic dredge with attached Vic-Vac™ prepares to launch in target portions of the Ashtabula River AOC.

equipped with an innovative Vic-Vac™ suction dredge-head (Figure 2). The 8-inch dredge operated in parallel with the 12-inch dredge, with both simultaneously discharging to the double-walled pipeline. By operating in parallel, the 12-inch dredge could focus on high production dredging that generated thicker cuts, while the 8-inch dredge focused on cleanup dredging that generated thin residual sediment layers. Typically, cleanup dredging results in hydraulic slurries with just 1-2% percent solids, which can present problems with dewatering and water treatment. By operating parallel dredges and combining the slurry streams, however, operations were able to maintain a consistent and reasonably high solids content (8-15%) in the combined slurry while performing cleanup operations specifically targeted at reducing residual contamination. The 8-inch dredge operated at an average production rate of approximately 1,000 gpm, and the 12-inch dredge operated at an average rate of 3,500 gpm. Cleanup dredging was performed on approximately 10 of the site's total 30 acres where underlying bedrock prevented overdredging of contaminated sediments.

Previous experience at this and other sites suggested that significant amounts of residual contamination would remain in these dredged areas. Confirmation sampling after dredging indicated, however, that in areas where the Vic-Vac was used, the surface-weighted average concentration was 0.1 mg/kg total PCBs, well below the long-term cleanup goal.

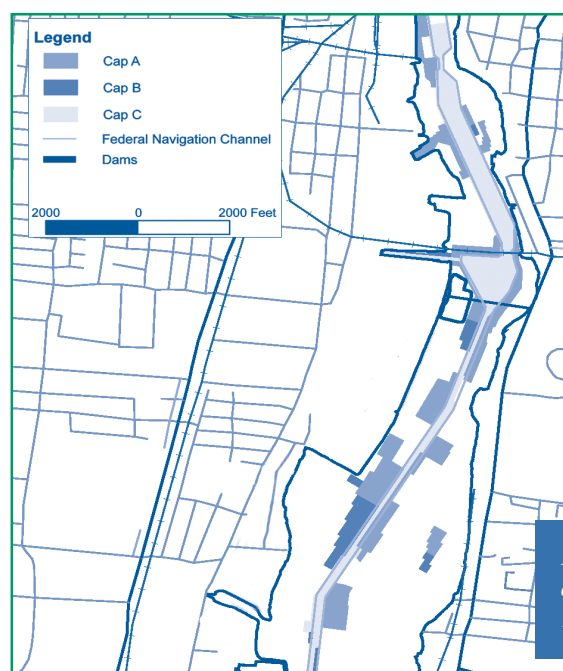
**Figure 3.** “Cap C” armored caps will cover approximately 100 acres in OU 4.

consists of a 33-inch layer of sand, gravel, and quarry spall. For design and construction purposes, this cap type was designated as a “Cap C.” (Figure 3). In other areas, the cap consists of 13 inches of sand and gravel (Cap A) covering approximately 200 acres, or 16 inches of sand and gravel (Cap B) covering approximately 70 acres. An estimated 25 additional acres of shoreline caps will be constructed using larger armor stone to be determined case by case. The areal extent of each cap and total acreage of cap types is subject to ongoing refinement. Other areas having sediment profiles with PCB concentrations below 2 ppm or in thin deposits (6 inches or less) are covered with 6 inches of clean sand imported from local sand and gravel pits. Shortly after placement, the thickness of each cap layer is verified to specified engineering standards.

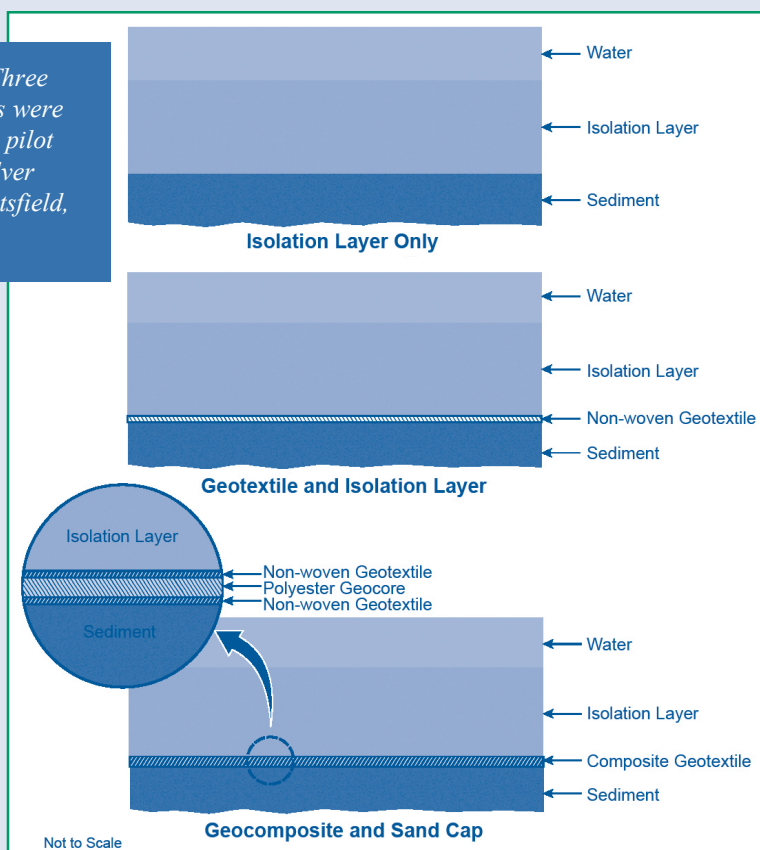
**Figure 4.** Three cap designs were used in the pilot study at Silver Lake in Pittsfield, MA.

Between early October and late November 2006, the pilot study was conducted at three contiguous 45-ft by 300-ft sub-areas. An isolation layer was placed directly on the soft sediment in one sub-area (Figure 4). This layer contained 2.5 parts pond sand (by volume) mixed with 1 part topsoil using conventional earth-moving equipment to achieve approximately 1% total organic carbon (TOC) in the dry mix. A custom-made, barge-mounted, spreader box broadcasted slurried material in thin 1- to 2-inch lifts to minimize the potential for resuspension and mixing of the underlying sediments. The thin lifts also help avoid settlement or slope failure resulting from the relatively low-strength, highly-compressible sediments and steep slope of the lake floor near the shore. The lifts were broadcasted until a depth of 12-14 inches was achieved.

The second sub-area was covered with a non-woven geotextile before subsequent placement of the same isolation material. Three 15-ft wide by 300-foot long rolls of

The third sub-area was covered with a composite geotextile mat before placement of the isolation layer. The composite geotextile was constructed of two layers of a non-woven geotextile sewn together and filled with a thin layer (less than 1 inch) of a sand/organo-clay mix. The mix had a TOC similar to the isolation layer. This composite configuration was prepared in nine rolls (about 15-feet wide by 100-feet long) that were sewn together and unrolled from the barge similar to the non-
