**Arsenic Removal from Drinking Water by Adsorptive Media
U.S. EPA Demonstration Project at
Chateau Estates Mobile Home Park in Springfield, OH
Six-Month Evaluation Report**

**Battelle
Columbus, OH 43201-2693**

**National Risk Management Research Laboratory
Office of Research and Development
U.S. Environmental Protection Agency
Cincinnati, Ohio 45268**

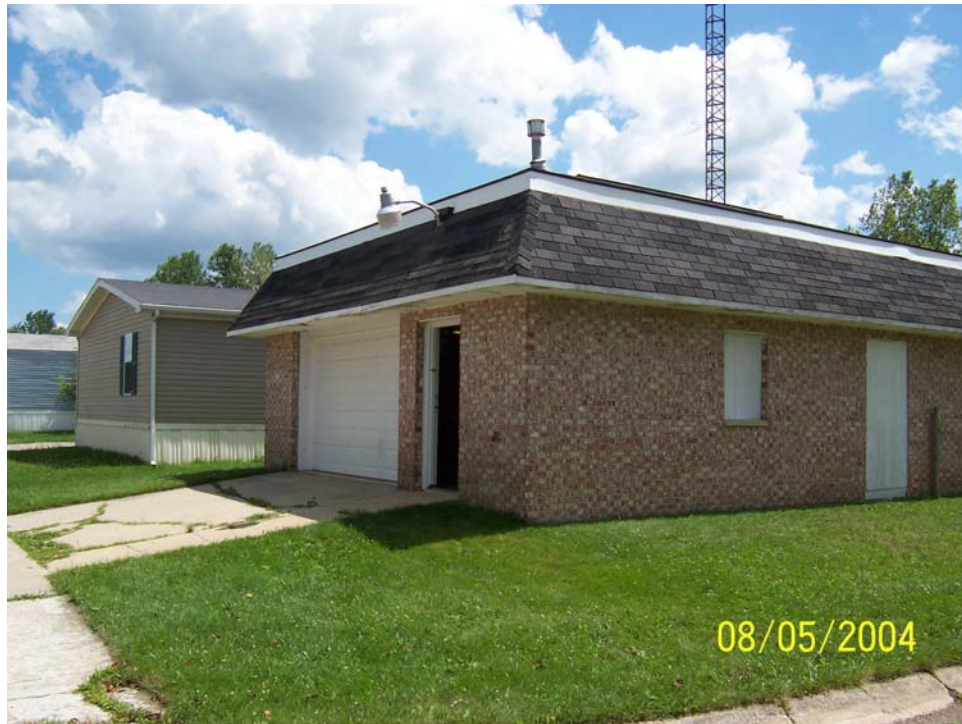
Figure 4-1. Pre-Existing Treatment Building at Chateau Estates Mobile Home Park

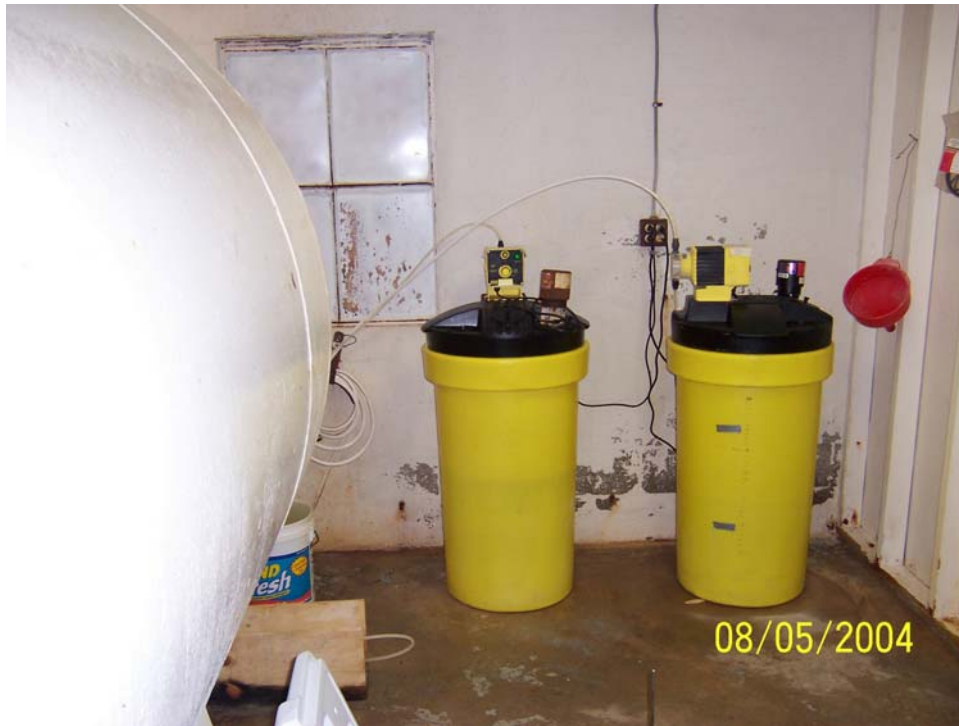
Figure 4-2. Pre-Existing Chlorine and Polyphosphate Addition Systems

The pre-existing water treatment system consisted of chlorination using a 12.5% NaOCl solution and addition of polyphosphate as a sequestering agent for corrosion and scale control. Figure 4-2 shows the chlorine and polyphosphate storage tanks and chemical metering pumps. Following chlorination and polyphosphate addition, extracted water was stored in a 2,000-gal hydropneumatic tank (Figure 4-3) prior to entering the distribution system.

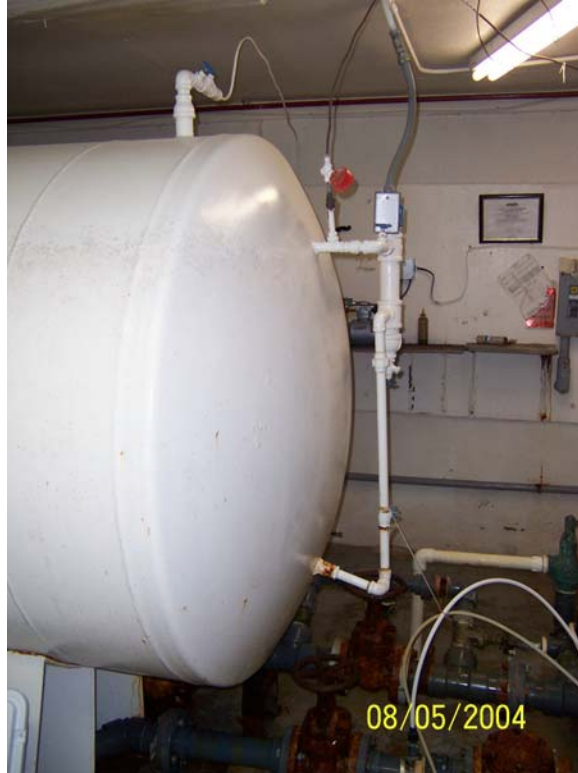
Figure 4-3. Pre-Existing Storage Tank

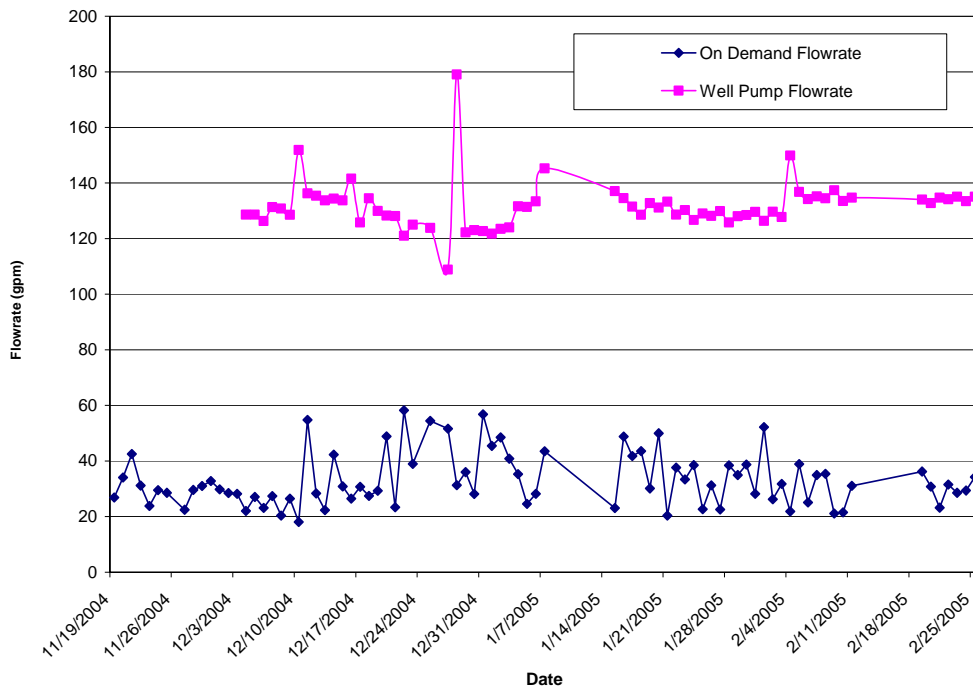
Figure 4-4. West Well Pump Flowrate and On-Demand Flowrate

Before the installation of the water treatment system, the West Well typically operated for approximately 5 hr/day, producing around 40,000 gal of water based on estimates provided by the facility. To help verify the flowrate of the West Well and the average flowrate to the distribution system from the existing hydropneumatic tank, a flow meter was installed downstream of the hydropneumatic tank in mid-November 2004. Readings from the flow meter and an hour meter (installed in early December 2004) on

the West Well pump were collected until the end of February 2005. These readings confirmed that, on average, the West Well pump operated 5.6 hr/day and produced an average of 43,740 gal.

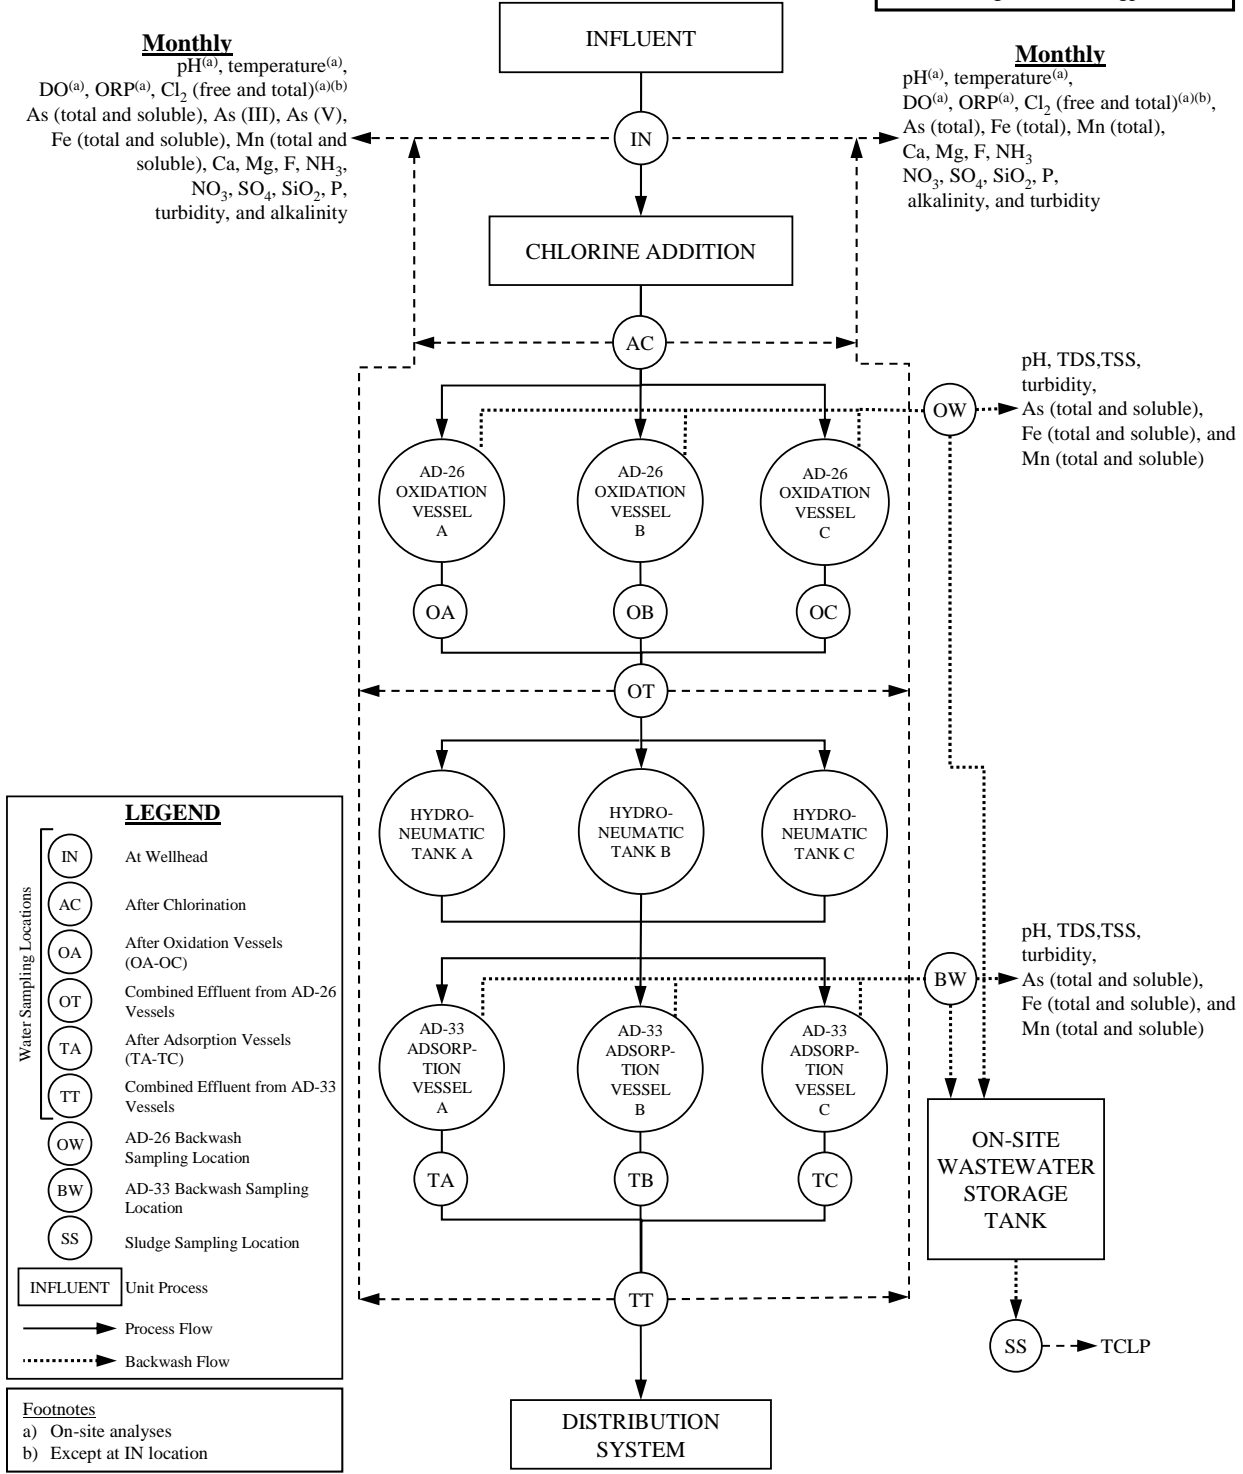
Springfield, OH
 AD26/AD33 Technology
 Design Flow: 250 gpm

Figure 4-5. Process Flow Diagram and Sampling Location

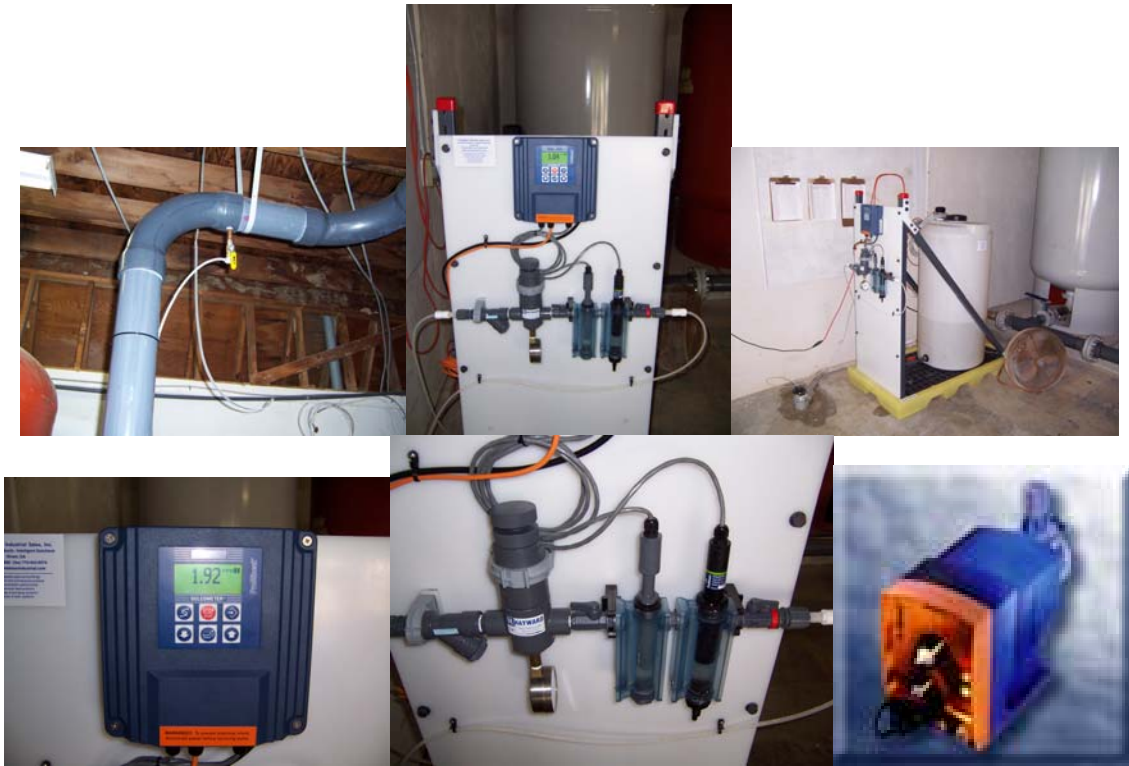
Figure 4-6. Chlorine Injection System

(Clockwise from Top: Chlorine Injection Point; Chlorine Monitor/Control Module; Chlorine Injection System; Metering Pump; Chlorine Sensor; Chlorine Monitor/Controller)

4.4.2 Chlorine Injection. As described in Section 4.2, chlorine was added as an oxidant to oxidize As(III) and Fe(II) using a 12.5% NaOCl solution. The chlorine injection system experienced operational irregularities during the first six months of system operation, as reflected by a variation of free and total chlorine residuals measured at the entry point shown in Figure 4-15. After system startup, with a free chlorine set point of 2.5 mg/L (as Cl₂), free and total chlorine residuals varied considerably from 0.34 to 3.49 mg/L and from 0.43 to 3.91 mg/L (as Cl₂), respectively, which, at the time, were thought to have been caused by the fluctuating on-demand flow flowing through the treatment system. The system was, therefore, reconfigured on October 26, 2005, so that the chlorine addition system and the AD-26 system were located before the hydropneumatic tanks and operated based on the well flowrate of either 130 or 90 gpm. Table 4-6 summarizes timelines of the settings and activities associated with the chlorine injection system.

In addition to the problems related to elevated free and total chlorine residuals, the presence of iron particles after chlorination caused the inline chlorine probe and tubing leading from the inline mixer to the chlorine probe to clog. As a result, erratic readings were taken by the chlorine monitor, causing a wide variation of chlorine levels in water. The operator has included the cleaning of the relevant system components as part of the routine system O&M. The vendor has been informed of the problems and continued to monitor and troubleshoot the problems.

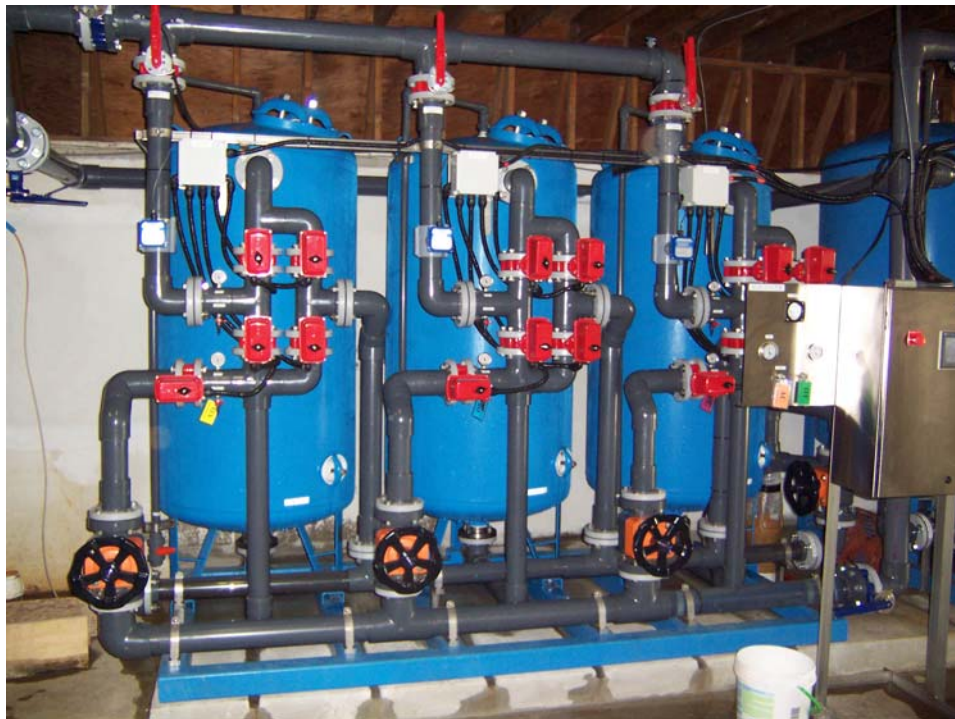
Figure 4-7. AD-26 Treatment System

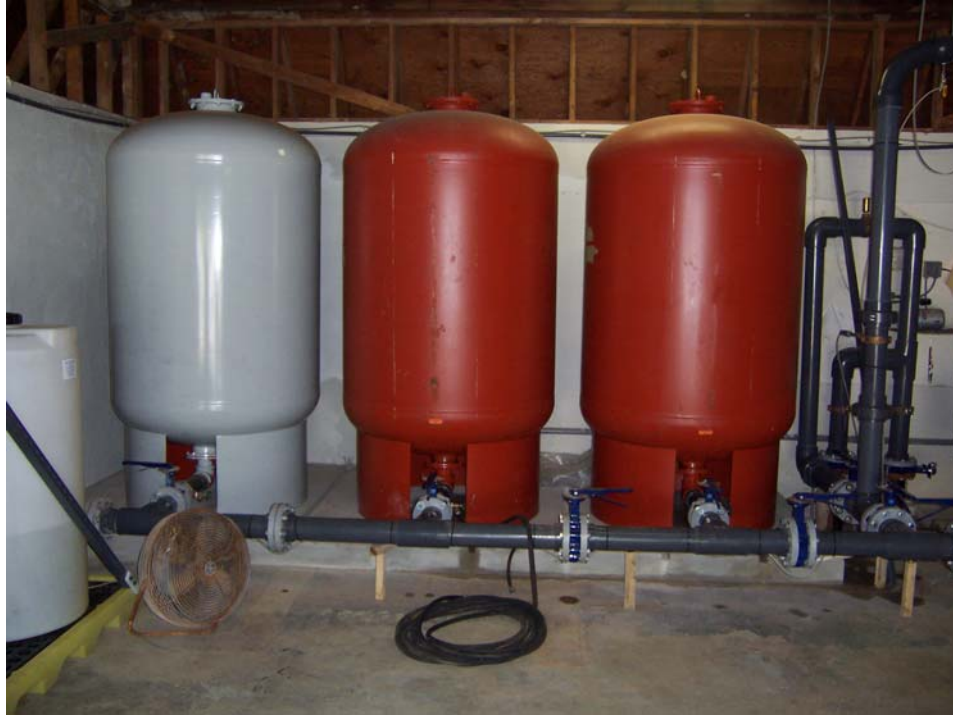
- **Hydropneumatic Tanks.** The filtered water from the AD-26 system entered the three hydropneumatic tanks for storage until needed to meet demand. Each tank had a storage capacity of 528 gal for a total capacity of 1,584 gal. Figure 4-8 is a photograph of the three hydropneumatic tanks.

Figure 4-8. Hydropneumatic Tanks

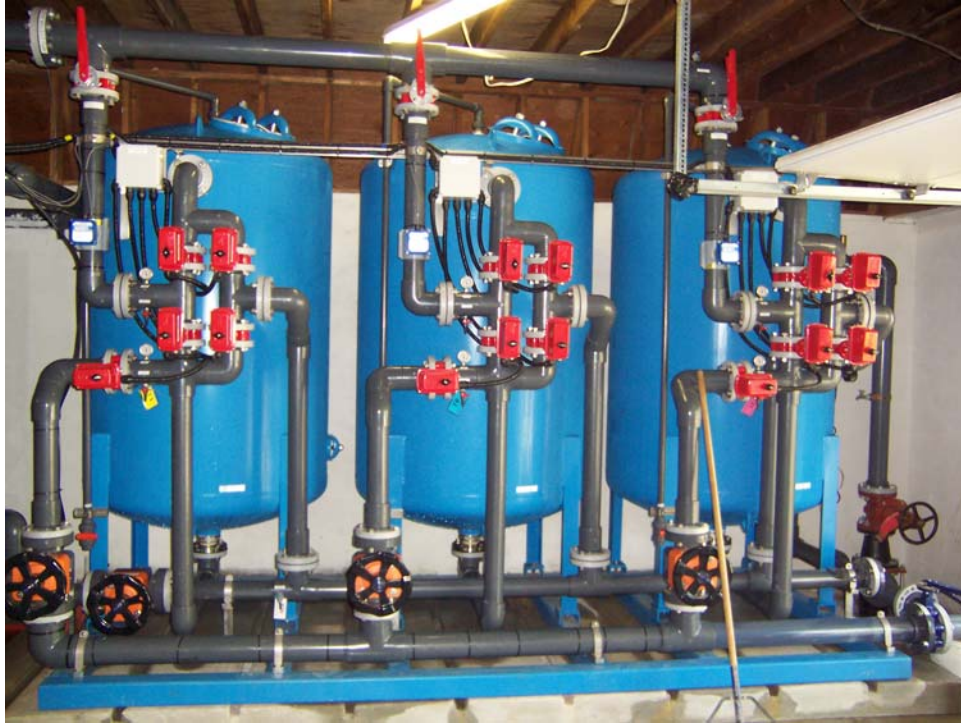
Figure 4-9. AD-33 Treatment System

- **Arsenic Adsorption.** Upon demand, water stored in the hydropneumatic tanks flowed through the APU arsenic adsorption system at a varying flowrate. As discussed in Section 4.1, flowrates ranging from 18.1 to 58.2 gpm and averaging 33.0 gpm (Figure 4-4) were recorded flowing from the existing hydropneumatic tank to the distribution system during a pre-demonstration water demand study. The APU system consisted of three 48-in-diameter, 60-in-sidewall height carbon steel pressure vessels also configured in parallel. Each of the APU vessels contained approximately 38 ft³ (114 ft³ total) of AD-33 media. Assuming a flowrate of 33.0 gpm (or 11.0 gpm/vessel), the media empty bed contact time (EBCT) in each vessel would be 25.8 min, which is at least 5 times higher than that recommended by the vendor. Figure 4-9 is a photograph of the APU system. Similar to the AD-26 system, the APU system was controlled by a series of electrically actuated butterfly valves and the PLC unit. Figure 4-10 presents a photograph of the APU control panel.

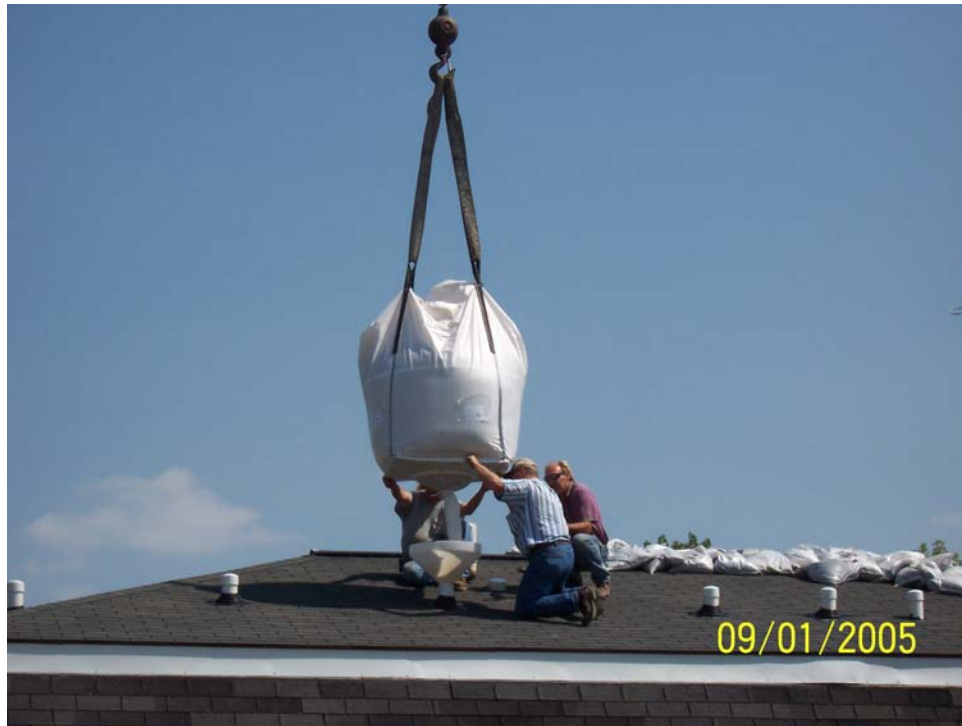
Figure 4-11. AD-33 Media Loading

Upon completion of system installation, the media vessels were tested hydraulically before media loading on September 1, 2005. For the APU system, six 100-lb bags of coarse gravel (for a total of 600 lb [or 6 ft³]), three 100-lb bags of fine gravel (for a total of 300 lb [or 3 ft³]), and one and one fifth 1,100-lb supersacks of the AD-33 media (for a total of 1,330 lb [or 38 ft³]) were loaded sequentially into each vessel containing approximately half a tank of water. Figure 4-11 shows a photograph of loading the AD-33 media from a supersack through a hatch on the roof of the building. Each AD-26 vessel was loaded with five 100-lb bags of fine gravel (for a total of 500 lb [or 5 ft³]) and then approximately 41 55-lb bags

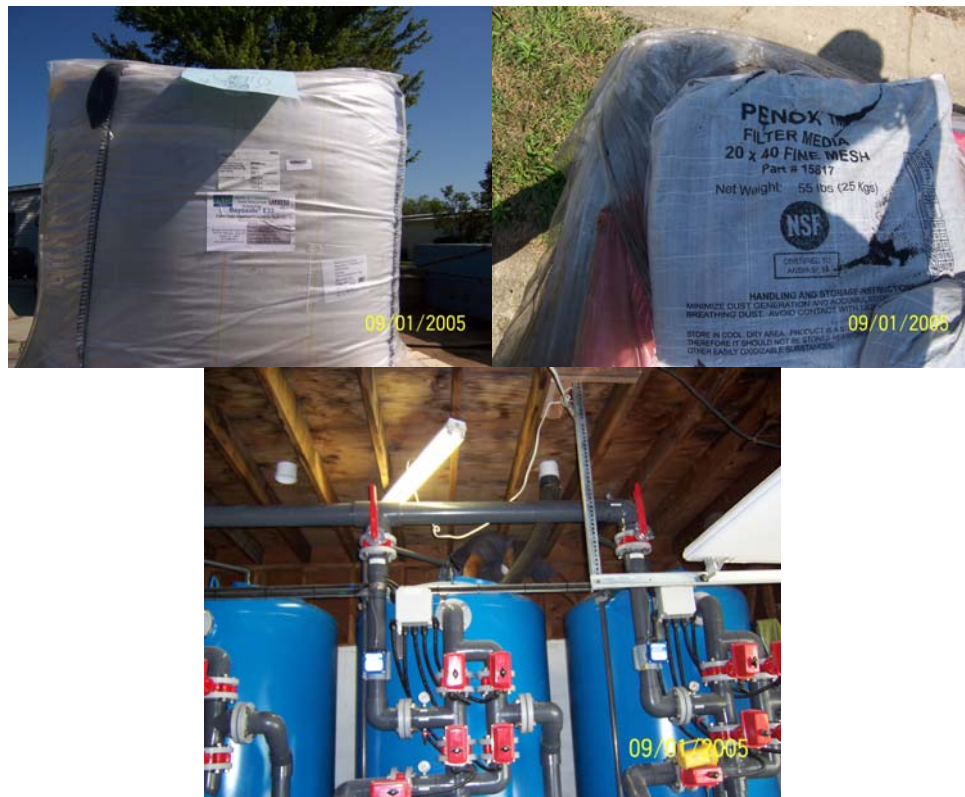
Figure 4-12. AD-33 Media Supersack, AD-26 Media Bags and Loading of Underbedding

of the AD-26 media (for a total of 2,255 lb [or 19 ft³]) with the vessel containing about half a tank of water. Figure 4-12 is a composite of pictures showing the media bags and media loading into one of the AD-33 vessels.

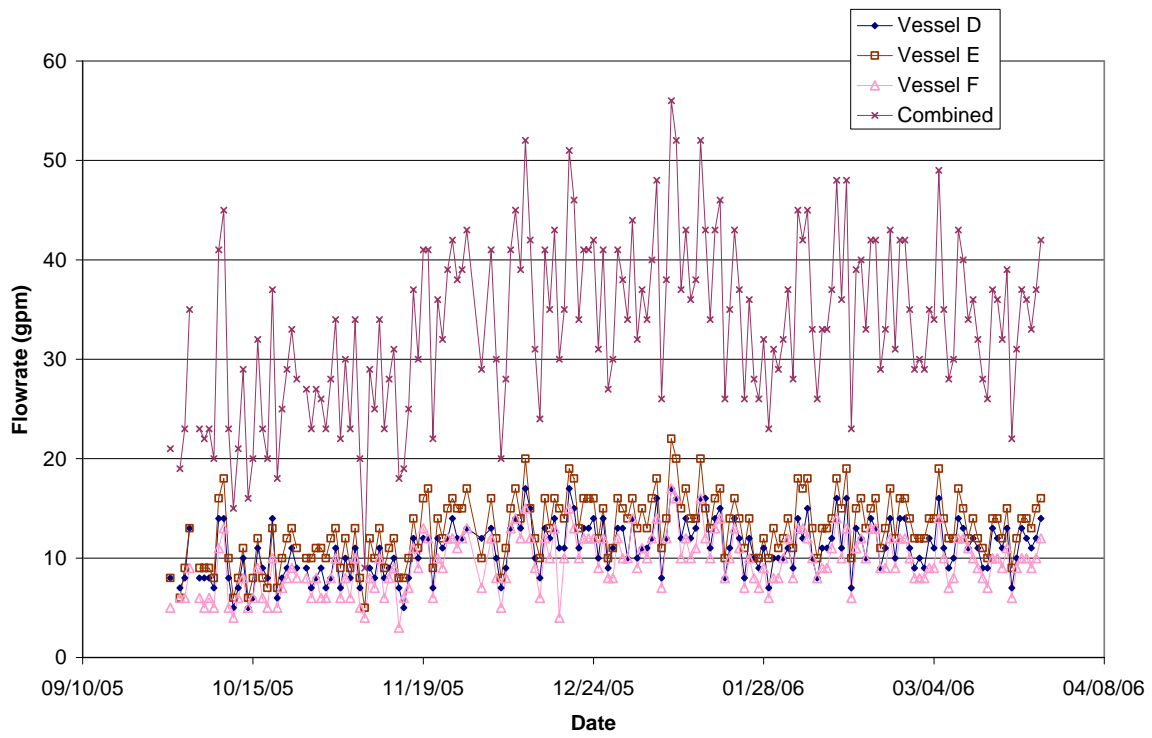
Figure 4-13. AD-33 Adsorption System Flowrates

Based on the flowrates to the individual vessels and system, the EBCTs for the individual adsorption vessels varied from 12.9 to 94.8 min and averaged 26.4; the EBCTs for the system varied from 5.1 to 31.6 min and averaged 25.8 min. This EBCT is at least 5 times higher than what normally would be recommended by the vendor for iron-based adsorptive media.

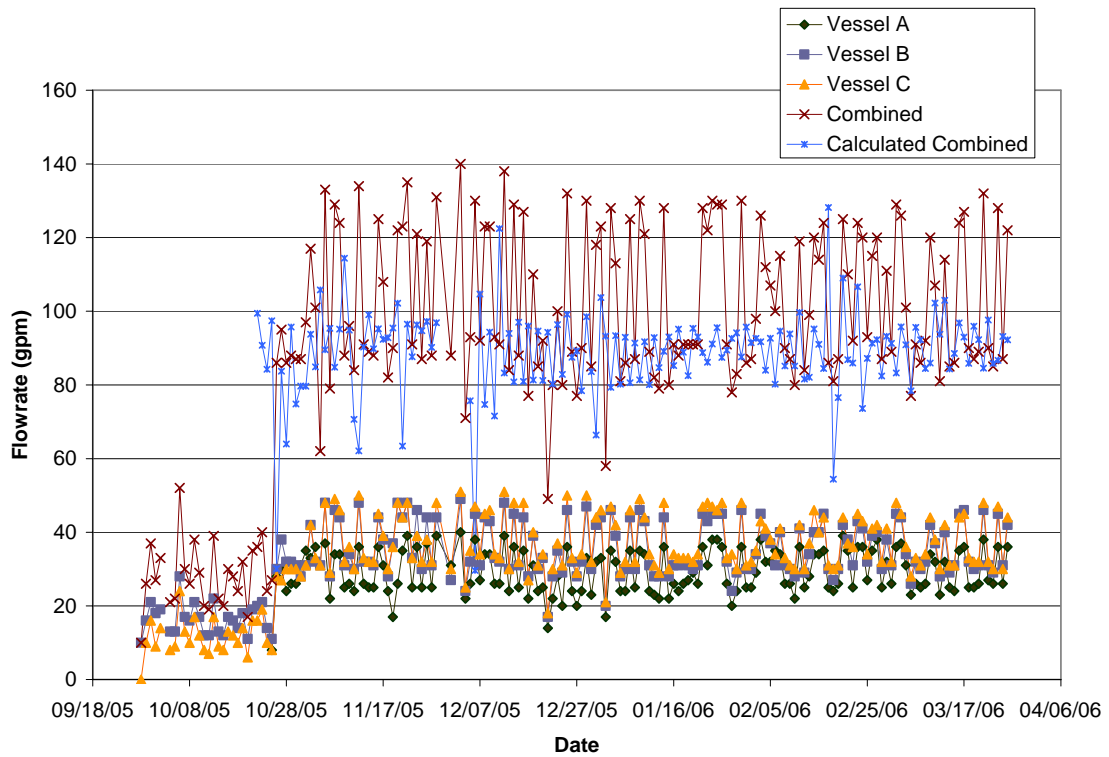
Figure 4-14. AD-26 Oxidation/Filtration System Flowrates

Flowrates through the three AD-26 vessels were monitored using individual totalizers/flowmeters installed at the exit side of the vessels. Before the system piping retrofit, instantaneous on-demand flowrate readings taken from the meters ranged from 6 to 28 gpm for Vessels B and C, with combined flowrates ranging from 17 to 52 gpm and averaging 29 gpm (Table 4-5 and Figure 4-14). As noted above, little or no flow passed through Vessel A during this time period. After the system piping retrofit, the system operated at the well pump flowrates. The instantaneous flowrate readings taken from the meters ranged from 14 to 51 gpm for the three vessels with combined flowrates ranging from 49 to 140 gpm and averaging 102 gpm. The combined flowrates from the meter readings are compared in Figure 4-14 with the calculated flowrates derived by dividing the combined throughput values by the corresponding operating hours. As expected, the calculated flowrates were much less scattered than the instantaneous readings (i.e., 30 to 128 gpm [averaged 89] versus 49 to 140 gpm). The average flowrate obtained from the meter readings was closer to the operating time-weighted average (i.e., 117 gpm) of the West and East Wells flowrates (i.e., 130 and 90 gpm, respectively).

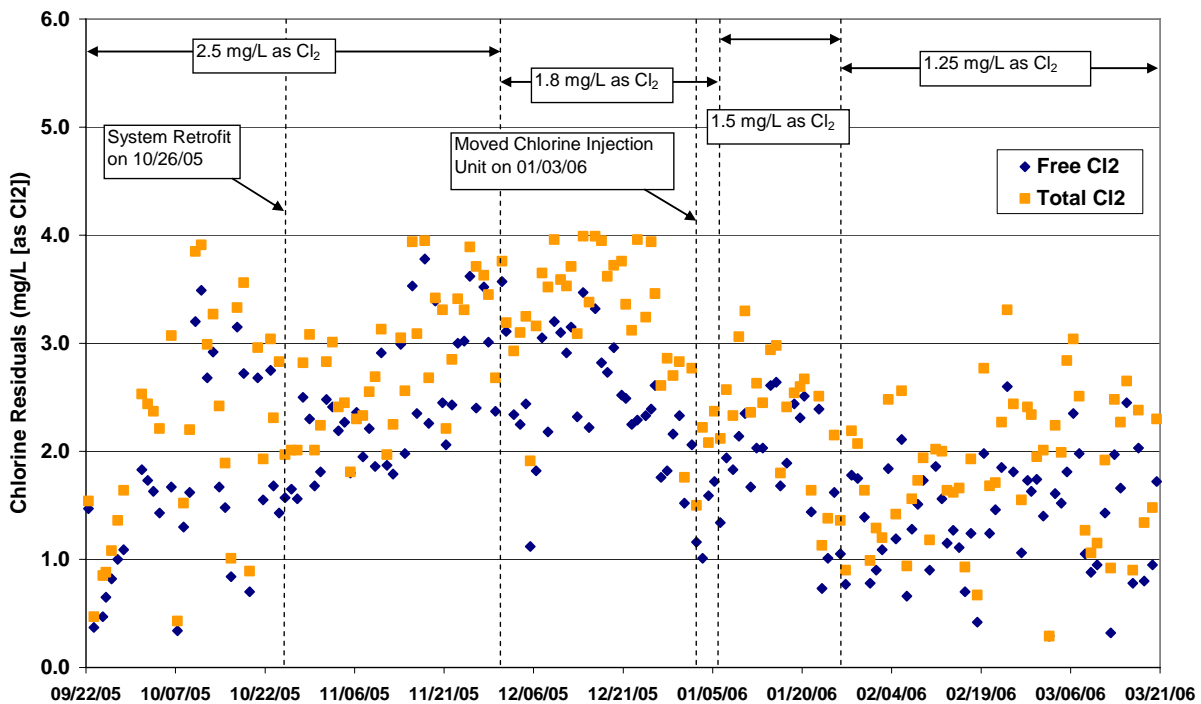
Figure 4-15. Free and Total Chlorine Residuals at Entry Point

After system reconfiguration, the free chlorine set point was maintained at 2.5 mg/L (as Cl₂). Although somewhat improved, the free and total chlorine residuals measured at the entry point continued to scatter, with concentrations ranging from 1.56 to 3.78 mg/L and from 1.81 to 3.95 mg/L (as Cl₂), respectively. On November 30, 2005, the free chlorine set point was decreased from 2.5 to 1.8 mg/L (as Cl₂), but the scattering of free and total chlorine residuals continued without significant improvement. On December 20, 2005, modification was made to the setting of pump stroke length in an attempt to reduce chlorine

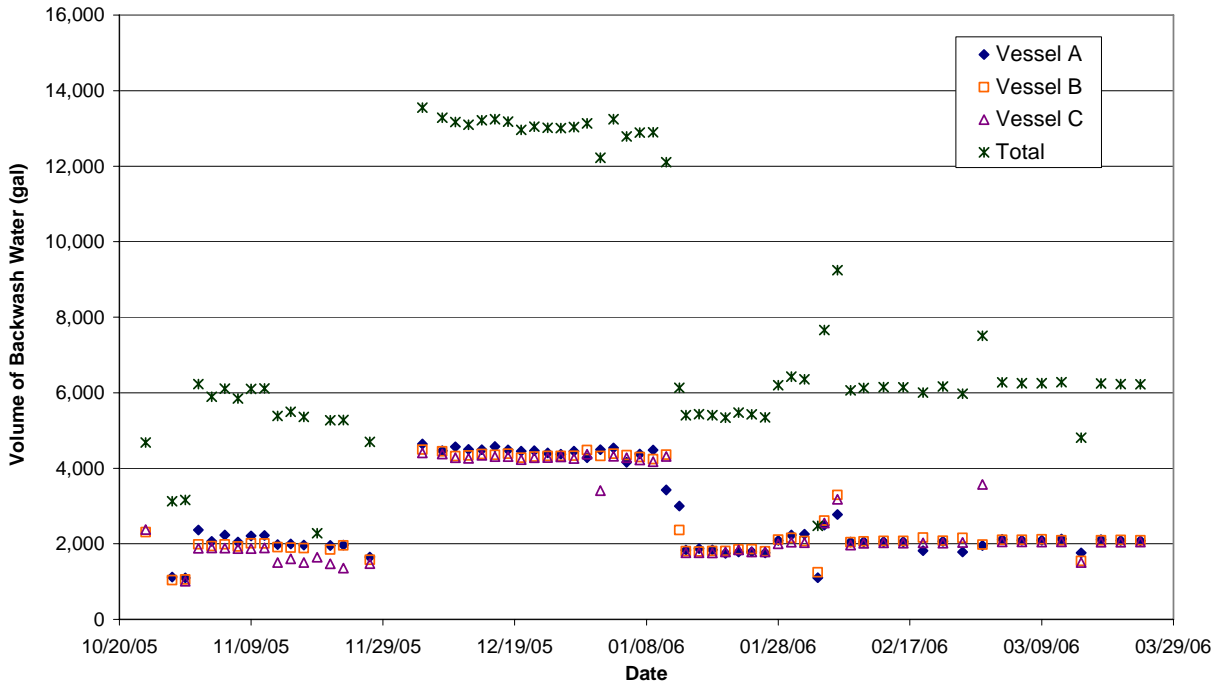
Figure 4-16. Volume of Wastewater Produced When Backwashing AD-26 Vessels

power outage on November 28, 2005, the backwash controls apparently were reset so that each vessel would be backwashed for 20 min and rinsed for an extended duration (the vendor reported 25 min but was not sure if it was correct). Consequently, more than twice as much wastewater, i.e., 13,100 gal on average, was produced from each backwash event. Upon request, the backwash settings were adjusted back to 15 min and 90 sec service-to-waste rinse on January 12, 2006, and the volume of wastewater produced was restored to an average of 5,890 gal per backwash event. Since the backwash water cleared up fairly quickly, it was decided on February 9, 2006, to reduce the backwash duration from 15 to 9 min while the rinse duration remained unchanged. This reduced backwash setting, however, did not result in the expected reduction in wastewater production per backwash event, with the average volume staying at 6,180 gal. Nonetheless, because the backwash frequency also was reduced from once every two days to once every three days on February 9, 2006, the overall wastewater production was reduced by 30%. The vendor was informed of this observation and was expected to look into the PLC for the discrepancies.

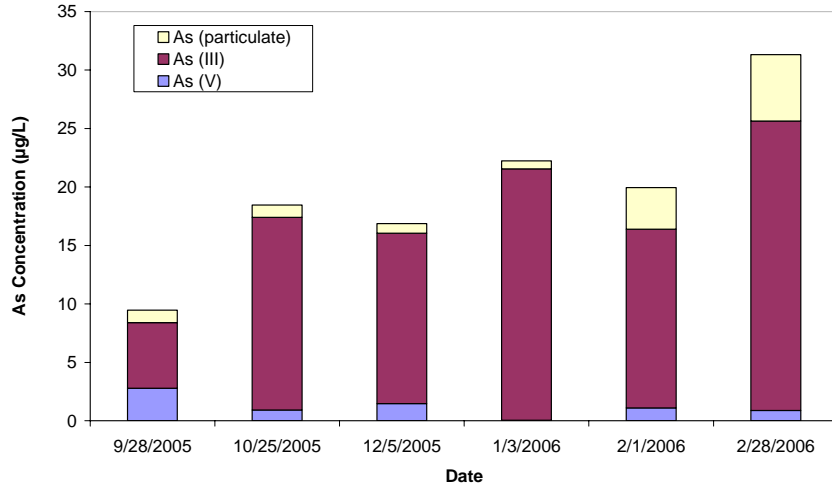
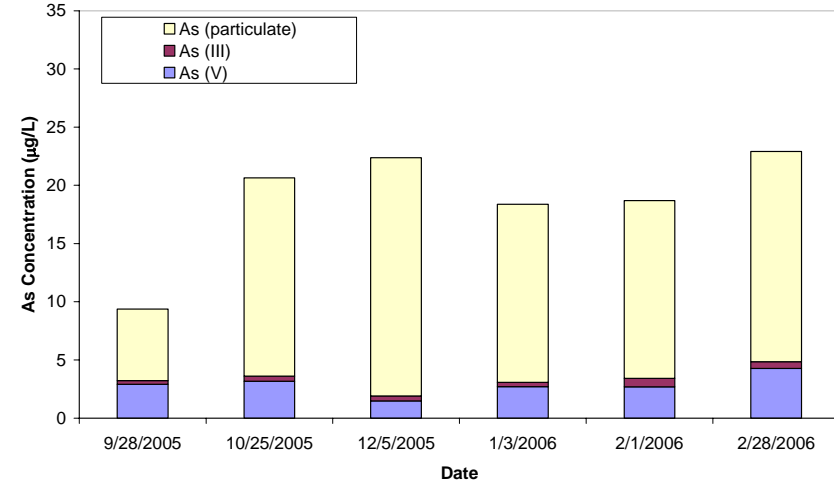
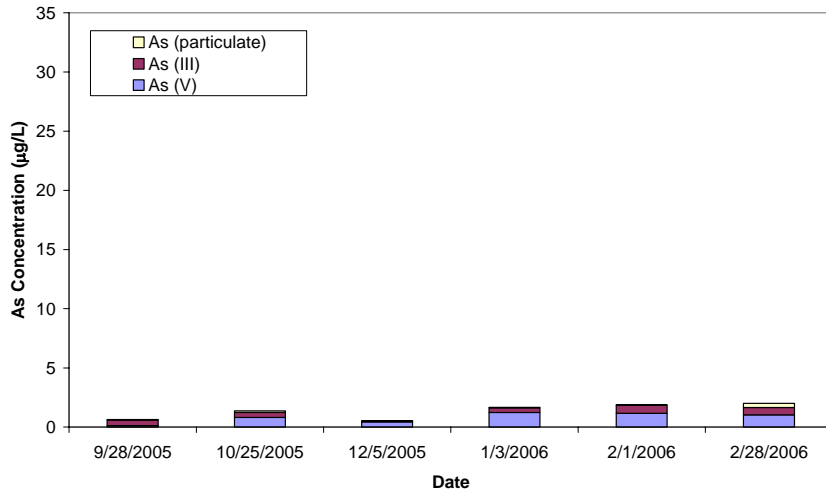
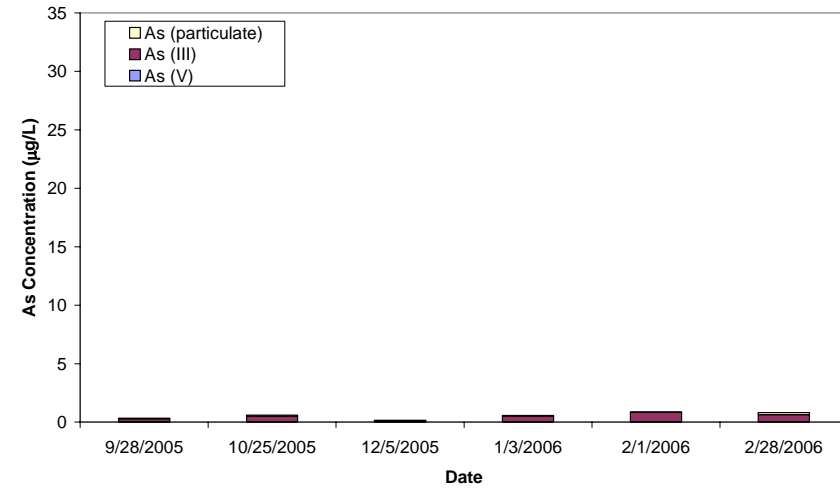
Arsenic Speciation at Wellhead (IN)

Arsenic Speciation after Chlorination (AC)

Arsenic Speciation after Oxidation/Filtration Vessels (OT)

Arsenic Speciation after Adsorption Vessels (TT)

Figure 4-17. Concentrations of Various Arsenic Species at IN, AC, OT and TT Sampling Locations

Figure 4-17 contains four bar charts showing the concentrations of total arsenic, particulate arsenic, As(III), and As(V) at the IN, AC, OT, and TT locations for each speciation event. Total arsenic concentrations in raw water ranged from 9.5 to 31.3 µg/L and averaged 21.5 µg/L (Table 4-8). As(III) was the predominating species, ranging from 5.6 to 24.7 µg/L and averaging 16.4 µg/L. As(V) and particulate arsenic concentrations were low, averaging 1.2 and 2.1 µg/L, respectively. The presence of As(III) as the predominating arsenic species was consistent with the low DO concentrations (averaging 1.7 mg/L) measured (Table 4-9). The ORP readings, however, were high, averaging 76.2 mV. Recall that the ORP readings obtained during the August 5 and September 9, 2004, source water sampling events

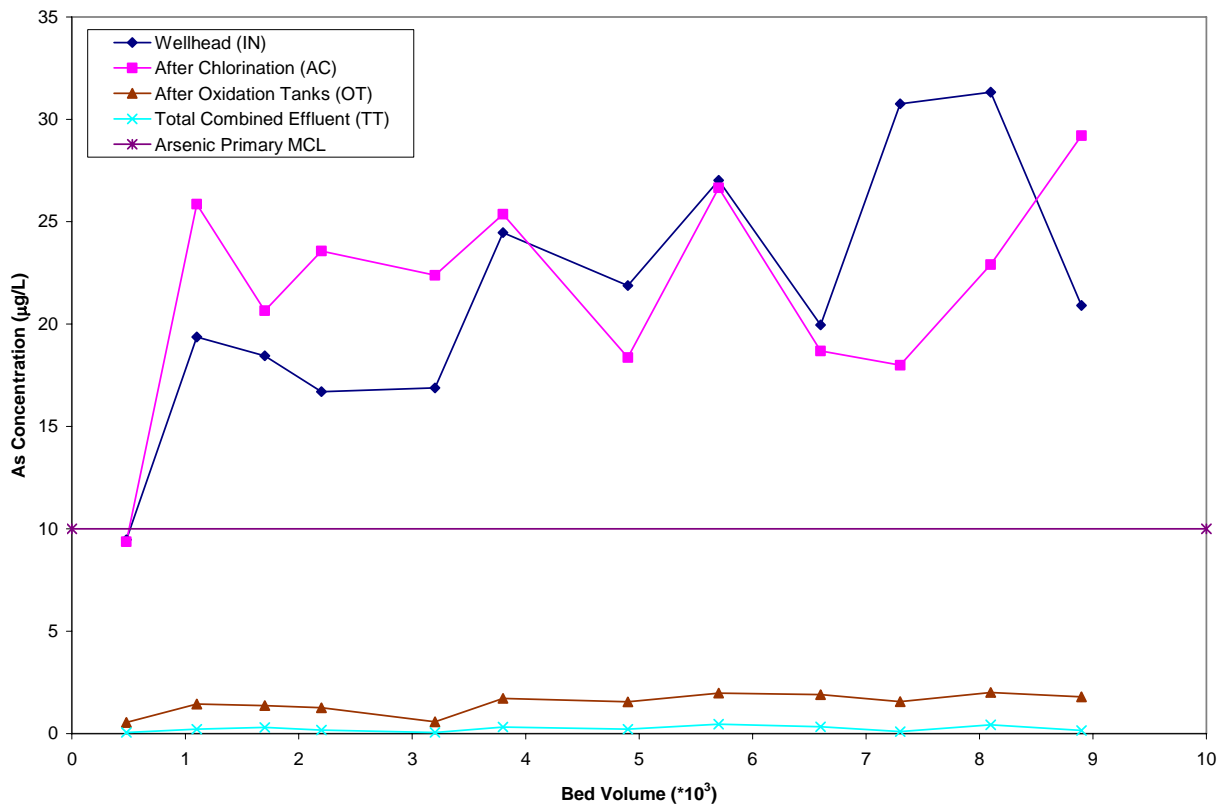
Figure 4-18. Total Arsenic Breakthrough Curves for AD-26 Oxidation/Filtration and AD-33 Adsorption System

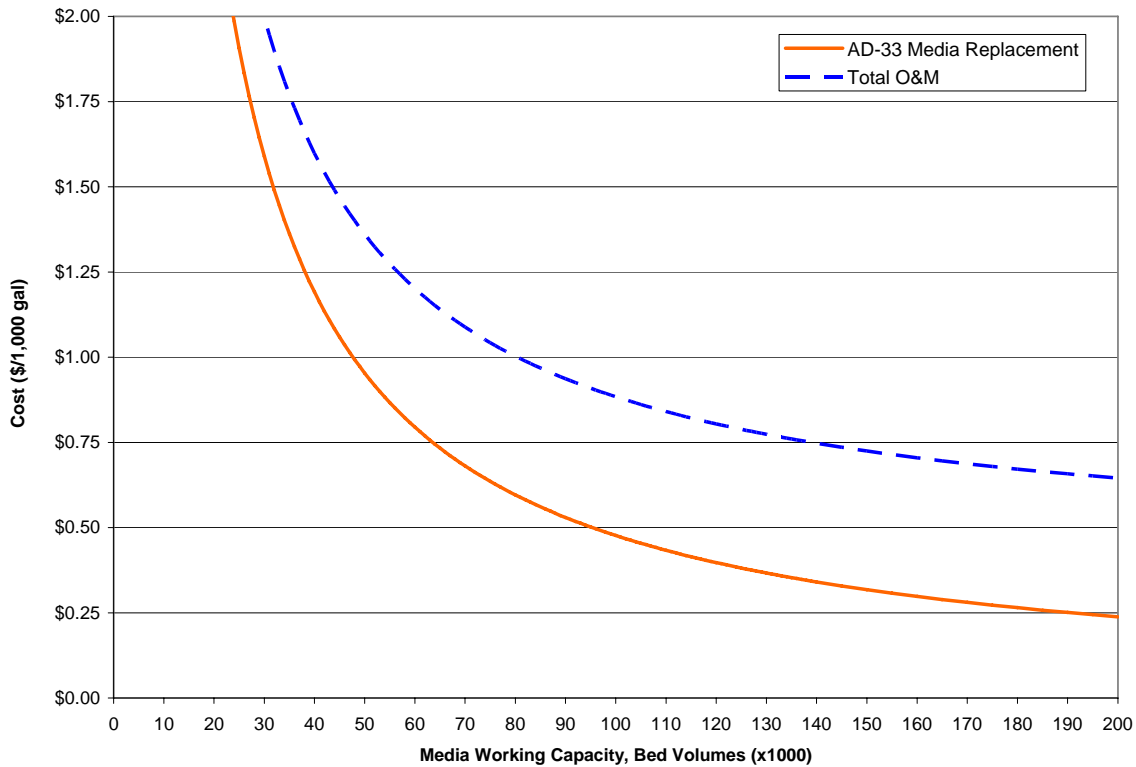
1 BV = 114 cubic feet = 850 gal

Figure 4-19. Media Replacement Cost Curves for Springfield System

The vendor estimated that the AD-33 media would have a 4.9-yr life expectancy before replacement. It was estimated to cost \$34,230 to change out the adsorptive vessels with 114 ft³ of AD-33 media; that estimate included the cost for media, freight, labor, travel expenses, and media disposal fee. This cost was used to estimate the media replacement cost per 1,000 gal of water treated as a function of the projected media run length to the 10-µg/L arsenic breakthrough (Figure 4-19).
