**Arsenic Removal from Drinking Water by Adsorptive Media
EPA Demonstration Project at Rollinsford, NH
Six-Month Evaluation Report**

**Battelle
Columbus, OH 43201-2693**

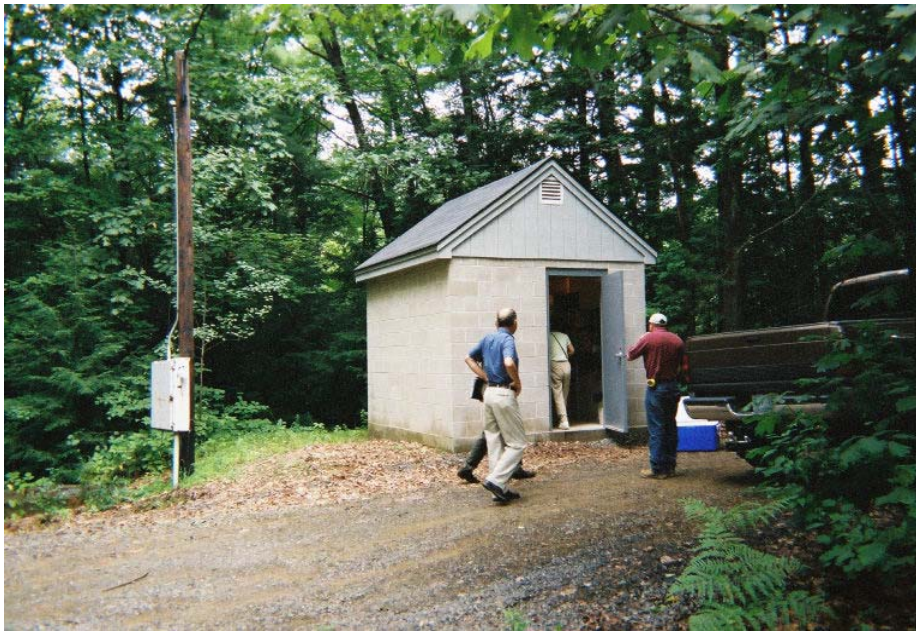
Figure 4-1. Existing Porter Well House

The treatment system supplies water to the town of Rollinsford and services about 450 connections. The water source is supplied by three bedrock wells, two of which, Wells No. 3 and No. 4, are controlled through the Porter well house shown in Figure 4-1. The Porter well house is located in a wooded area approximately ¼ of a mile south of the town of Rollinsford. Water from these two wells are combined and treated before being sent to the distribution system. The third supply well, the General Sullivan well, is located approximately 1.5 miles north of the Porter well house. Because the General Sullivan well is completely separated from the Porter well house, this well was not treated by the AdEdge APU-100 treatment system as part of the demonstration study.

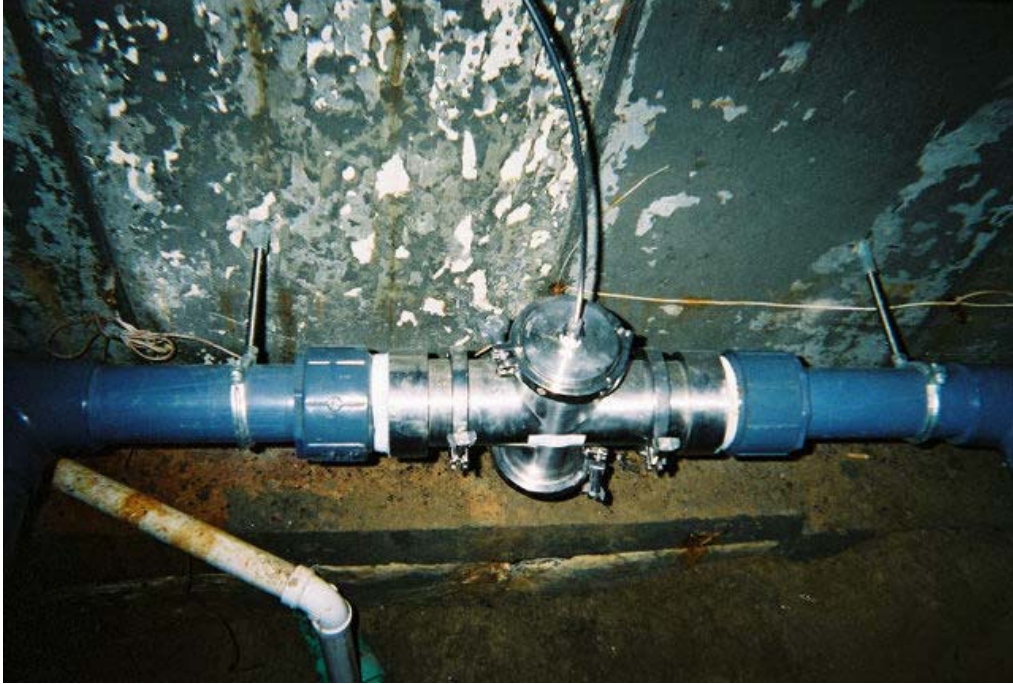
Figure 4-4. Gas Injection Point for the CO₂ System Used for pH Adjustment

4.4.3 CO₂ Injection. As described in Section 4.2, pH adjustment using a CO₂ injection module was a process component. This module also experienced operational irregularities during the first 6 months of the demonstration study. First, leaks were detected in the CO₂ system resulting in frequent change-outs of the CO₂ gas cylinders during the first few weeks of the system operation. Second, the CO₂ injection module was not functioning properly, which was caused by a broken gas regulator and damaged O-rings located at the CO₂ injection point. Following maintenance, the CO₂ system operated more consistently by maintaining pressure and requiring regular change-outs about every 2-3 weeks.

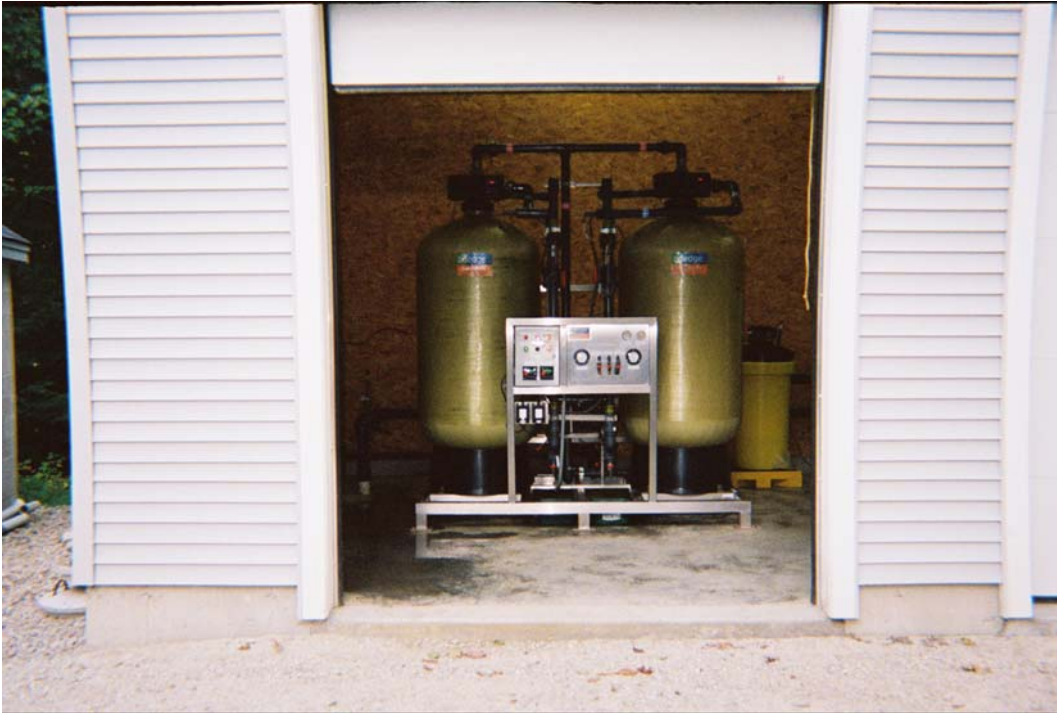
Figure 4-5. APU-100 Treatment System

The APU-100 treatment system consisted of two 36-inch-diameter, 72-inch-tall fiberglass reinforced plastic (FRP) vessels in parallel configuration, each containing approximately 27 ft³ of AD-33 media. The AD-33 media is an iron-based adsorptive media developed by Bayer AG and packaged under the name of AD-33 by AdEdge. This media is identical to Severn Trent Services' SORB 33™ media used at larger arsenic removal systems. The system was designed for a peak flowrate of 100 gallons per minute (gpm) (50 gpm to each vessel) corresponding to a design empty bed contact time (EBCT) of about 4 minutes per vessel and a hydraulic loading to each vessel of about 7 gpm/ft².

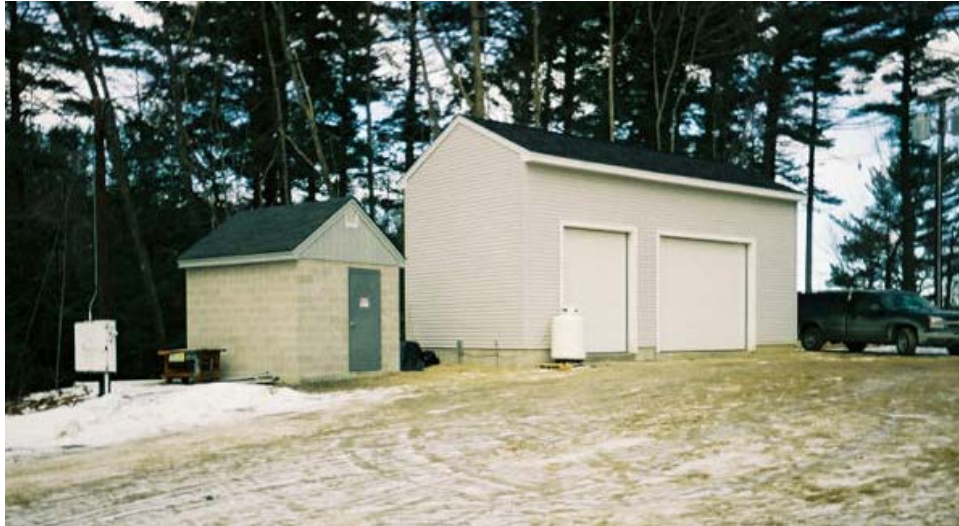
Figure 4-6. New Treatment Building (Right) and Existing Porter Well House (Left)

4.3.2 Building Construction. Building construction began on November 3, 2003 and was completed on December 22, 2003. The 33-ft × 13-ft building has a concrete foundation and floor and a wood frame with vinyl siding. It includes two 10-ft roll-up doors on the front allowing access to the treatment equipment, and one walk-through door on the end of the building (Figure 4-6). Additionally, the Water and Sewer District installed a subsurface drainage structure in the parking area in front of the building to handle the disposal of backwash water generated by the treatment system.

The Rollinsford Water and Sewer District constructed a new treatment building next to the existing Porter Well House. The wood frame structure measured 33 ft × 13 ft and has a concrete foundation and floor. The building cost was approximately \$57,000, including design and construction of the subsurface leach field directly adjacent to the building, used for disposing of the backwash water from the system.

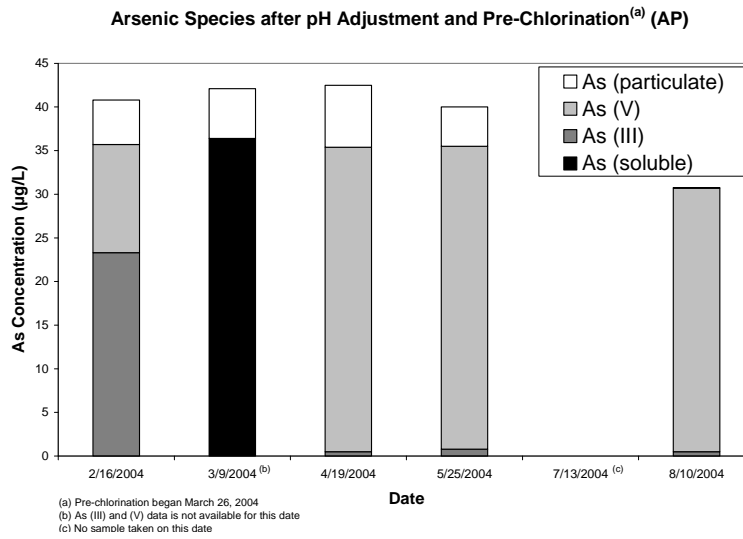
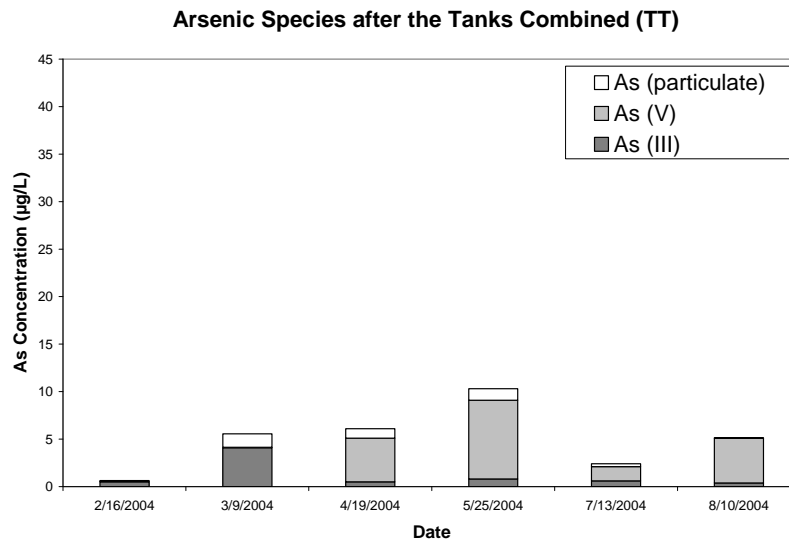
Figure 4-9. Concentration of Arsenic Species at the IN, AP, and TT Sample Locations

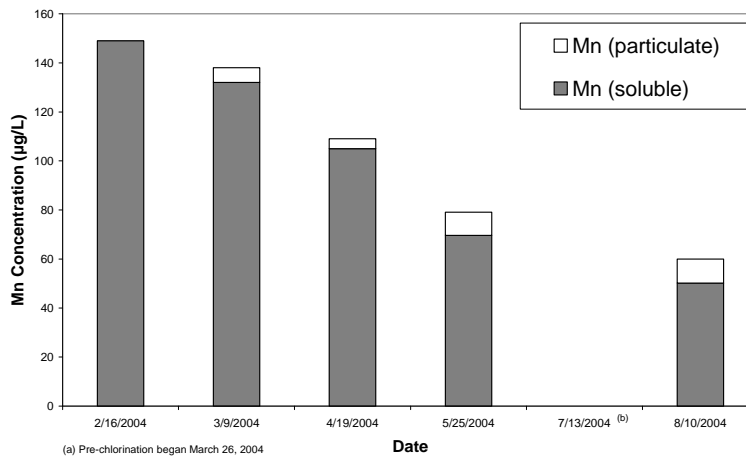
Figure 4-12. Concentration of Manganese Species at the IN, AP, and TT Sample Locations

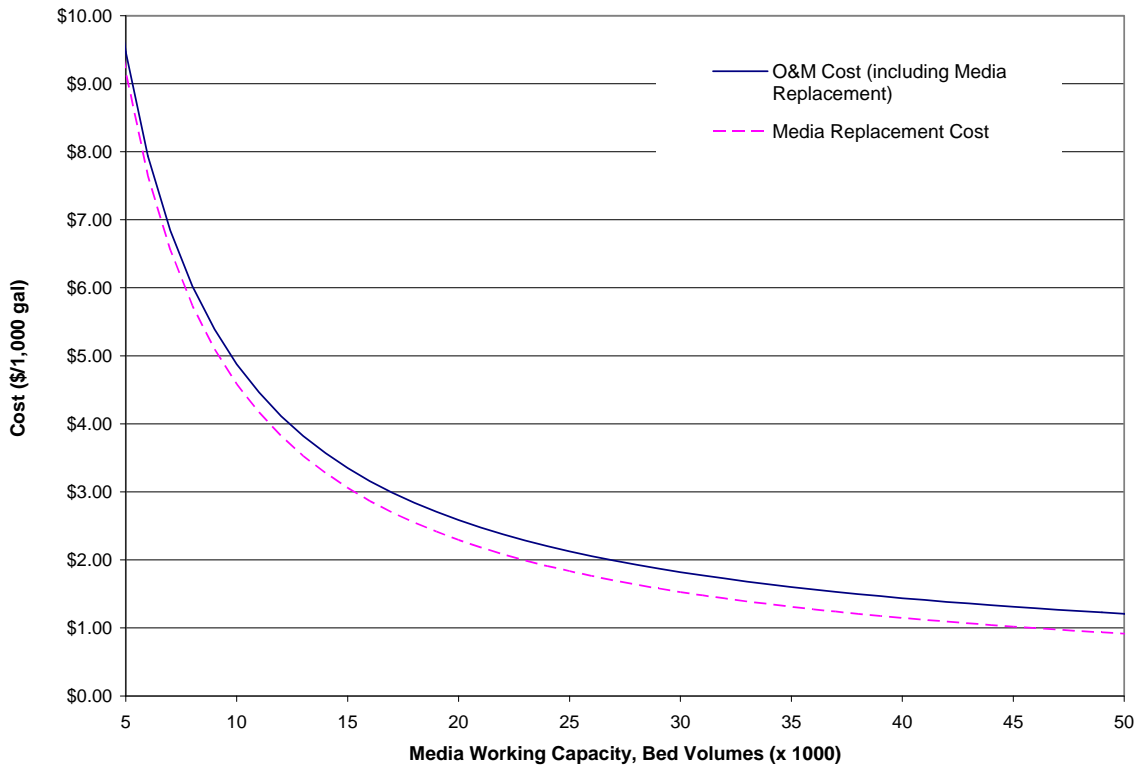
Figure 4-14. Media Replacement and Operation and Maintenance Costs

4.6.2 Operation and Maintenance Costs. O&M costs include such items as media replacement and disposal, chemical supply, electricity, and labor. These costs are summarized in Table 4-11. Although not incurred during the first six months of system operation, the media replacement cost represented the majority of the O&M cost and was estimated to be \$16,810 to change out both vessels. This media change-out cost included costs for media, freight, labor, travel expenses, and media profiling and disposal fee. This cost was used to estimate the media replacement cost per 1,000 gallons of water treated as a function of the projected media run length to the 10 µg/L arsenic breakthrough (Figure 4-14).
