**Arsenic Removal from Drinking Water by Iron Removal
USEPA Demonstration Project at Climax, MN
Six-Month Evaluation Report**

**Wendy E. Condit
Abraham S.C. Chen**

**Battelle
Columbus, OH 43201-2693**

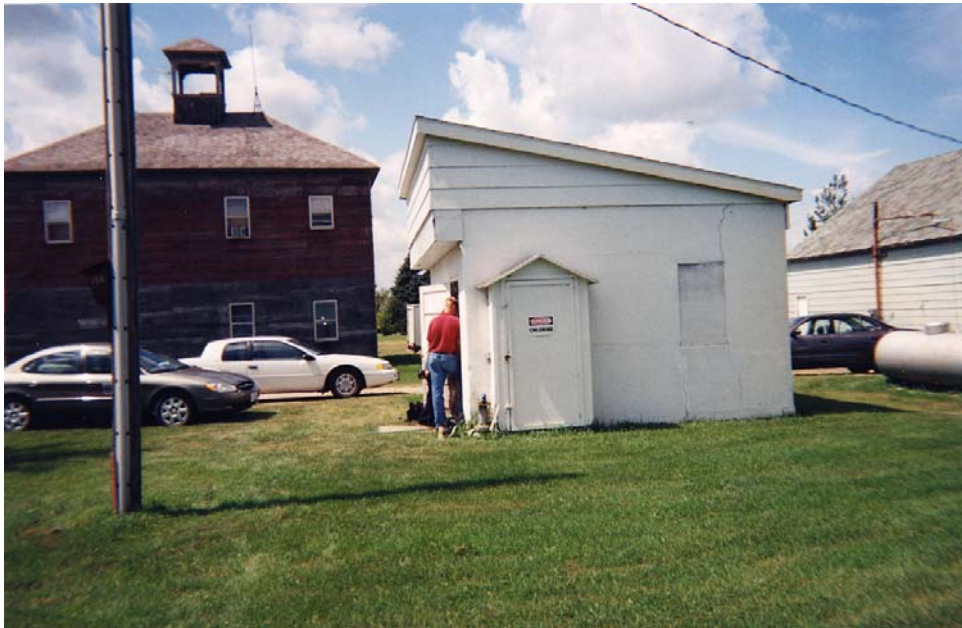
Figure 4-1. Pre-Existing Pump House at Climax, MN, Site

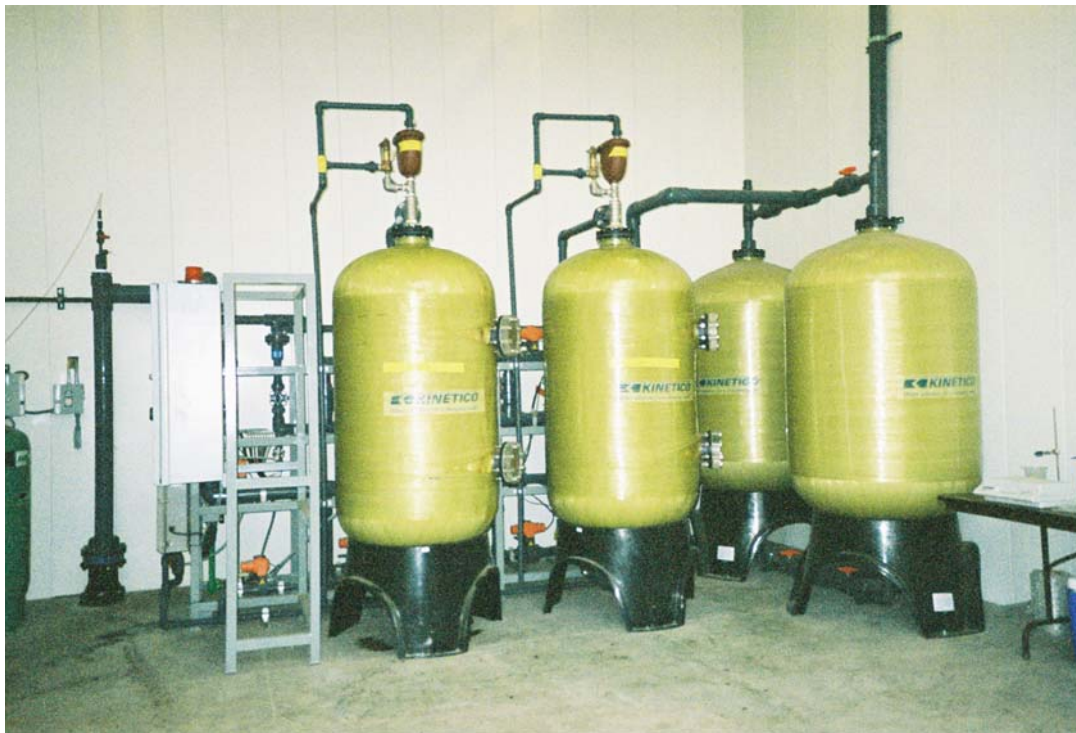
Figure 4-5. Photograph of the Macrolite® Pressure Filtration System

- Contact** - Two 345-gal contact tanks arranged in parallel were used to provide 5 min of contact time to facilitate the formation of iron flocs prior to filtration. The 42-inch-diameter by 72-inch-height contact tanks were constructed of fiberglass-reinforced plastic (FRP) and had 6-inch top and bottom flanges.

- Pressure Filtration** – Pressure filtration involved downflow filtration through two vessels arranged in parallel. The 36-inch-diameter and 72-inch-height FRP vessels, equipped with 6-inch top and bottom flanges, were mounted on a polyurethane-coated

steel frame. Each vessel was filled with approximately 24 inches (14 ft³) of 40/60 mesh Macrolite[®] media, which was underlain by a fine garnet fill layered 1 inch above the 0.006-inch slotted stainless steel wedge-wire underdrain. The flow through each vessel was regulated to less than 70 gpm using a flow-limiting device to prevent filter overrun or damage to the system. The normal system operation with both tanks would produce a total system flowrate of 140 gpm.

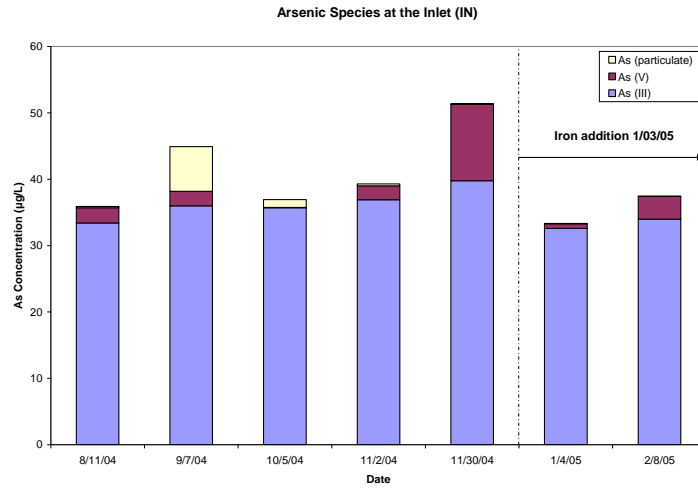
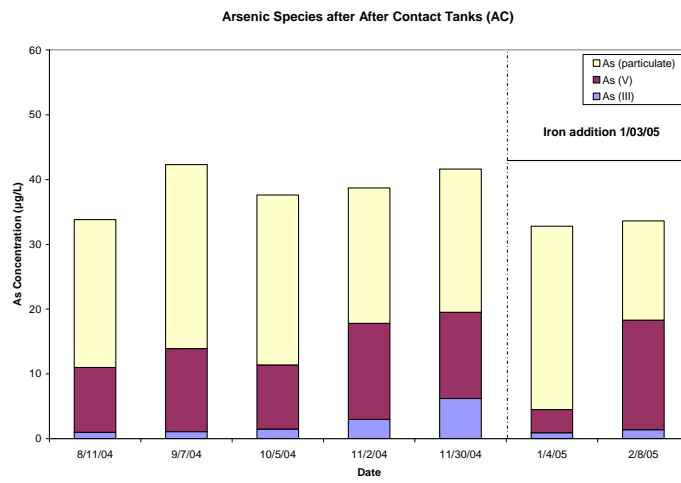
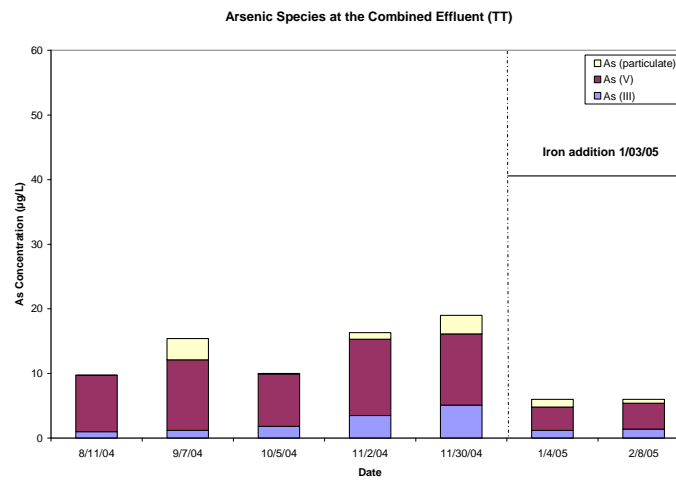
Figure 4-10. Concentrations of Arsenic Species at the Inlet (IN), after Contact Tanks (AC), and after Combined System Effluent (TT) Sampling Locations
