A newsletter about soil, sediment, and groundwater characterization and remediation technologies

Issue 53

May 2011

Full-Scale PTS Uses Six-Step Process to Treat Polluted Mine Discharge

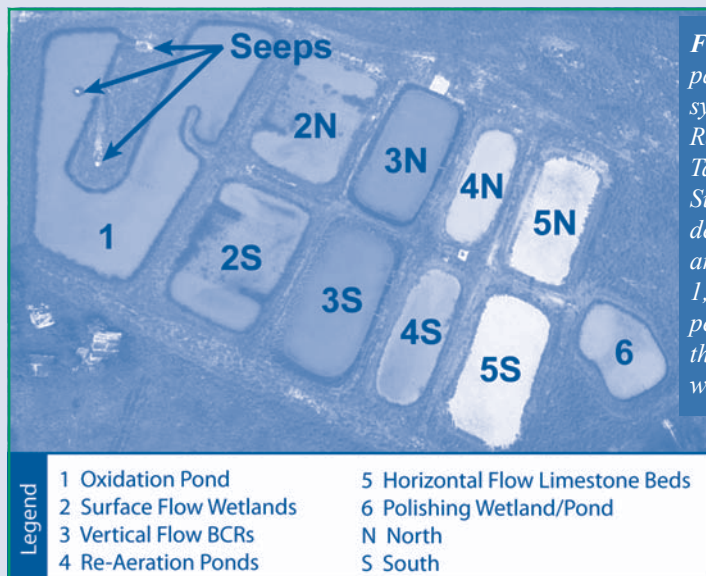
Figure 1. A six-step passive treatment system near Mayer Ranch within the Tar Creek Superfund Site is designed to receive and treat up to 1,000 liters of flow per minute from three artesian mine water discharges.

The completed PTS includes six distinct process units that include parallel treatment trains (Figure 1) to allow for maintenance and estimation of variance in performance. The system was consolidated into a compact "footprint" area (about 2 ha) to comply with construction requirements adjacent to an existing utility corridor.

The first process unit is an oxidation pond that receives the artesian MIW and oxidizes and hydrolyzes the Fe²⁺. Oxidized iron then settles out as iron oxyhydroxide solids.

Effluent water flows by gravity feed to the two parallel surface water wetlands. Emergent vegetation in the shallow zones (<0.3 m) increases retention time of solids, while the deeper pools facilitate settling of oxidized and hydrolyzed iron solids from solution. Water then flows to the third process unit comprising parallel vertical-flow BCRs designed to provide a reducing environment to remove cadmium, lead, and zinc. The BCRs were constructed with a 45-cm layer of organic substrate (a mixture of 45% spent mushroom compost, 45% hardwood chips, and 10% manufactured limestone sand) overlying a 30-cm limestone gravel drainage layer containing perforated drainage pipes. A low-permeability HDPE liner beneath the gravel maintains design integrity.

In the fourth process unit, submerged aeration systems in two parallel aeration ponds re-oxygenate water from the BCRs. Aeration reduces odors caused by the emission of hydrogen sulfide gas during bacterial sulfate reduction. Water in one pond is aerated by a vertical displacement pump powered by a 20-foot-tall windmill; as a result, water is aerated only when the wind is blowing. Water in the adjacent pond is aerated by a high-volume compressor powered by a 120-watt photovoltaic (PV) system that charges a deep-cycle battery. The PV system operates the compressor on a 20-hours-on, 4-hours-off cycle. Horizontal-flow limestone beds in ponds of the fifth process unit further improve water quality by removing additional zinc and manganese and increasing water hardness to offset the bioavailability of any remaining trace metals. The limestone beds are greater than 1 meter thick to provide a minimum 14-hour retention time.

The final polishing pond/wetland facilitates settling of residual solids through vegetative filtration and re-aerates water through passive photosynthesis. Water from the pond discharges via an exit pipe into a small channel that feeds into the Tar Creek tributary. The wetlands provide a

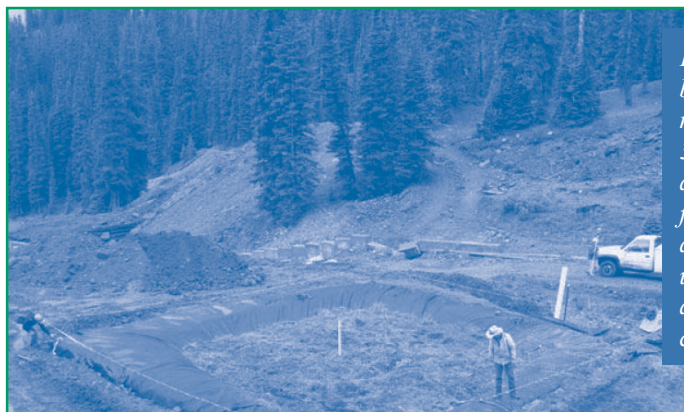
Figure 2. The biochemical reactor occupies a 35- by 35-foot area approximately 200 feet from the mine adit and 25 feet upgradient of the aerobic polishing cell.

PTS construction began in 2007 with installation of the BCR. The BCR consists of a 5-foot-deep geomembrane-lined cell filled with 30% (by weight) limestone along with wood chips, manure, and hay totaling

approximately 5.5 tons of organic material (Figure 2). This reactive substrate provides an organic carbon source for microbial population and promotes biological reduction of sulfate and removal of metals as metal sulfide precipitates.

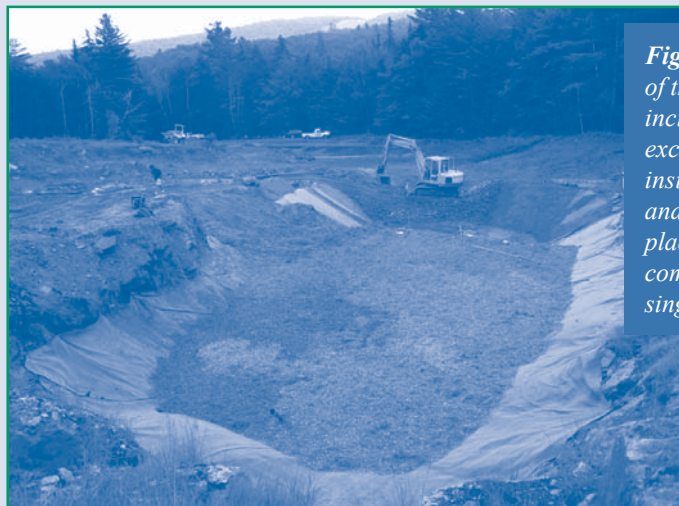
Figure 3. Construction of the Ore Hill BCR, including sediment excavation, lining installation, plumbing, and reactive substrate placement, was completed within a single month.

A total of approximately 130 tons of reactive substrate containing (by weight) 2.5% manure, 47.5% wood chips, 10% hay, and 40% limestone were placed in the approximate 90- by 40-foot BCR (Figure 3). The wood chips and hay were obtained from local producers and mixed at a nearby dairy farm providing the manure. The reactive substrate was hauled in batches three miles to the site. Following final placement of the substrate, the BCR remained closed at its base for approximately 30 days to provide an incubation period and increase growth of microbial populations in the substrate.

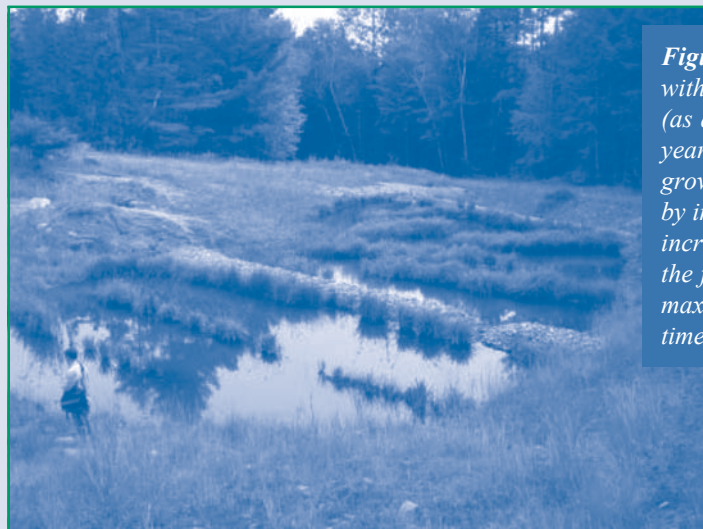
Figure 4. Circulation within the wetlands (as depicted after one year of vegetative growth) is enhanced by inner berms to increase the length of the flow path and maximize residence time of MIW.

The wetland was constructed approximately 100 feet downgradient of the BCR. Due to the ground slope and the need for shallow wetlands, the design called for two constructed wetland cells operating in series and covering a total of about 5,600 ft² (Figure 4). In July 2009, two thousand plugs of various native species were planted in the wetlands by high school students participating in a Forest Service training program.
