Muskegon County Wastewater Management System

Progress Report 1968 through 1975

Muskegon County Department of Public Works
Muskegon, Michigan 49442

Project 802457

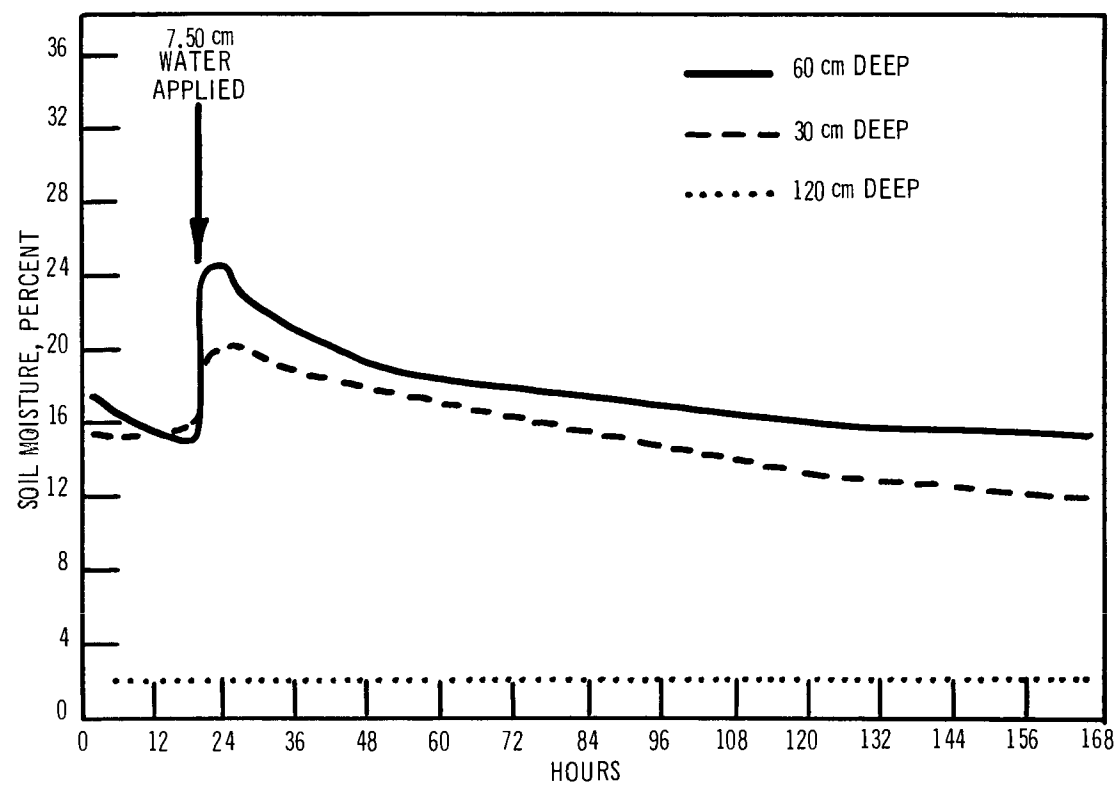
Figure 24. Soil moisture in cropped sandy loam at three depths before, during, and after irrigation

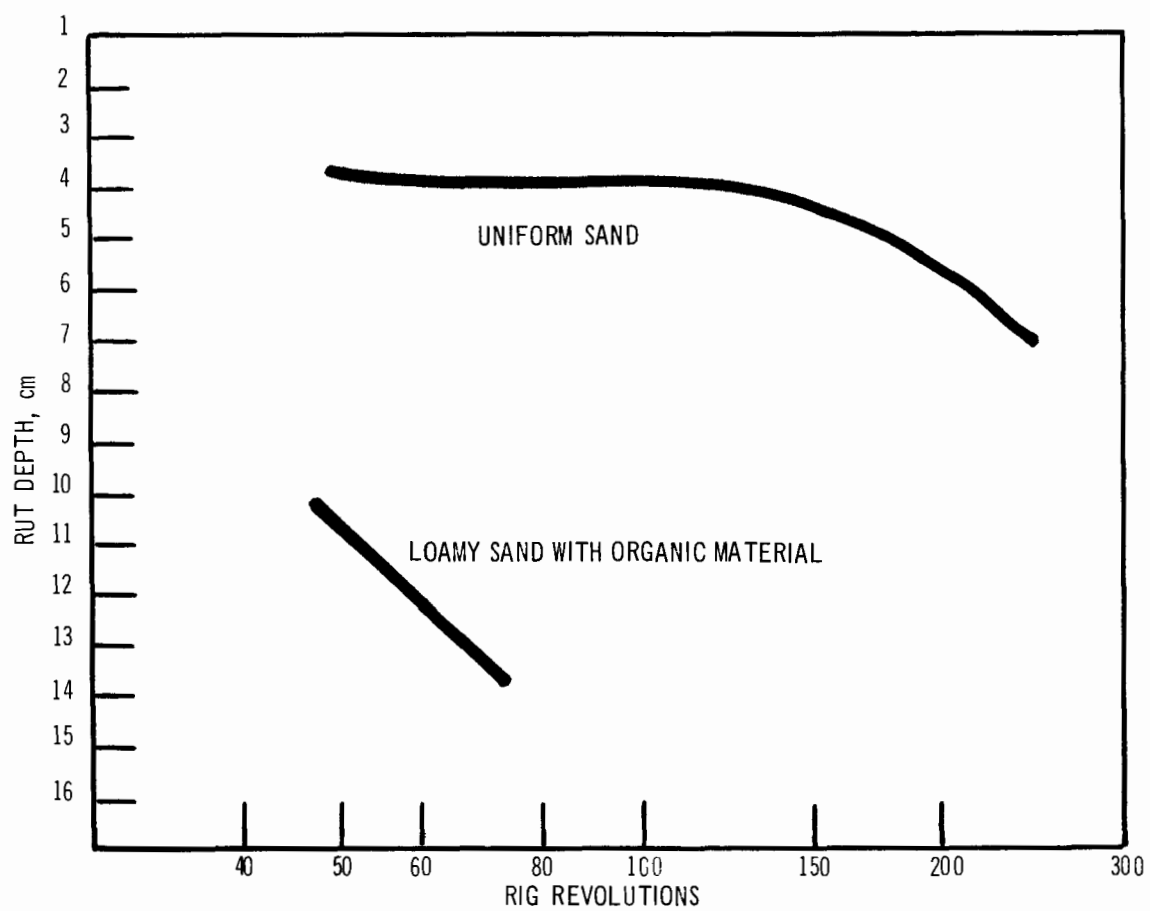
Figure 27. Rut depth produced in sand and loamy sand with rubber tires by the Enresco rig in Circle 39

The Enresco and Lockwood rigs were equipped with steel spoke wheels (107 cm diameter x 25 cm width) and rubber tires (57 cm diameter x 25 cm width) on alternate towers of each rig. Both were tested on different circles at the Muskegon project over a period of several months to compare their performance regarding rutting. There was no evidence of deeper ruts caused by either wheel type. However, the steel spoke wheels did indicate inferior performance in other areas. They often accumulated soil between the wheel cleats which reduced pulling traction resulting in rig misalignment. Mud within the outer wheel was carried up and deposited by rotation on the drive transmission. This contributed to failure of mechanical parts. Branches and roots became easily lodged between wheel spokes. As pointed out in the section covering operational problems, the steel spoke wheels were replaced with rubber tires early in the testing program because they caused frequent mechanical breakdowns. For this reason all data covering rut development were obtained with the use of rubber tire rigs.

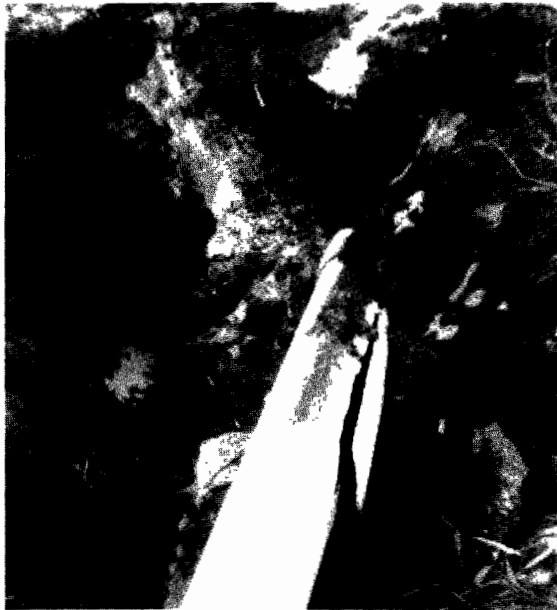
Figure 37. Ruptured irrigation pressure pipe, 30.5 cm diameter

These pipe failures were of three types: beam fracture due to differential settlement and aggravated by water hammer stresses during operations; rupture caused by water hammer during filling or during routine operation; and collar failure at points of small leaks beneath the gasket, gradually eroding pipe material. About 46 percent of the breaks were simple rupture, 30 percent collar involvement, and 24 percent beam collapse. See Figure 37.

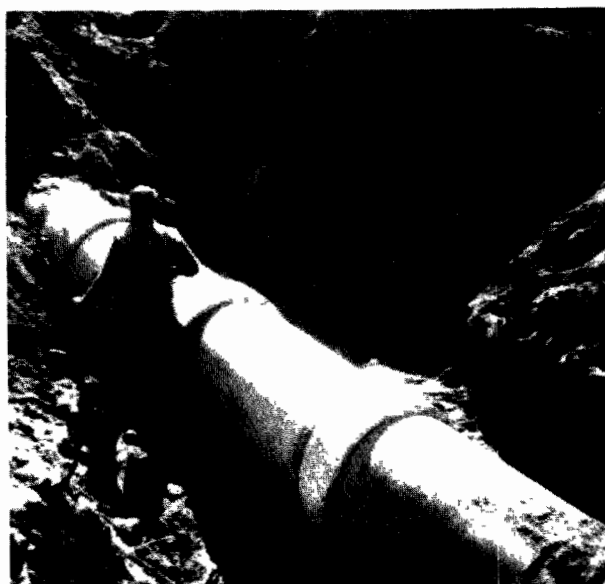
Figure 38. Repair in break of mainline pipe, 1 meter diameter

Isolation valves were installed in 1974 at major junctions throughout the network to minimize rig shutdown.

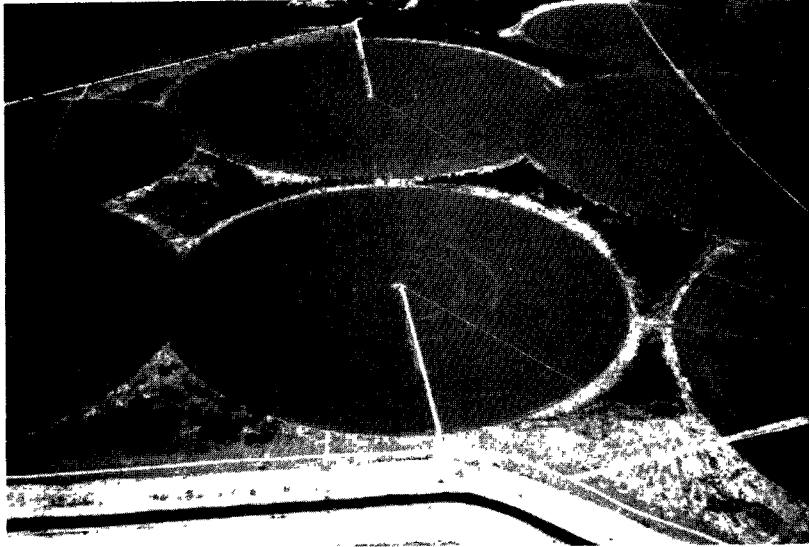
Figure 44. Irrigation circles with uniform crop coverage, indicating properly functioning rigs and satisfactory soil
