Superfund At Work

Krysowaty Site Profile

Krysowaty Farm...Cleaned Up

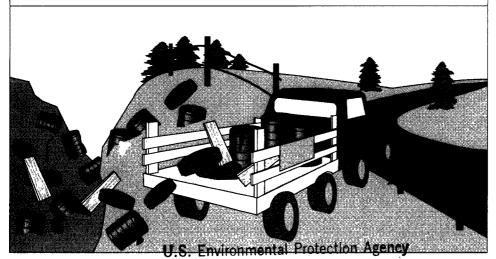
The Krysowaty Farm site had hazardous material strewn over a one-acre area of a ravine. Tires, demolition debris, and many corroded drums of paint, pesticides and dye wastes were illegally dumped.

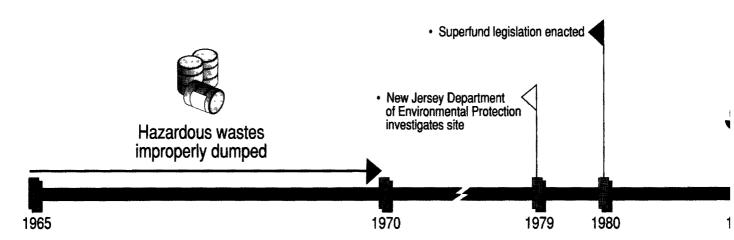
Dumped In Krysowaty Farm Ravine

- Hillsborough Township provides bottled water <
- · Site included on National Priorities List

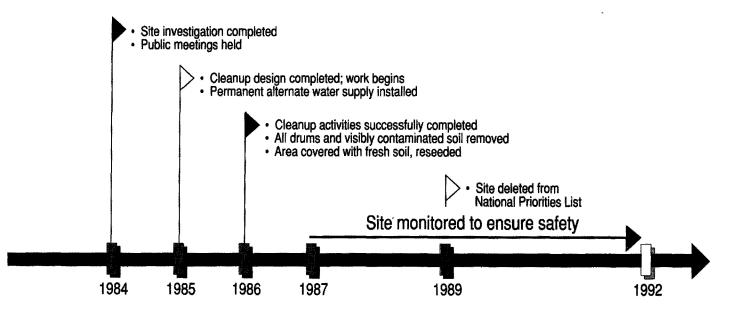
Excavating the Contamination EPA teams removed and transported 13,700 cubic yards of contaminated soil and wastes from the Krysowaty Farm site. The excavated area was then filled with new soil and reseeded.

times the shipments of contaminated material would take place. EPA teams then removed and transported 13,700 cubic yards of contaminated soil and wastes to an approved hazardous waste disposal facility. The excavated area was filled with clean soil and seeded for grass.

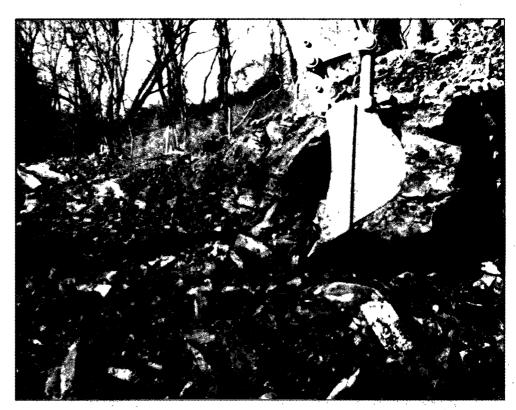
One Scoop At A Time As heavy construction equipment removes contaminated soil at the Krysowaty Farm site, progress is made one scoop at a time. EPA cleanup teams removed and transported 13,700 cubic yards of contaminated soil and wastes from the site, placing them in an approved hazardous waste facility. The excavated area was filled with clean soil, then reseeded for grass.
