EPA-600/2-77-013

August 1977

EVALUATION OF THE REFUSE MANAGEMENT SYSTEMS OF OPERATION BREAKTHROUGH SITES

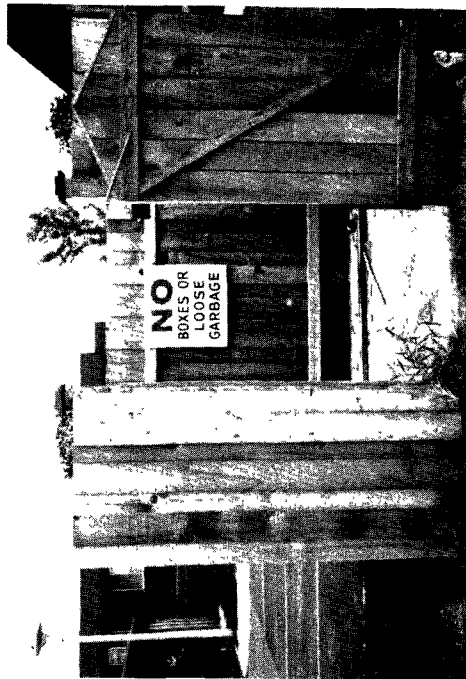
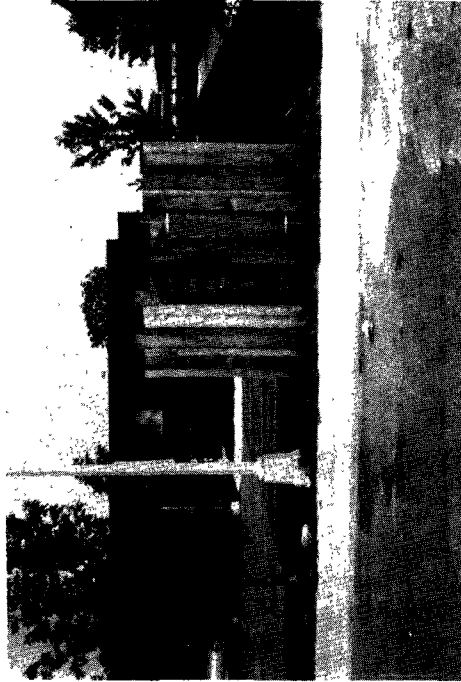
FIGURE 1. Typical of 24 refuse storage pens at the Indianapolis Operation Breakthrough site. Only plastic bags are allowed and are collected by the municipal refuse service.

A regulation not allowing residents to place bags of refuse in the pens except on pickup days should be considered. This would influence residents to properly close and tie bags and prevent exposure to weather and animals (pets, mostly cats and dogs). A top to the pens would help prevent weather effects but would prevent the cleansing effect of direct sunlight; therefore, a top is not recommended.

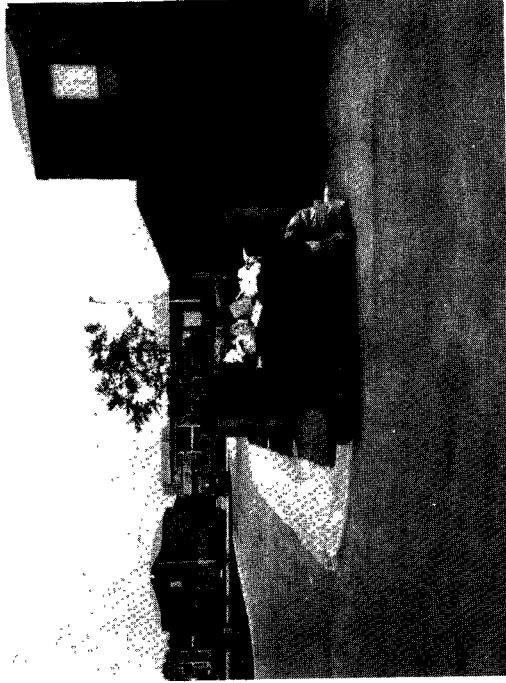
FIGURE 3. Typical of two standard 4 cu yd containers at the Indianapolis Operation Breakthrough site.

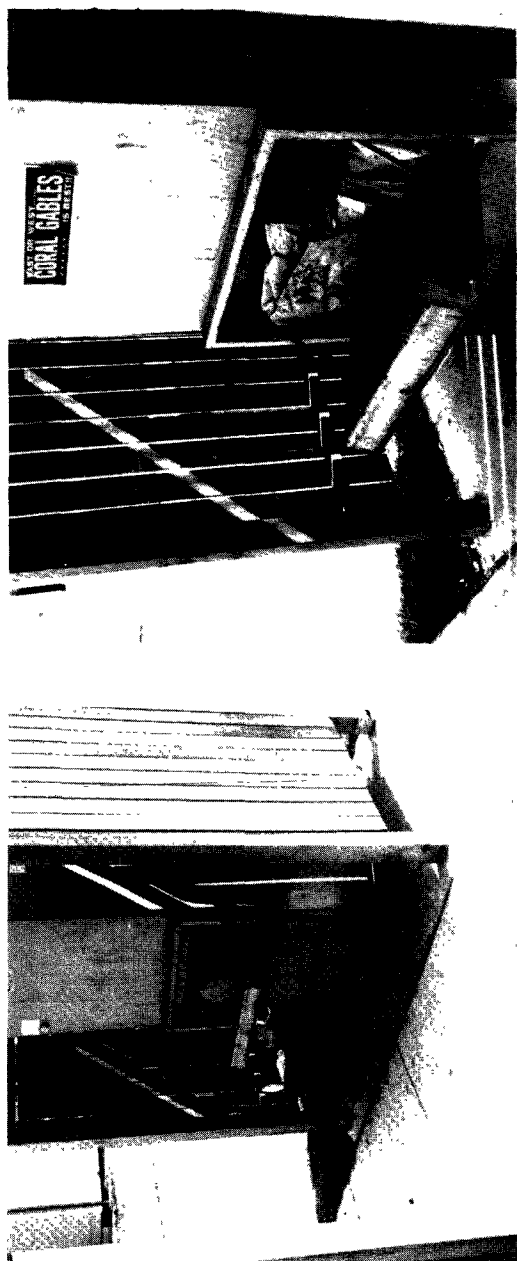
FIGURE 5. Typical of sixteen compactors in covered pens located around Kalamazoo, Michigan site. Note that the compactors have not been actuated after refuse insertion.

Considerable effort on the part of the site management has not resulted in residents using the communal compactors so that maximum benefits of refuse volume reduction are realized. It is doubtful that the residents will ever properly utilize the equipment; therefore, it is recommended that curbside pickup once a week be initiated at the site with a one or two-man crew. Another alternative is to use centrally located containers serviced by a private contractor.

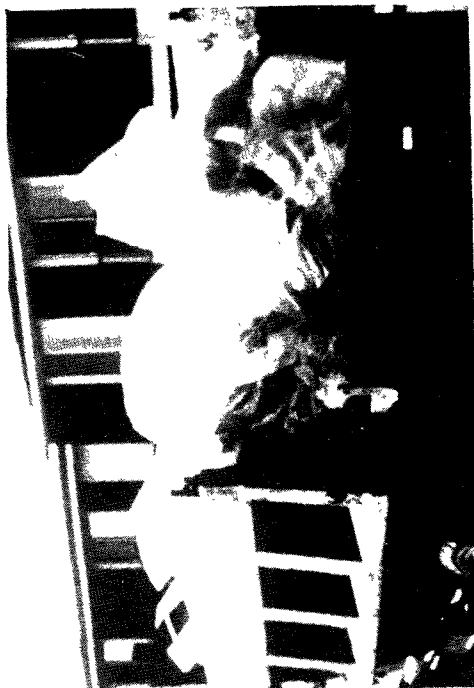
FIGURE 6. On-site refuse collection at Kalamazoo, Michigan.
Note the use of a barrel for disposal of glass by residents in the left photograph.

The use of plastic bags in the chamber of the compactor created a safety hazard due to broken glass. This has resulted in the need to segregate glass from the trash. It is recommended that a metal, hinged carrying "caddy" or similar device be devised for handling compacted packages which are removed for disposal.

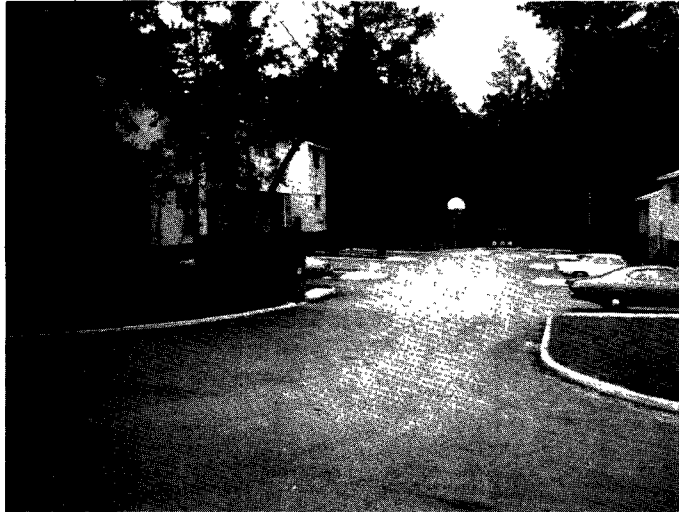
FIGURE 9. Two typical containers and pen locations at the Macon site. One is center left next to the trees. The other is just to the right of the basketball goal.

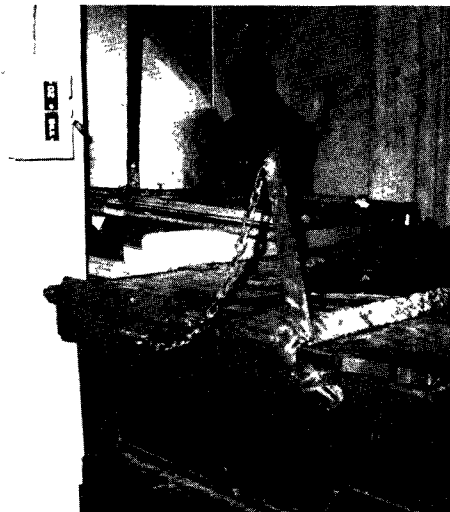
FIGURE 10. The Chute-fed compactor and container in the MFM/HR building at the Macon site.

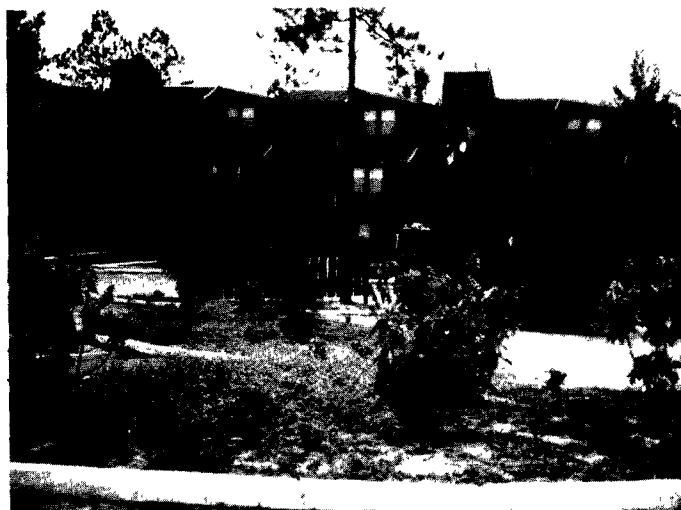
FIGURE 13. Private contractor top-loading packer truck used to empty containers at the Macon site.

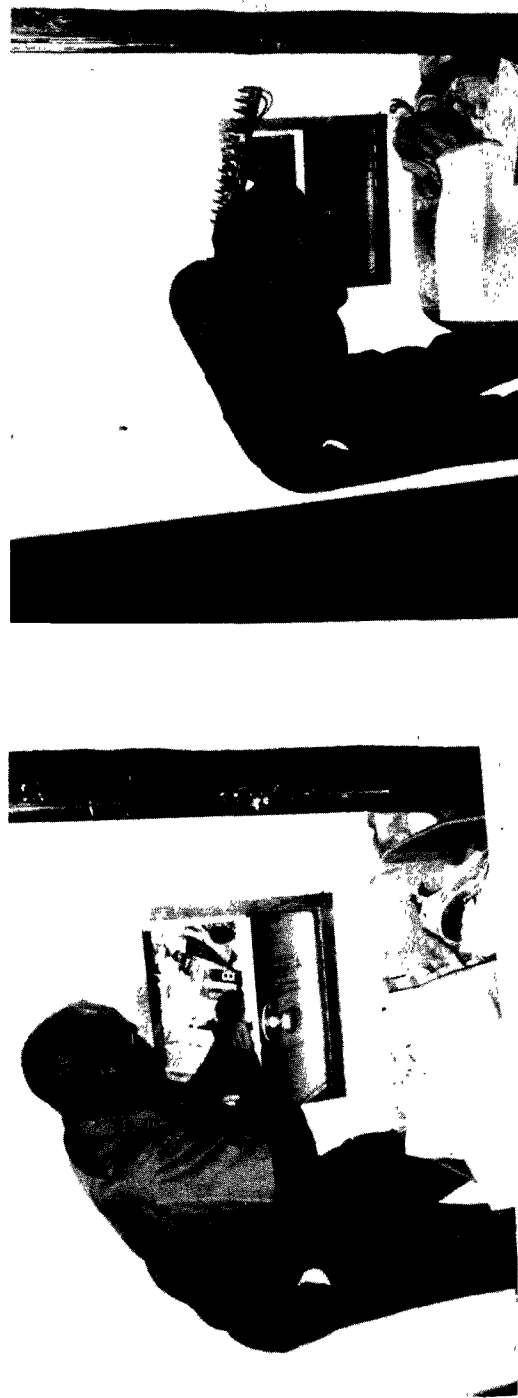
FIGURE 15. Refuse chute blockage at second floor of MFM/HR building at the Macon site. Chute was backed up to third floor.

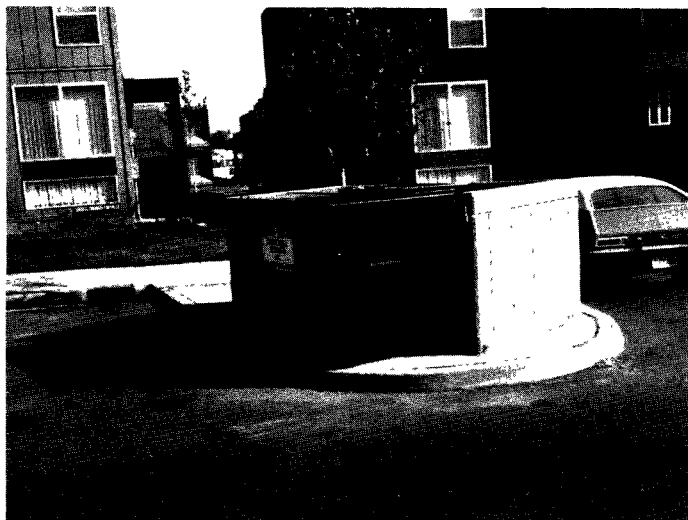
FIGURE 17. Typical 3-cu yd container and concrete pen installation at the Memphis site. Note that the container is not set inside the pen because of lack of clearance room.

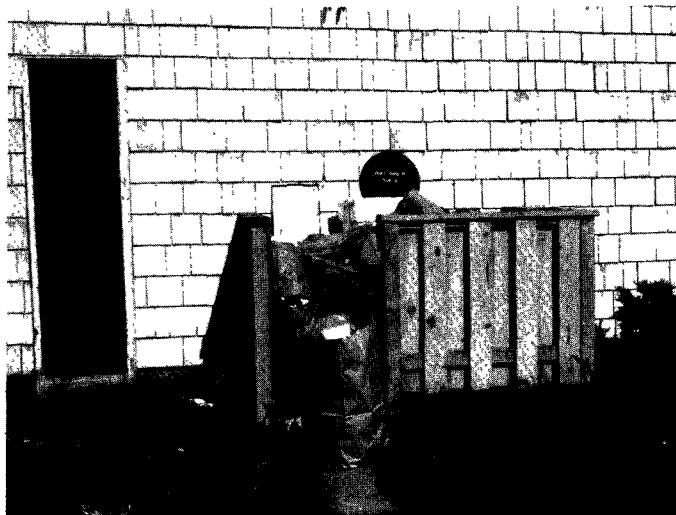
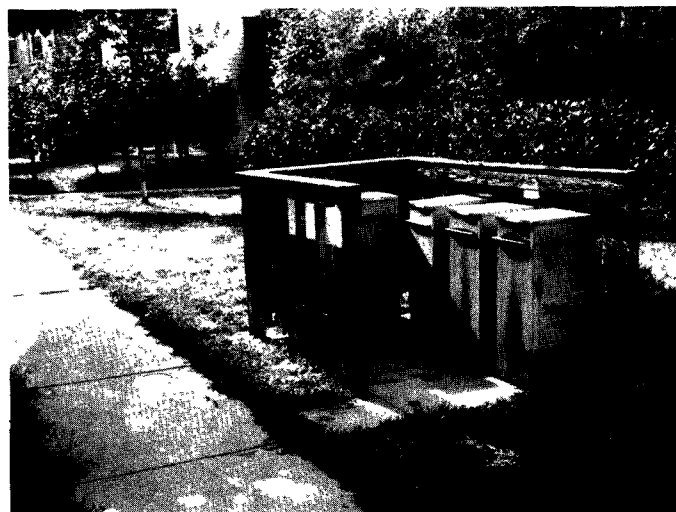
FIGURE 22. Thirty-five gallon containers and enclosures as used for refuse in La Clede Town, St. Louis, MO. There are 587 containers and 127 redwood enclosures around the site. Plastic bag liners are replaced each day in each container.

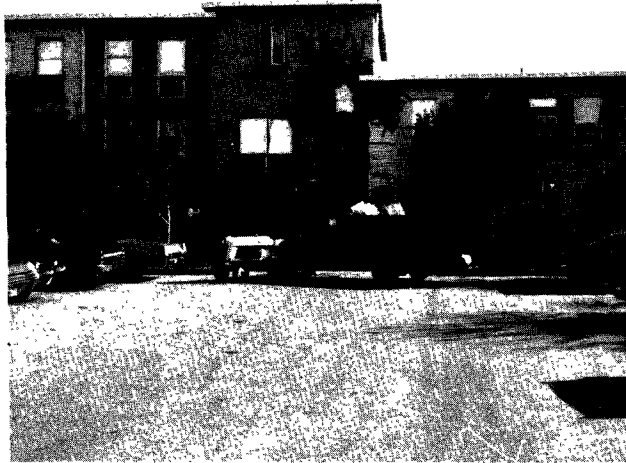
FIGURE 23. Tractor and trailer used by four men to collect refuse from containers in La Clede Town. Refuse is collected six days per week.

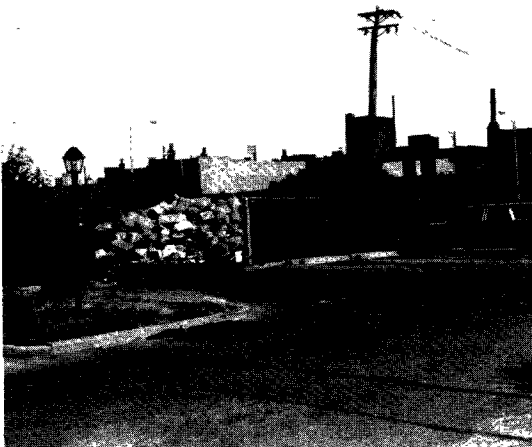
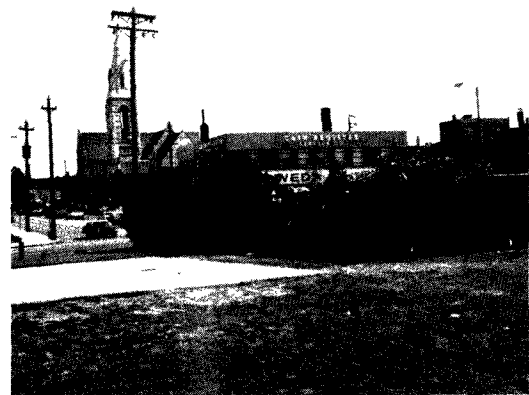
FIGURE 24. West and east views of pen where La Clede Town refuse is stored for pickup by municipal service.

The existing system is not aesthetically obtrusive. All containers and pens are well disguised by shrubbery. The storage pens are outside and the sanitation is questionable because refuse builds up in the pens, decays, attracts flies, causes extreme odor problems, and probably attracts vermin. Also, excessive handling of the bagged refuse caused bag tears and refuse spillage which increases the probability that storage problems occur.

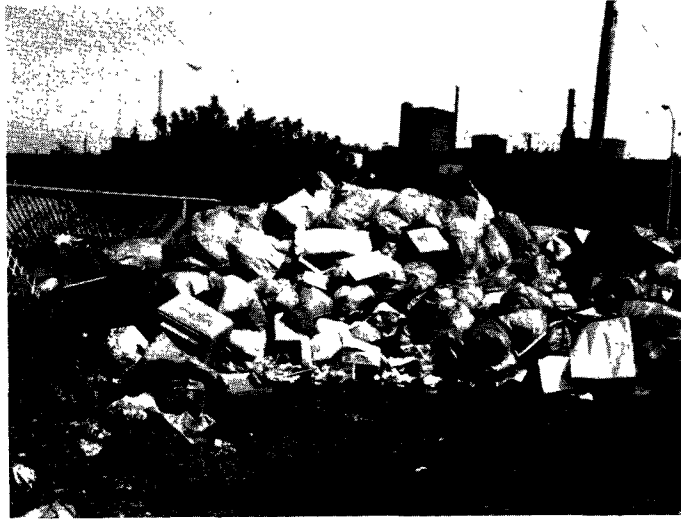
FIGURE 25. Closeup photograph of La Clede Town refuse pen which shows bags of refuse intact and broken open, yard wastes, and appliances.

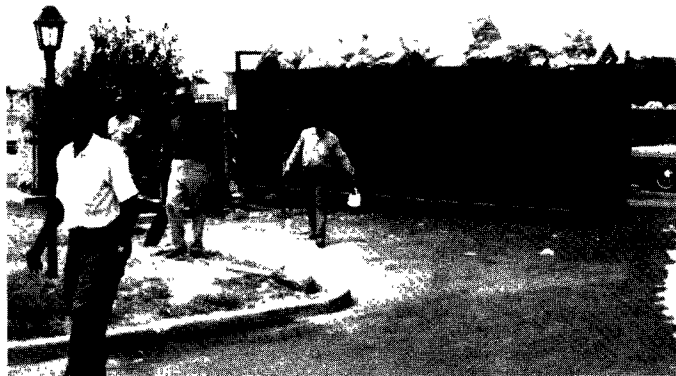
FIGURE 26. Roll-off 30-cu yd container used at La Clede Town refuse storage pen to supplement municipal removal services.

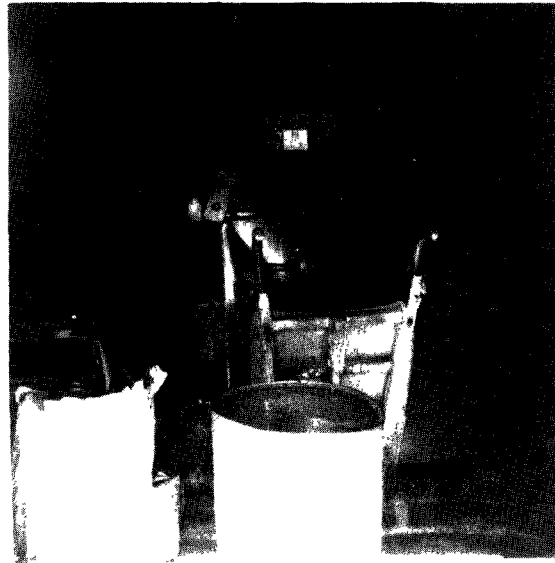
FIGURE 27. Typical chute-fed compactor installation in the MFHR buildings. Two are installed, one in the MFHR in La Clede Town East and the other in the MFHR in La Clede Town West. A private contractor services the containers.

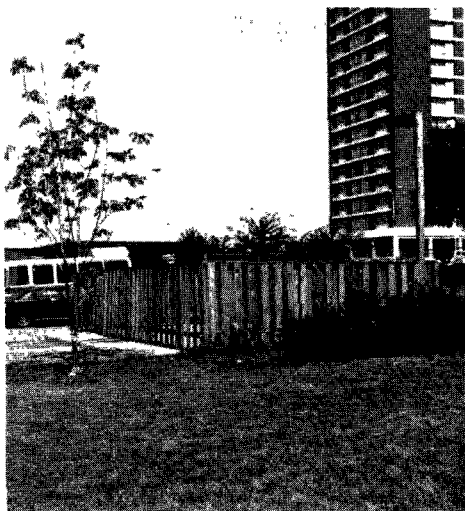
FIGURE 29. Refuse storage pens for refuse from the MFLR and MFMR buildings of La Clede Town East and West sections. Refuse is picked up by site personnel and stored in the pens until picked up by municipal service.

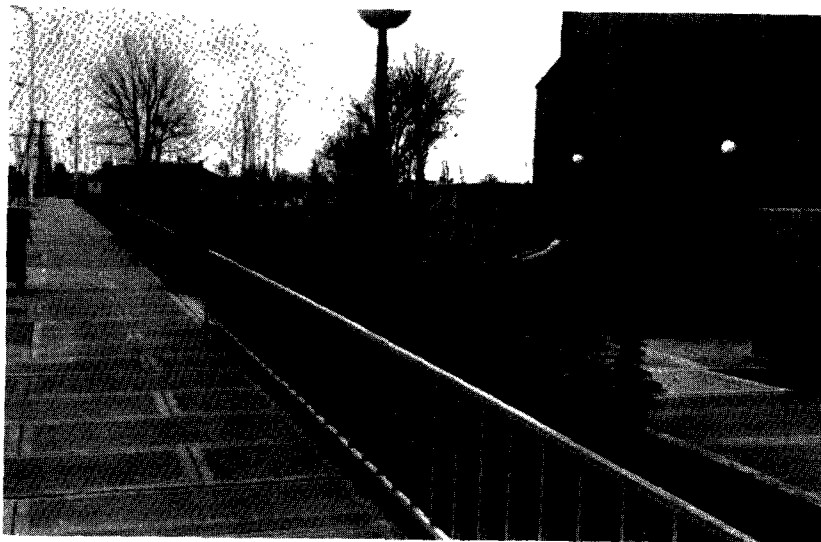
FIGURE 31. Enclosure for four one-cu yd containers at the Seattle site. The enclosure is located beside building.

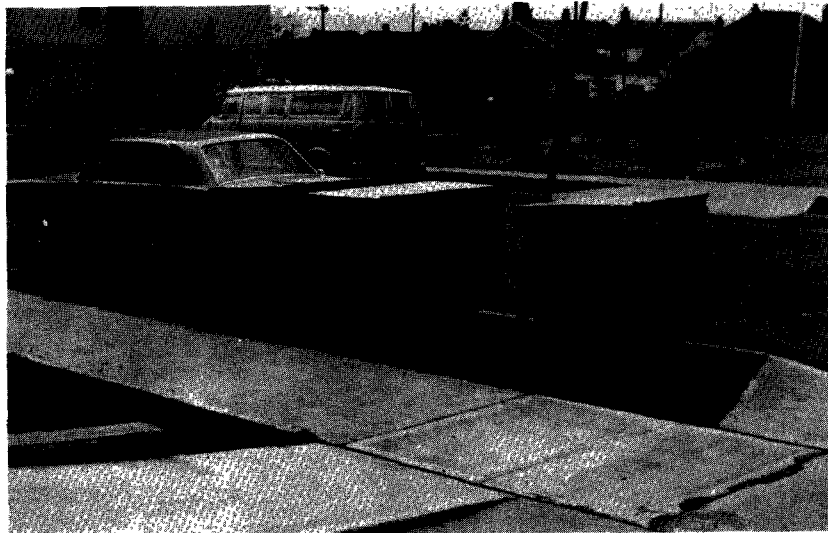
FIGURE 34. Closeup of one-cu yd containers from chute-fed refuse room at the Seattle site.

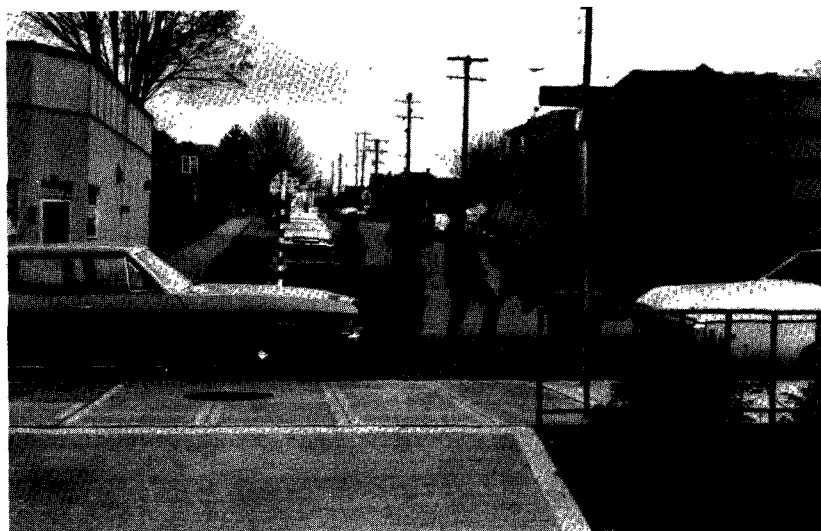
FIGURE 35. Refuse collection at the Seattle site using a rear-loading packer truck. The containers are rolled to the truck, emptied, and returned.

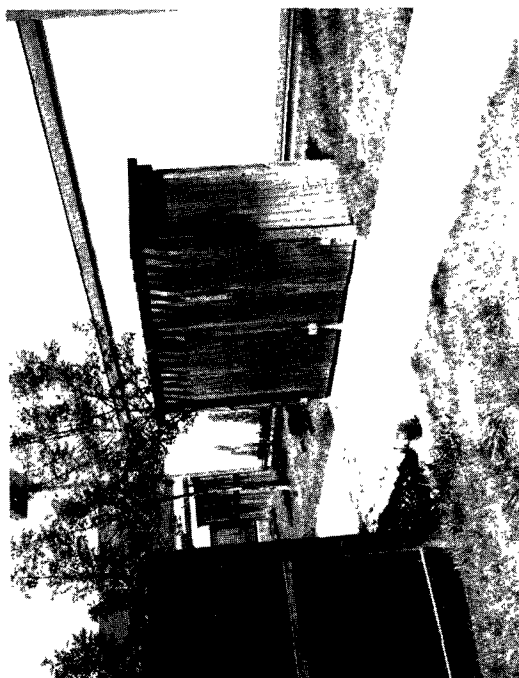
FIGURE 38. Typical of ten redwood pens and trash cans as used for the MFLR section and one SFA section of the Sacramento site. The left photograph is one of nine four-can pens. The site has one six-can pen. The photograph at right shows one-half of a four-can unit on day before pickup.

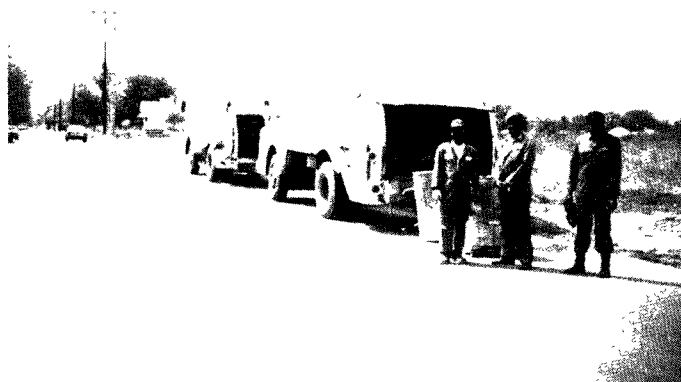
FIGURE 40. Two rear-loading packer vehicles and crew which serviced the MFLR and most of the SFA units at the Scaramento site. Note the tote cans for collection and carrying refuse.

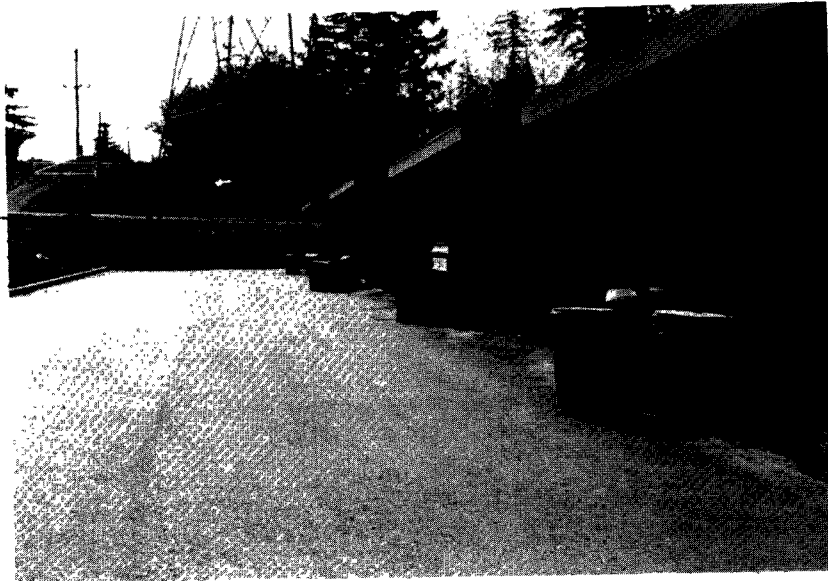
FIGURE 44. Refuse (trash) cans left curbside behind SFA units at the King County Operation Breakthrough site.

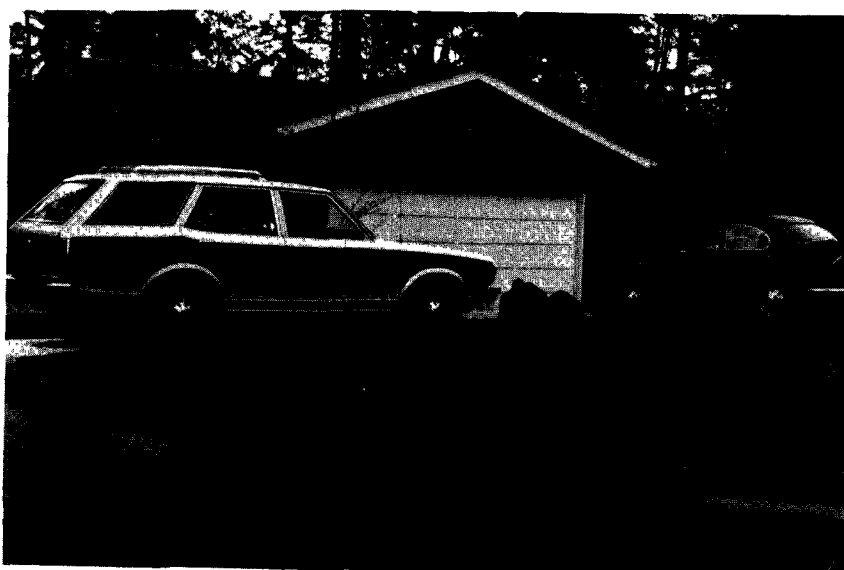
FIGURE 51. Bagged refuse set curbside for pickup,
NE 150th Street, King County, Washington

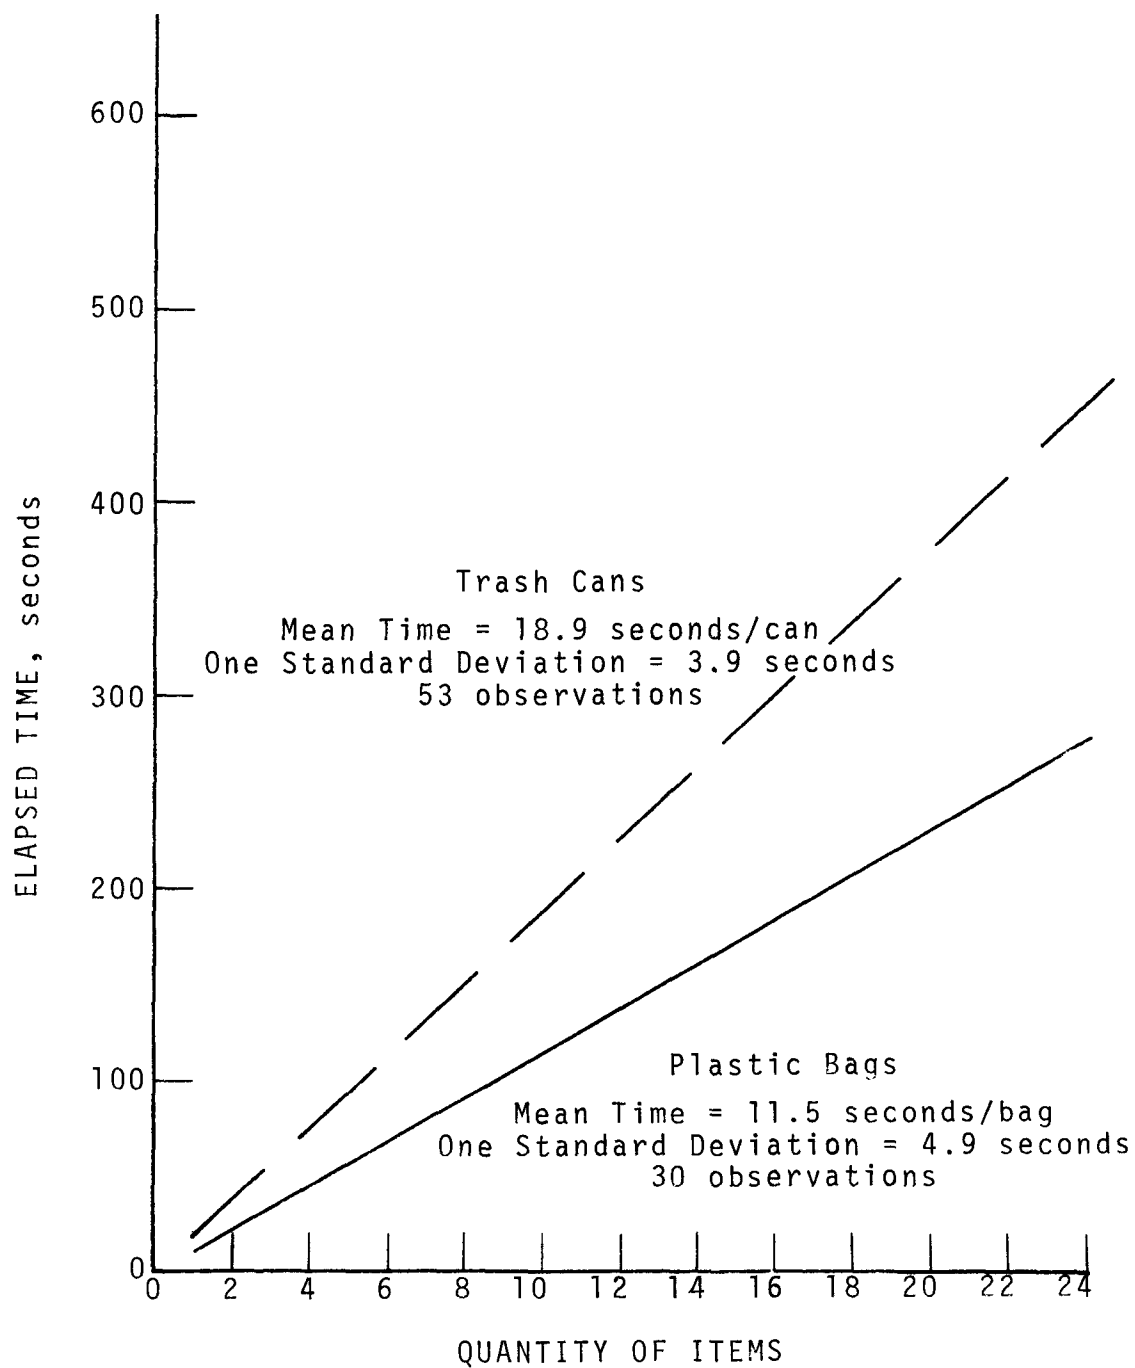
FIGURE 53. Observed total elapsed time to collect refuse in trash cans and plastic bags. Total time includes time spent riding, handling and walking, waiting, and packing.

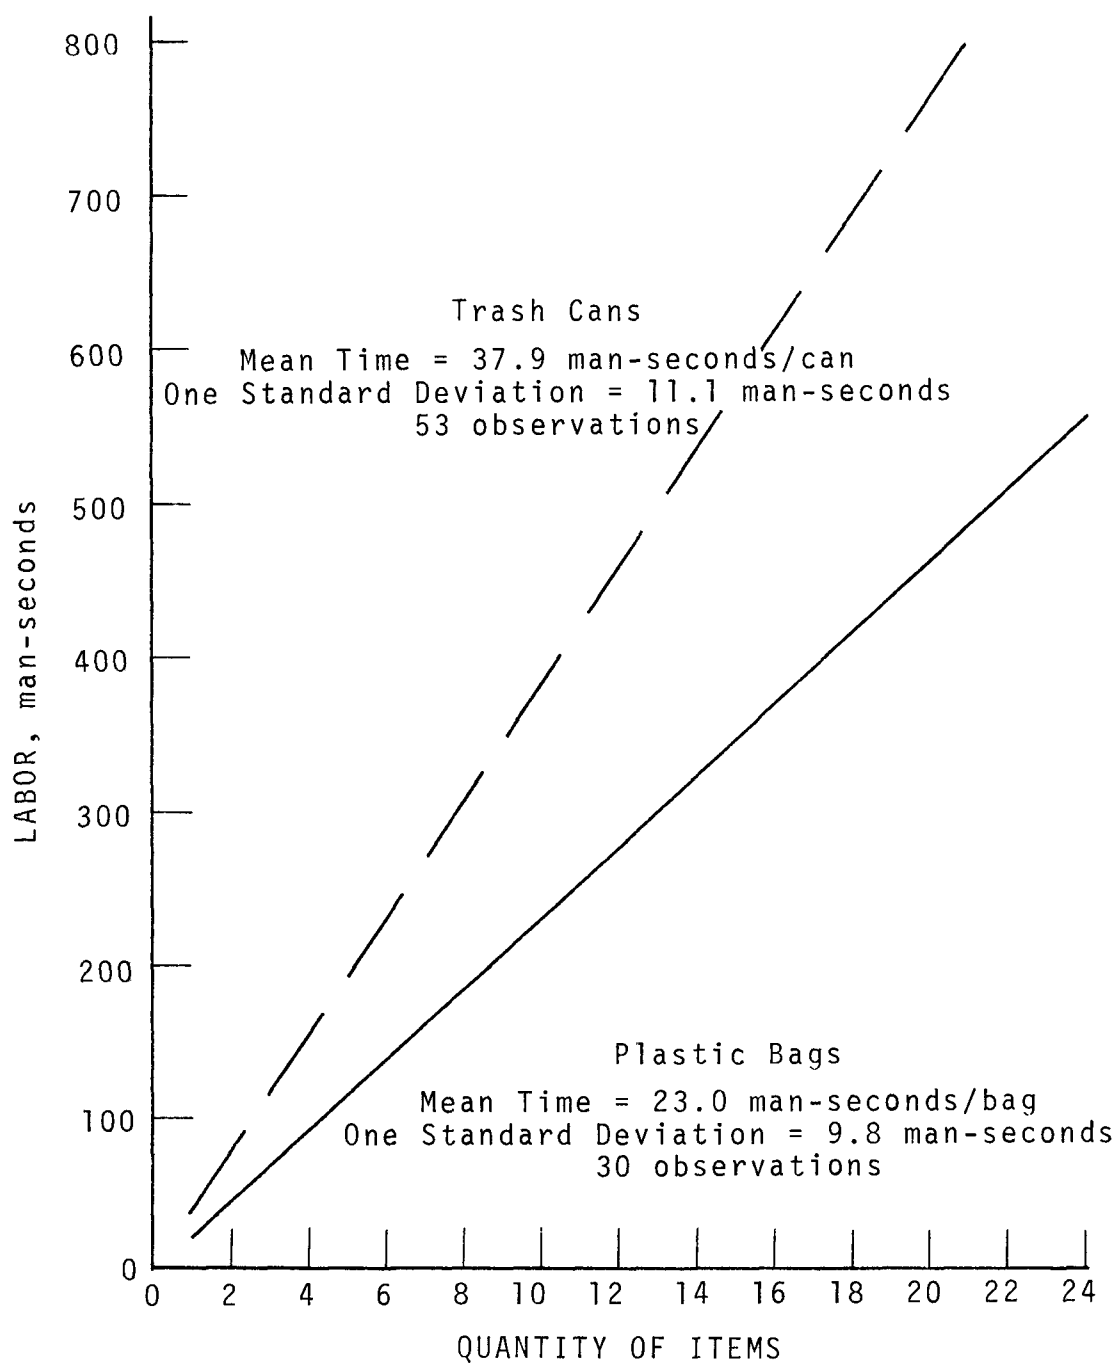
FIGURE 54. Observed total man-time to collect refuse in trash cans and plastic bags. Total man-time includes time spent riding, handling and walking, waiting, and packing.

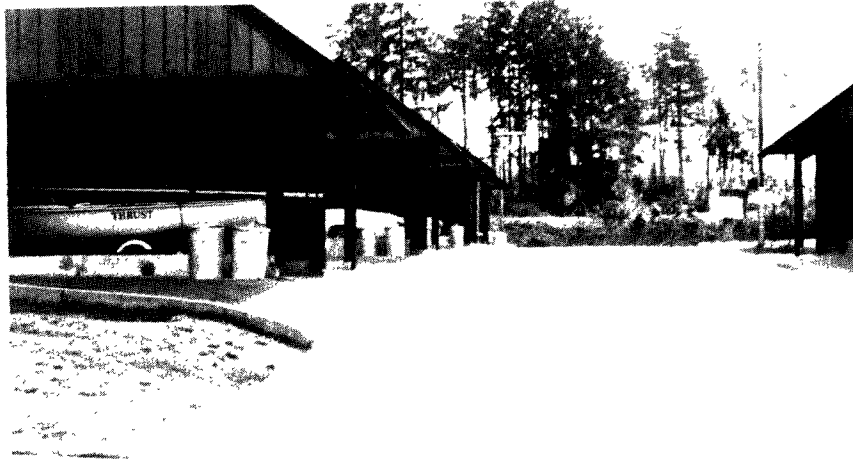
FIGURE 56. Photographs of trash cans left curbside after pickup.

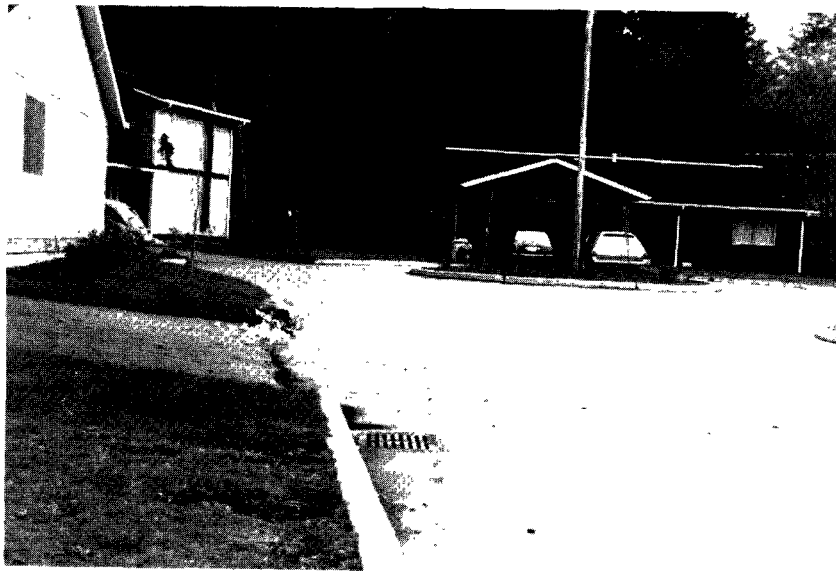
FIGURE 57. Refuse spilled from a plastic bag as the result of being torn open by a pet.

The special plastic bag study at the King County site showed definite advantages to use of plastic bags in place of containers. A warmer time of day for pickup or a warmer climate might change the results if bags weaken. Only heavy duty bags are recommended if a plastic bag requirement is instituted.
