Providing Solutions for a Better Tomorrow

A Progress Report on U.S. EPA's Drinking Water Treatment Technology Demonstrations in Ecuador, Mexico and China

EPA/600/F-98/008

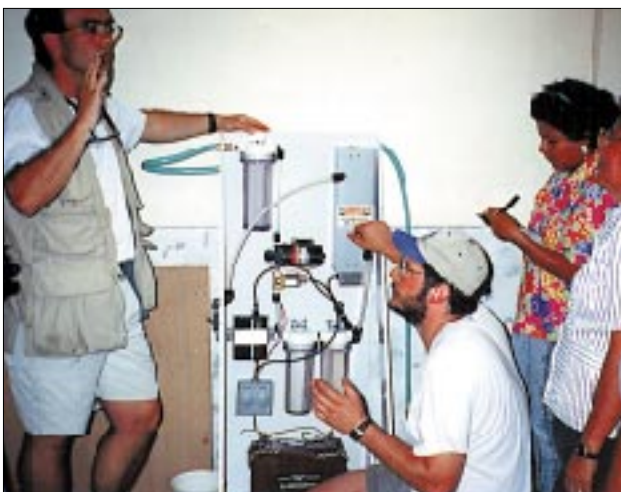
Technology representatives Lino Gallo (left) and Chip Landman (kneeling) explain the operation of a point-of-use water treatment unit to regional and local health staff in Ecuador. Landman noted, “The U.S. TIES program is certainly the most result-oriented, risk-reducing government program Watersolve International, LLC, has ever been associated with. The program has afforded our company an opportunity to collaborate with U.S. EPA and foreign authorities to help prove the effectiveness of U.S. technology in reducing waterborne disease — and saving lives — in developing locations throughout the world.”

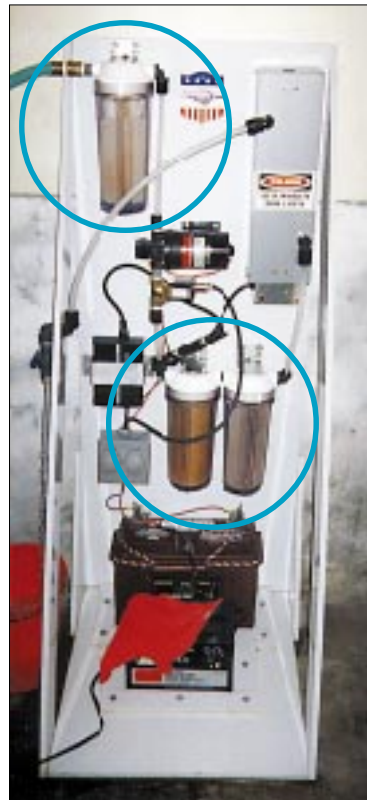
This treatment unit was installed at the La America clinic with untreated water entering through the green hose at top left. The filters (circled in blue) are set up in order of decreasing porosity. The top filter traps particles larger than 30 micrometers in diameter. The bottom two filters, with 5 micrometer (left) and 1 micrometer porosity, remove bacteria and protozoa. Brownish yellow materials visible on these filter cartridges are trapped contaminants. UV disinfection occurs in the grey box at top right.

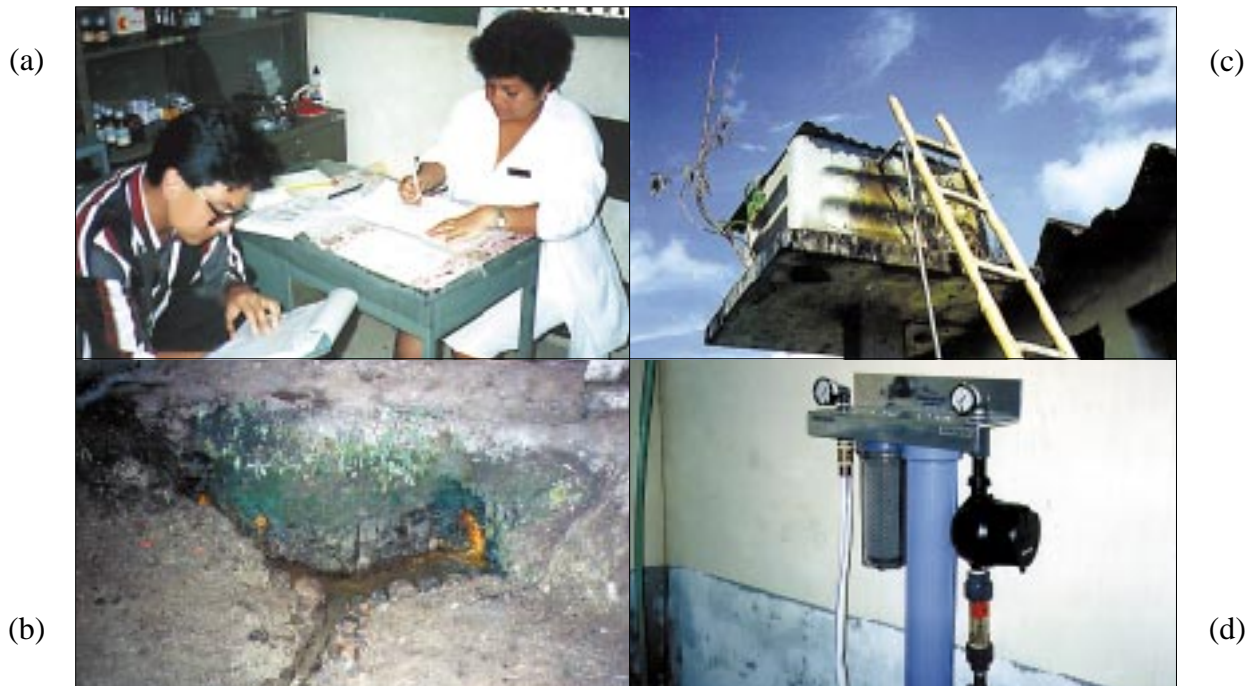
La America demonstration site. (a) Local clinic records are being reviewed for incidence of illness and death caused by diarrhea. (b) Drinking water source for LaAmerica. (c) Water storage tank for La America clinic. (d) One of the point-of-use treatment units installed in La America. Blue cannister contains an easily replaceable filtration cartridge.

Problems: The source water (see picture “b” above) and the holding tank are susceptible to contamination. Periods of negative pressure in the distribution system increase potential for contaminants to enter into the lines.

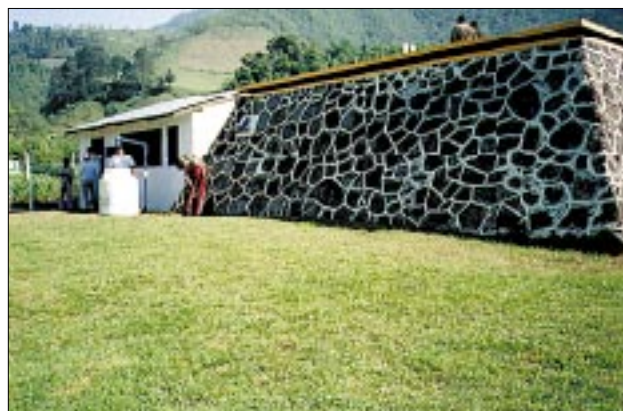
Drinking water treatment and storage facility at Ixhuacan, Mexico.

Solutions: Multimedia filters were installed followed by bag filters and a chlorination unit. The Vera Cruz state government has shown a great deal of interest in the drinking water treatment demonstration project at Ixhuacan. Improved drinking water quality is part of an overall plan to encourage residential and industrial growth in this part of Mexico.

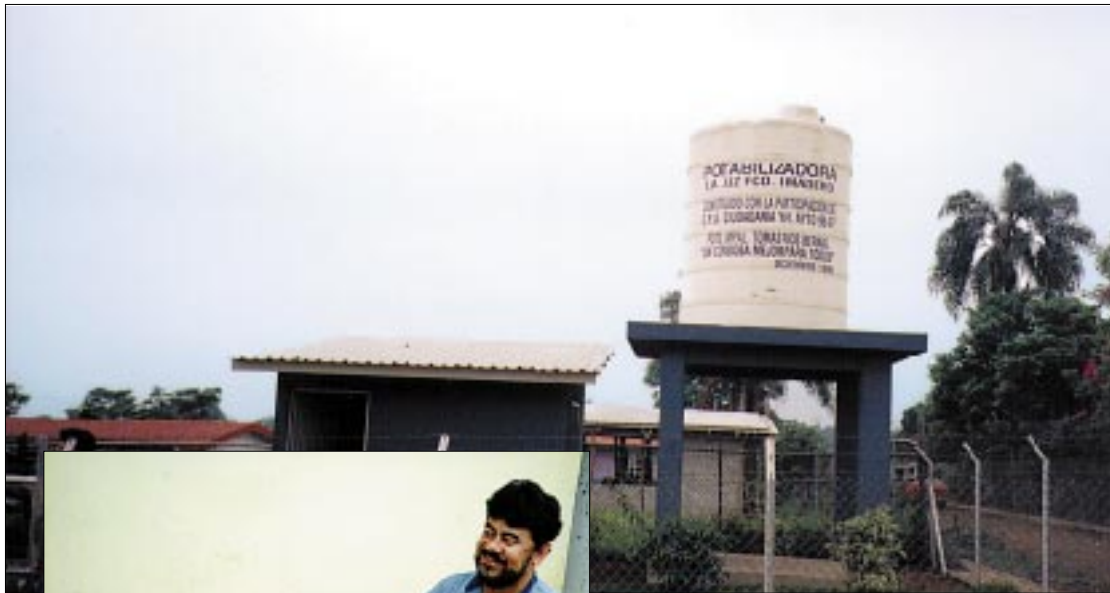
Treatment facility and storage unit installed at La Luz, Mexico demonstration site. Drinking water is provided to nearby elementary school and also made available to community residents.

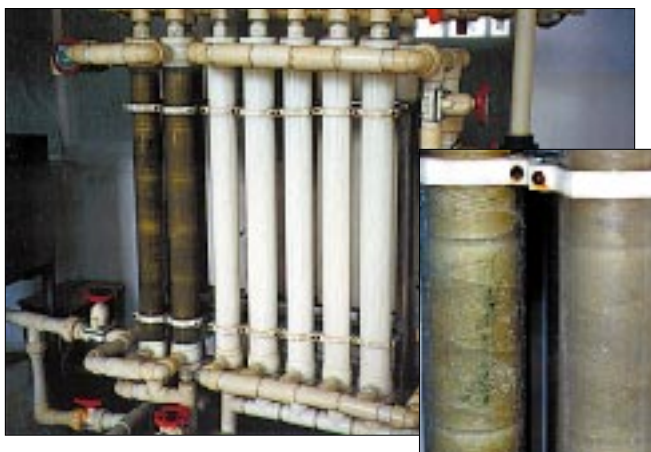
Use of locally manufactured materials presented an unexpected problem. Translucent plastic piping exposed to sunlight lead to heavy biofilm growth (green areas in two leftmost columns and inset) in a treatment system found in China.

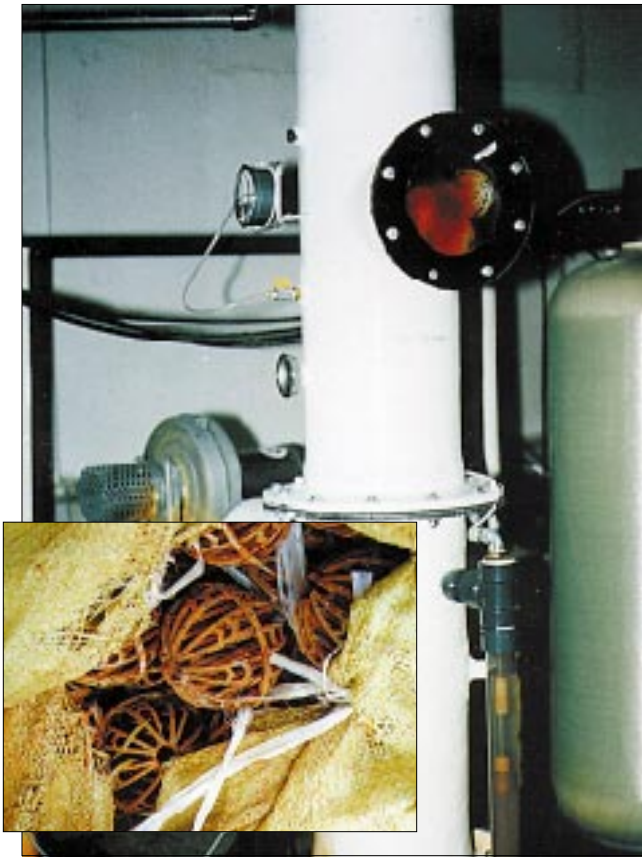
This component of the demonstration treatment technologies is an 'air stripper' used to remove volatile organics from the water. Its packing (visible in the porthole and inset photo), white when newly installed, has been fouled due to high iron concentrations.

Solution: Because of the extremely variable contaminant levels, substantial modifications have been made to the original treatment train as well as repair to the system following a recent typhoon. The system includes two iron filters, multimedia filtra-
