Project Summary

The National Atmospheric Deposition Program/National Trends Network (NADP/NTN) SITE Visitation Program (October 1989 through September 1990)

EPA/600/SR-92/151

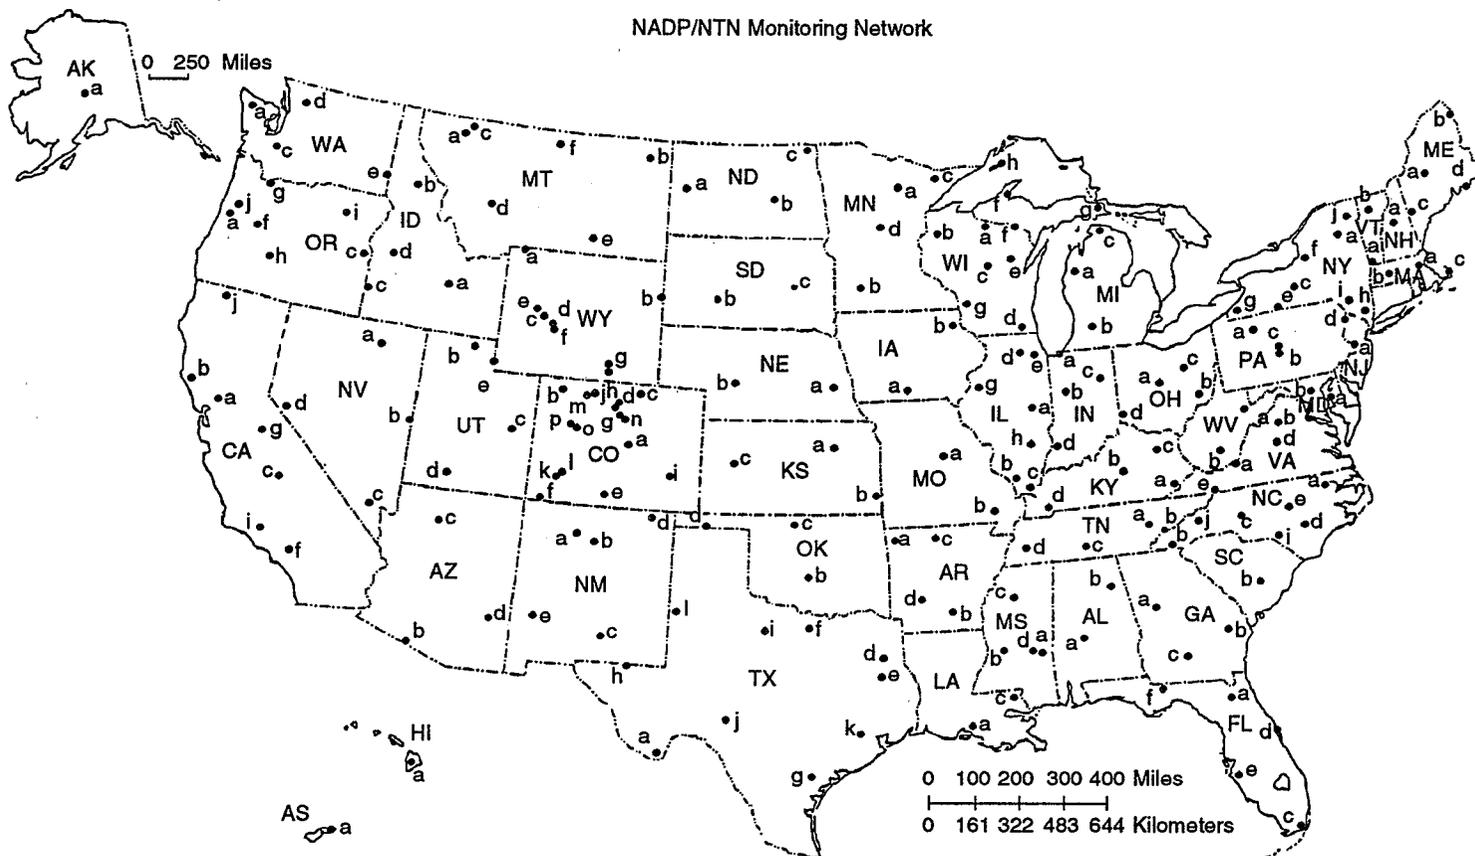
Figure 1. Active sites in the NADP/NTN monitoring network during 1990.

Sixty-seven of the 196 sites (with duplicate sites bringing the total to 205) that were in operation during 1990 were visited during this timeframe. Figure 1 shows the NADP/NTN site locations.

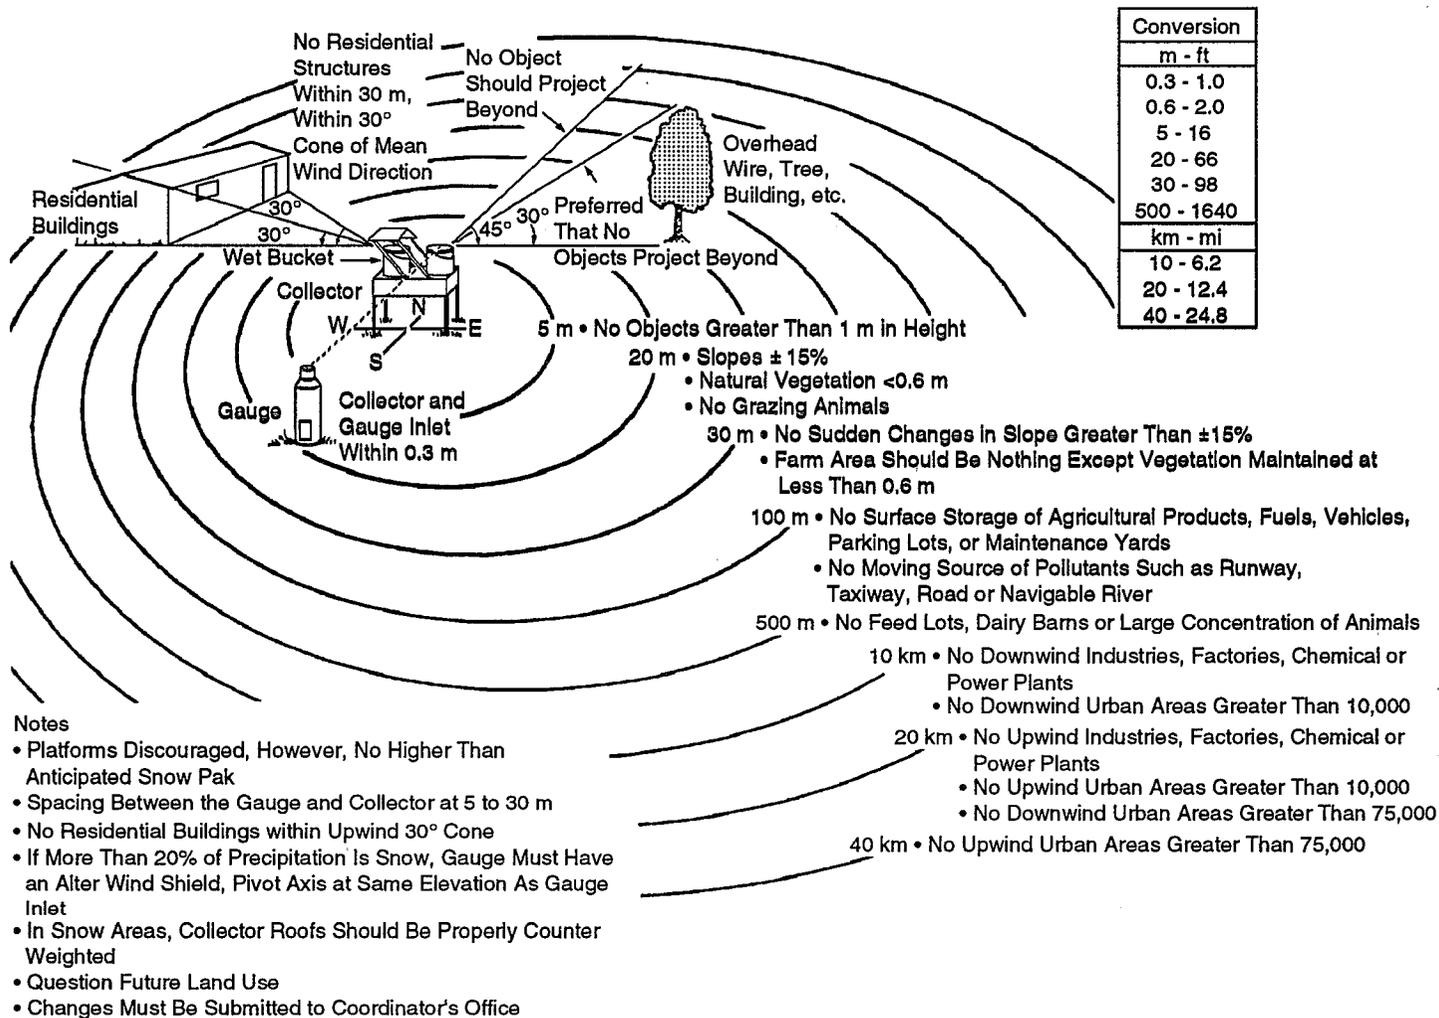
Figure 2. NADP/NTN siting criteria.

A quality assurance systems survey was conducted at each site to qualitatively assess the site, its surroundings, and the operator's adherence to procedures specified in the NTN design document and in the NADP/NTN site operator's instruction manual. Criteria for siting an NADP/NTN precipitation station are illustrated in Figure 2. The operator was asked to demon-
