# Demonstration of Aquafix and SAPS Passive Mine Water Treatment Technologies at the Summitville Mine Site

## Innovative Technology Evaluation Report

**National Risk Management Research Laboratory  
Office of Research and Development  
U.S. Environmental Protection Agency  
Cincinnati, Ohio**

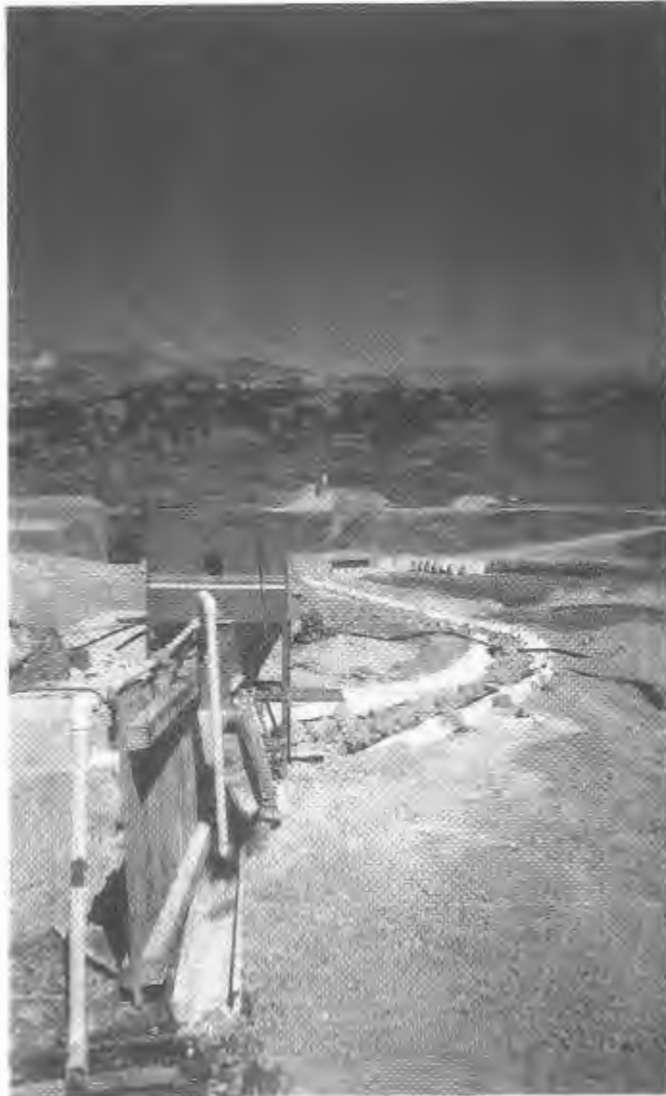
Aquafix System as set up at Summitville.

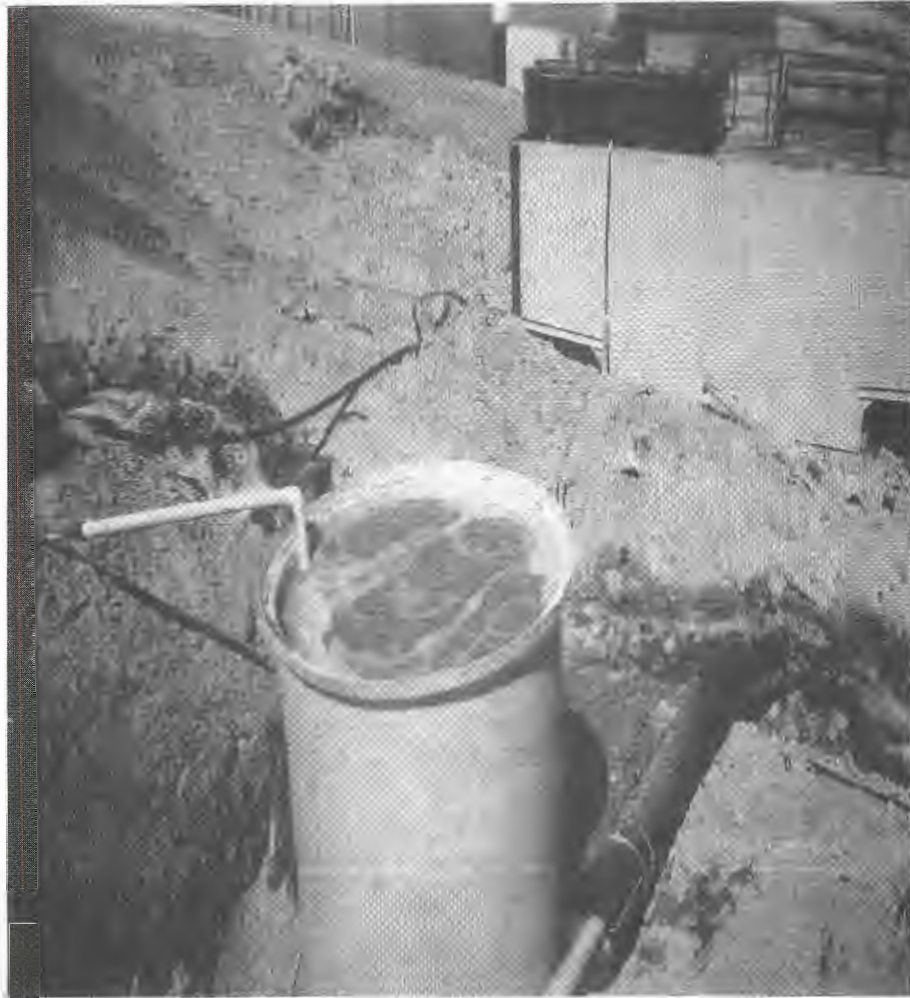
Oxidizing Aquafix effluent and discharge into Baker Tank for sludge setting.

In the Aquafix treatment system, a post treatment aeration tank consisting of a rotary pump and fine bubble diffuser was used for oxidation of the treated AMD stream. In this operation, the aeration system was utilized to enhance the conditions to facilitate the oxidation of ferrous ion to ferric ion, rather than as a source for the oxidation. In this case, aeration enhanced the conditions for the formation of metal hydroxide precipitate.

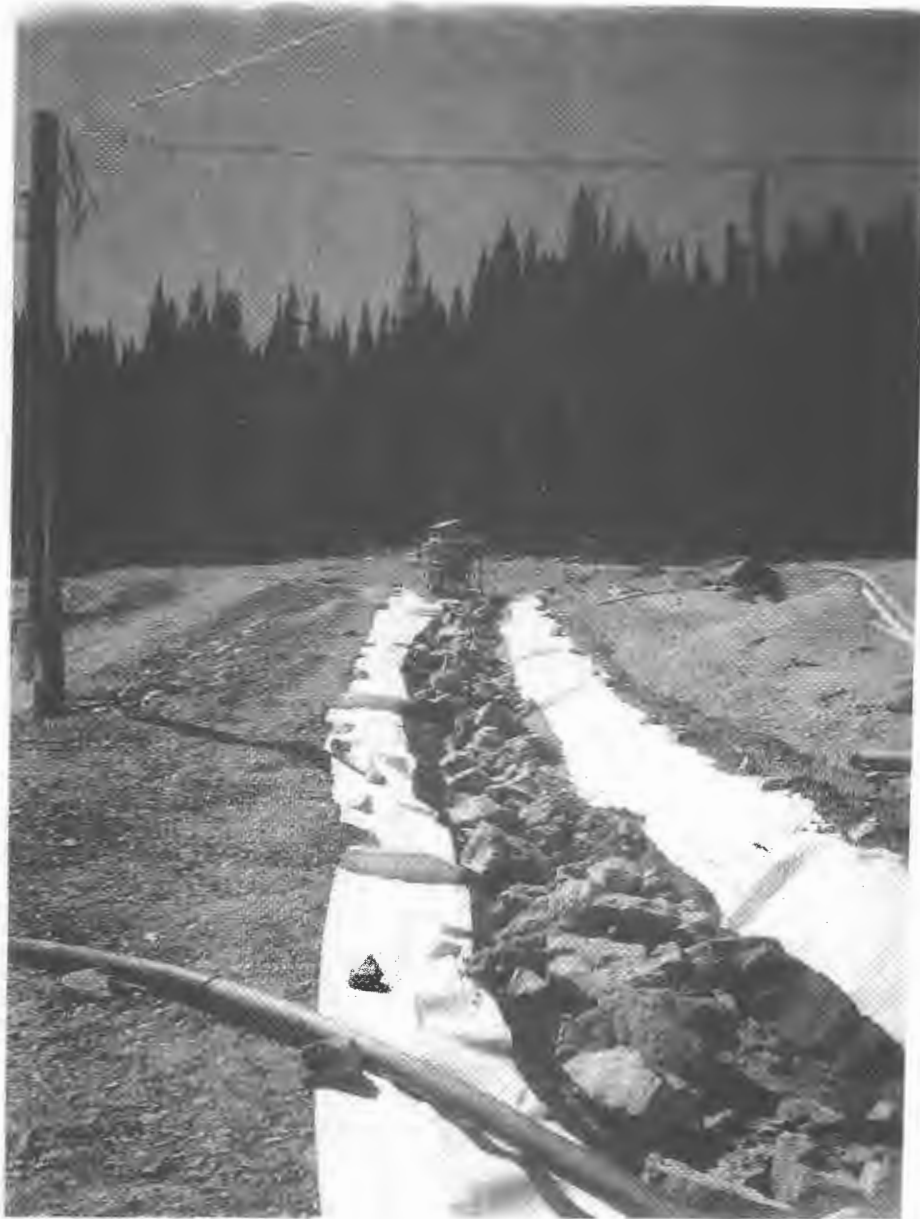
Photograph shows rock trench and plastic liner in foreground and Aquafix system in background.

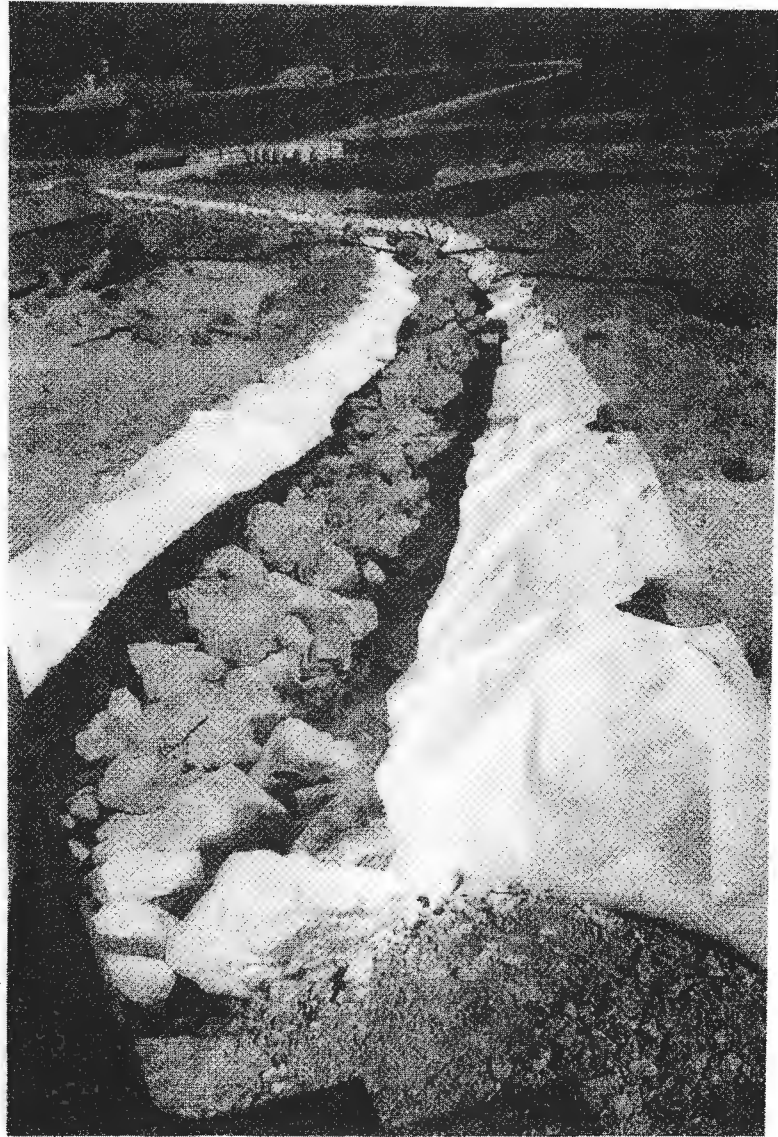
Limestone rock lined channel.
