A Guide for School Maintenance Personnel

Removing PCBs from Light Fixtures:

Protecting Students from Hidden Dangers

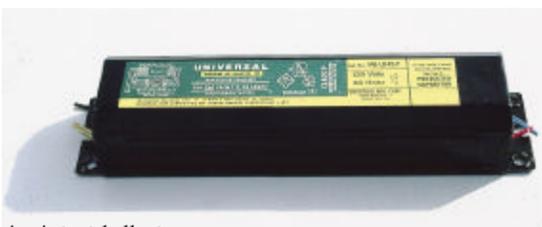
An intact ballast.

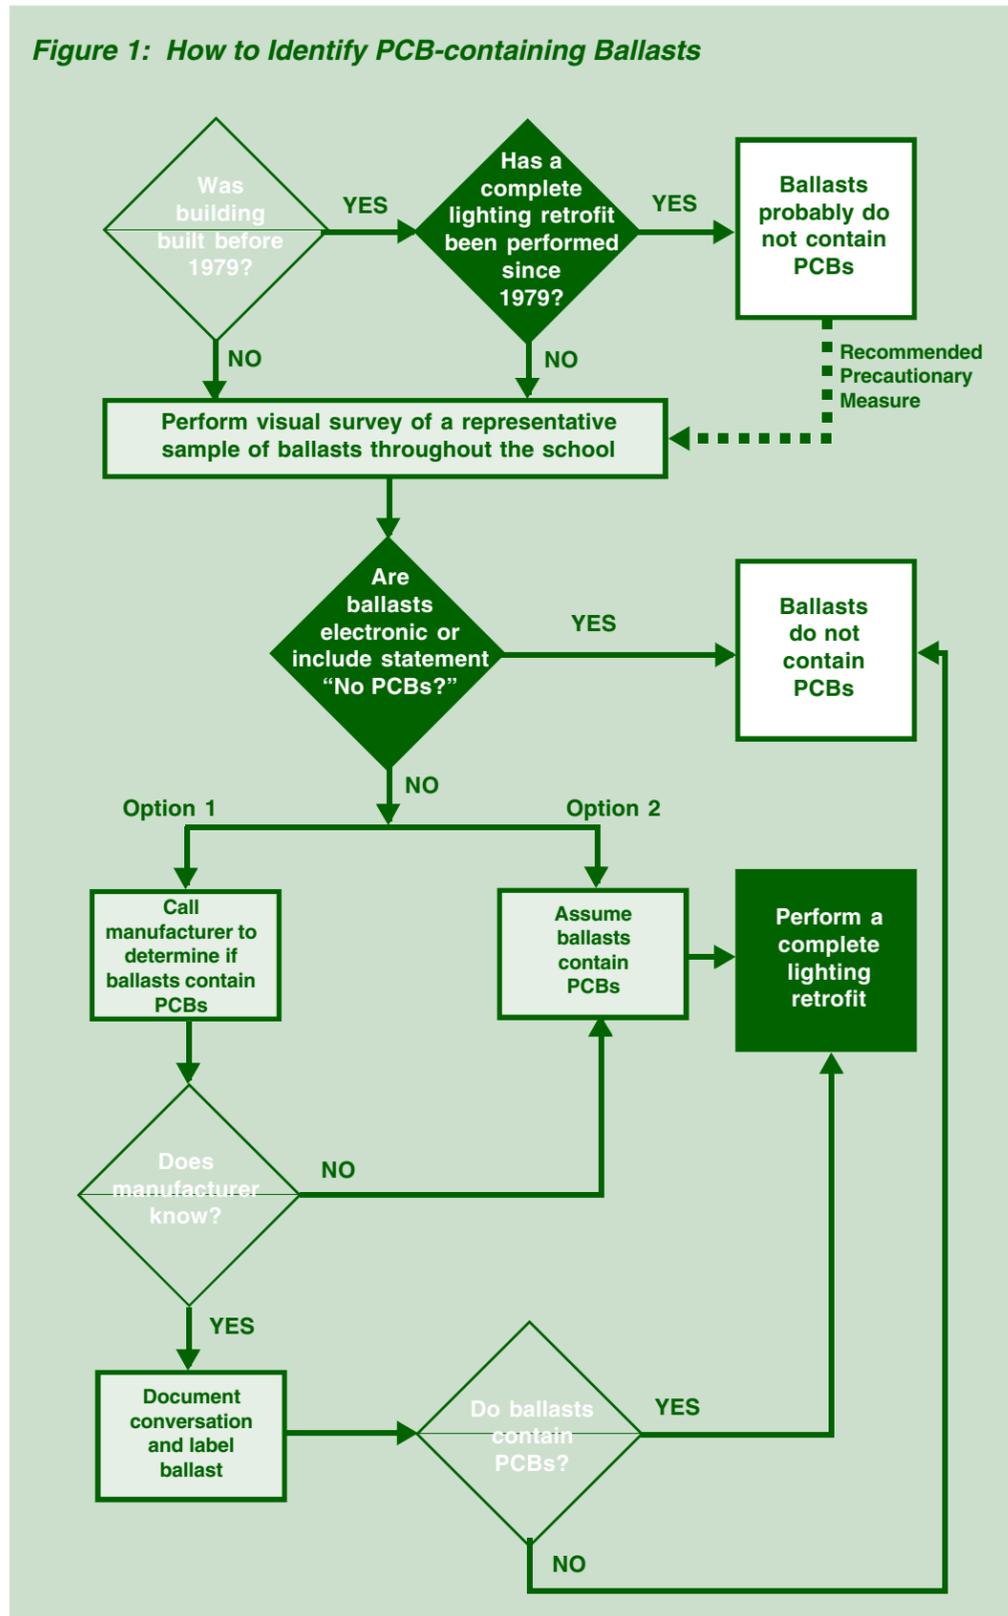
Figure 1: How to Identify PCB-containing Ballasts

Figure 1 (right) can help you determine whether there may be PCBs in your school. If you determine that your lights might have PCBs, you should conduct a visual inspection.

PCBs are found only in magnetic ballasts. If your ballasts are electronic, they are

PCB-free. Electronic ballasts should be clearly marked as electronic. After July 1, 1979, magnetic ballasts manufactured without PCBs in their capacitors or potting material

required the statement "No PCBs." Even if the ballasts in your sample are magnetic ballasts labeled "No PCBs," a lighting retrofit is recommended because of the educational and energy saving benefits.

If the magnetic ballasts do not have the statement "No PCBs," you have two options:

1. Assume that the ballasts contain PCBs and consider performing a lighting retrofit, OR
2. Contact the manufacturer to determine whether the ballasts contain PCBs.
