EPA 909B-00-003
May 2001
www.epa.gov/region09

A Guide for School Administrators

Removing PCBs from Light Fixtures:

Protecting Students from Hidden Dangers

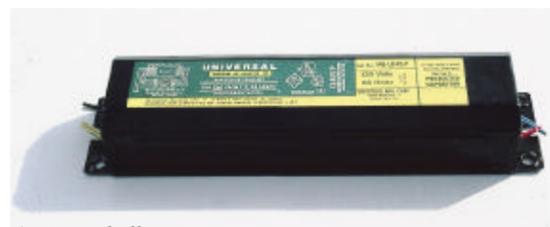
An intact ballast.
