MERCURY, ZINC, COPPER, ARSENIC, SELENIUM,  
AND CYANIDE CONTENT OF SELECTED WATERS  
AND SEDIMENT COLLECTED ALONG WHITEWOOD  
CREEK, THE BELLE FOURCHE RIVER, AND THE  
CHEYENNE RIVER IN WESTERN SOUTH DAKOTA  
DECEMBER 1971 - OCTOBER 1972

MERCURY, ZINC, COPPER, ARSENIC, SELENIUM, AND CYANIDE  
CONTENT OF  
SELECTED WATERS AND SEDIMENT ALONG  
WHITEWOOD CREEK, THE BELLE FOURCHE RIVER, AND THE CHEYENNE RIVER  
IN WESTERN SOUTH DAKOTA

December 1971 - October 1972

TECHNICAL SUPPORT BRANCH  
SURVEILLANCE AND ANALYSIS DIVISION  
U. S. ENVIRONMENTAL PROTECTION AGENCY  
REGION VIII

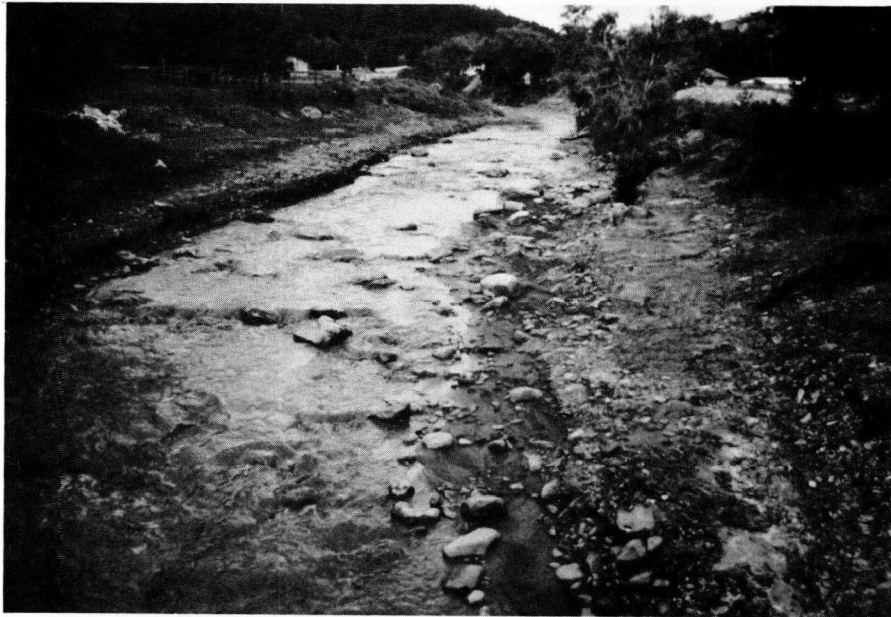
Photograph WC-1-1

Whitewood Creek, looking upstream from road bridge at Site WC-1. Sample SD-SED-4 collected from dark gray silt located as a surface covering over the poorly-sorted gravels. Note color of stream.

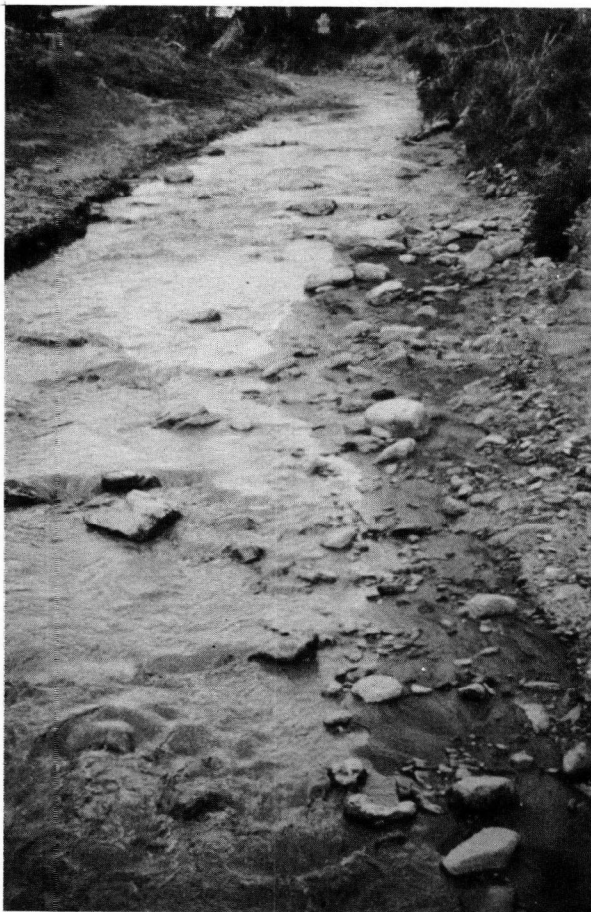
Photograph WC-1-2

Whitewood Creek--close-up of upstream view showing two levels of dark gray silt (lighter gray where higher and dryer). Area not identified as one containing "tailings" in November '71.

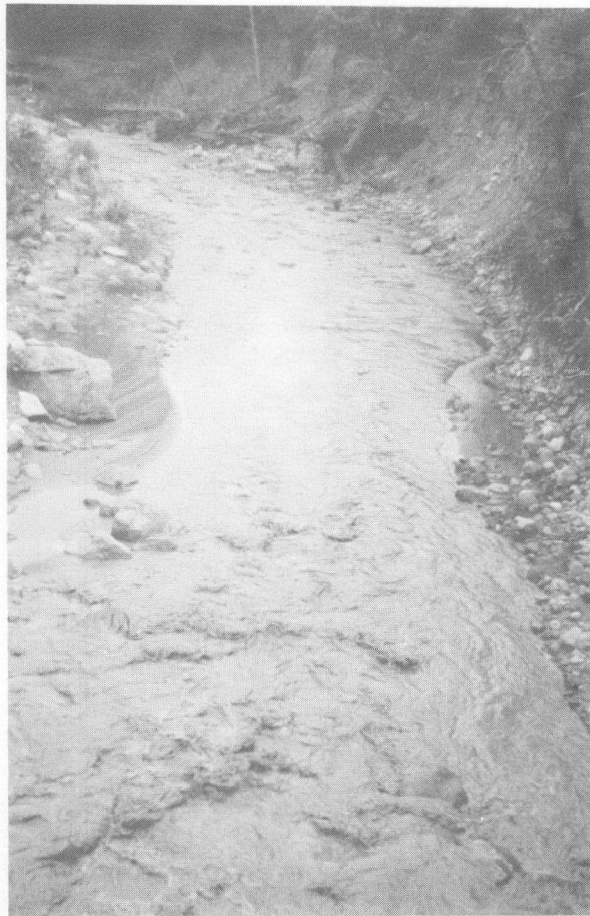
Photograph WC-1-3

Whitewood Creek, looking downstream from road bridge at Site WC-1, showing thin and recent (?) deposits of dark gray silt near channel.

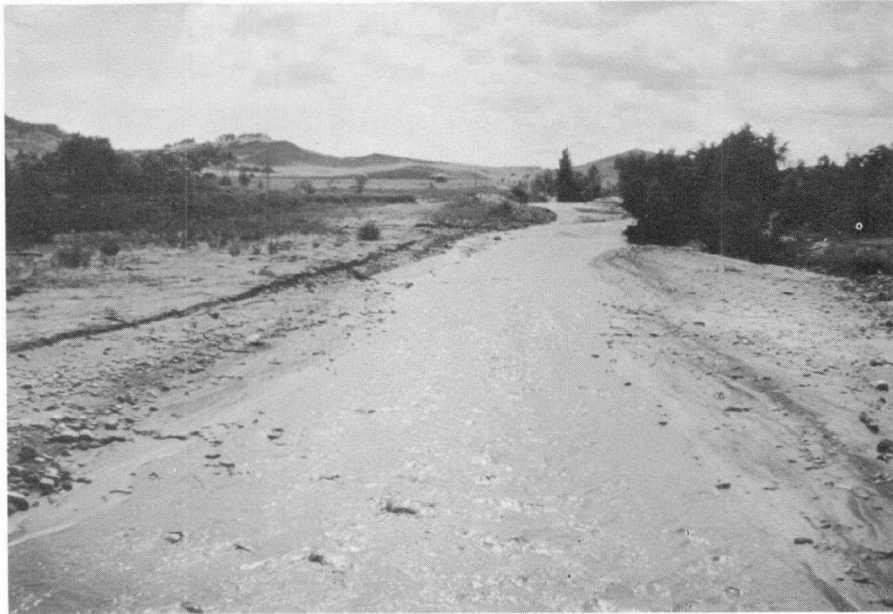
Photograph WC-2-1

Whitewood Creek looking upstream (SE) from road bridge showing widespread dark gray silt covering immediate flood plain and younger channel deposits. Sediment samples SD-SED-5A through C collected from left bank near edge of upper deposit.

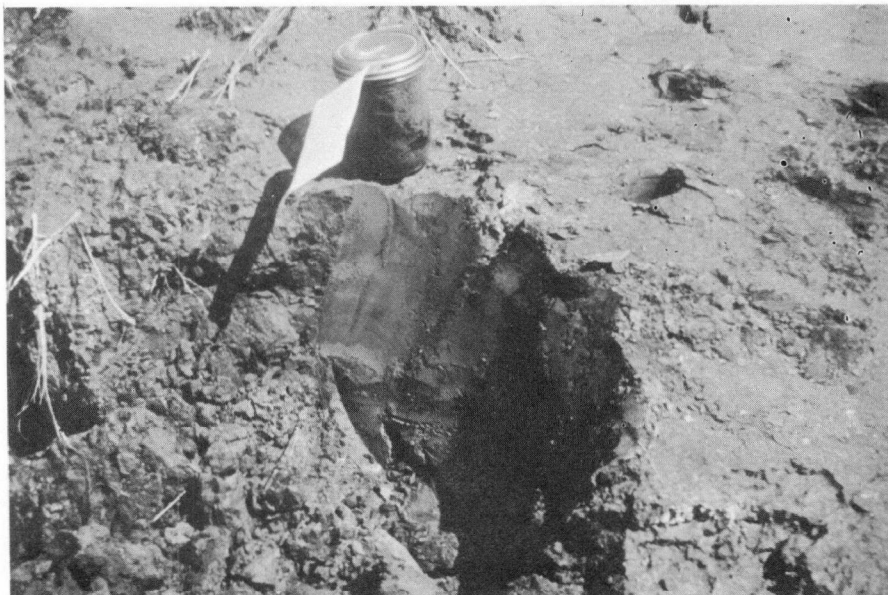
Photograph WC-2-2

Gray silt and reddish brown sand as sampled by sediment samples SD-SED-5A through C. Collected near stream edge of upper deposit to depth of about 30 cm. Note core hole to right of pint sample. Note also gray silt layer near bottom of pit and that silt from upper layers has been smeared over the lower brown sands by shovel.

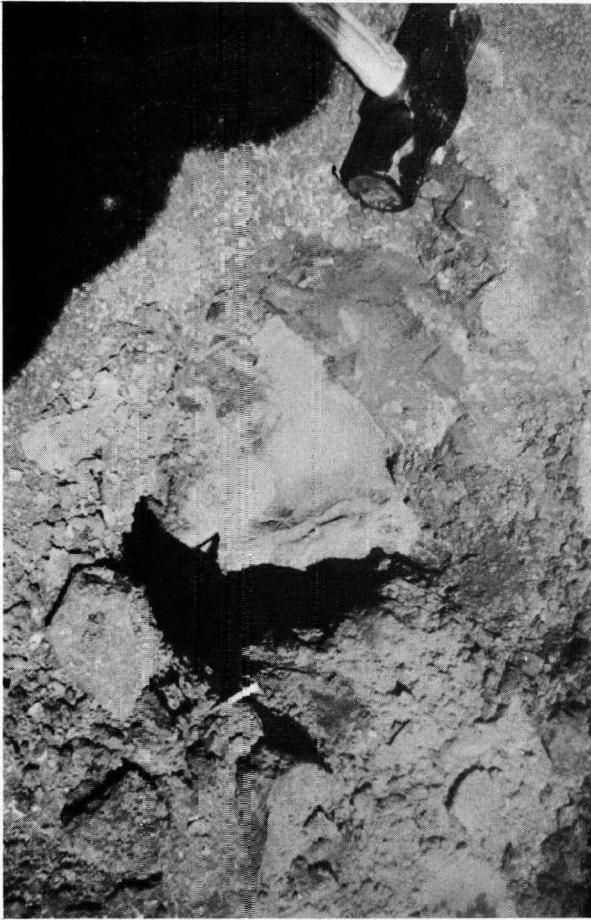
Photograph WC-2-3

Gray silt and brown sand from pit dug about 10 m. farther away from the shore (east of) sampling site showing surface layer of gray silt, sands beneath, and no silt found beneath sands.

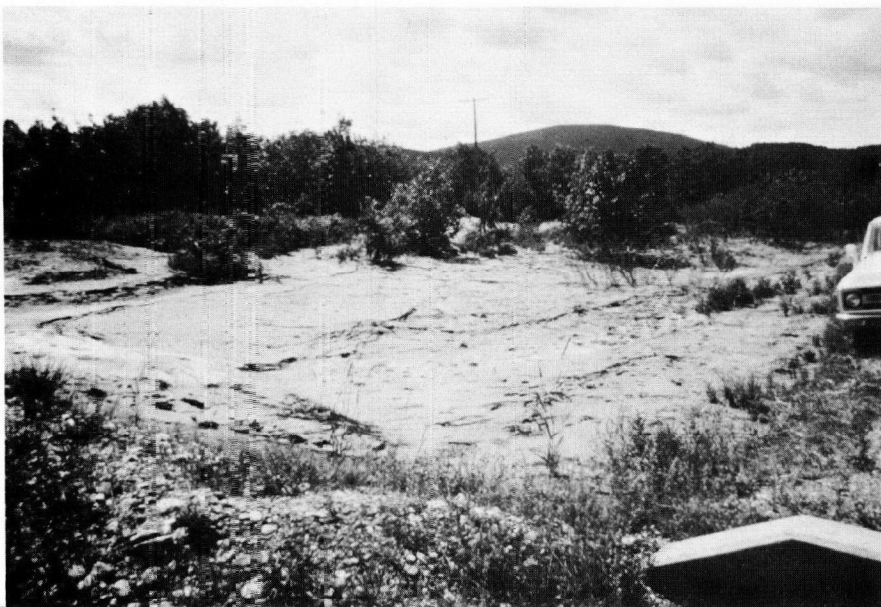
Photograph WC-2-4

Isolated deposit of dark gray silt beyond west bank of Whitewood Creek at Site WC-2. Note that silt was deposited well away from the Creek (west bridge abutment visible in lower right).

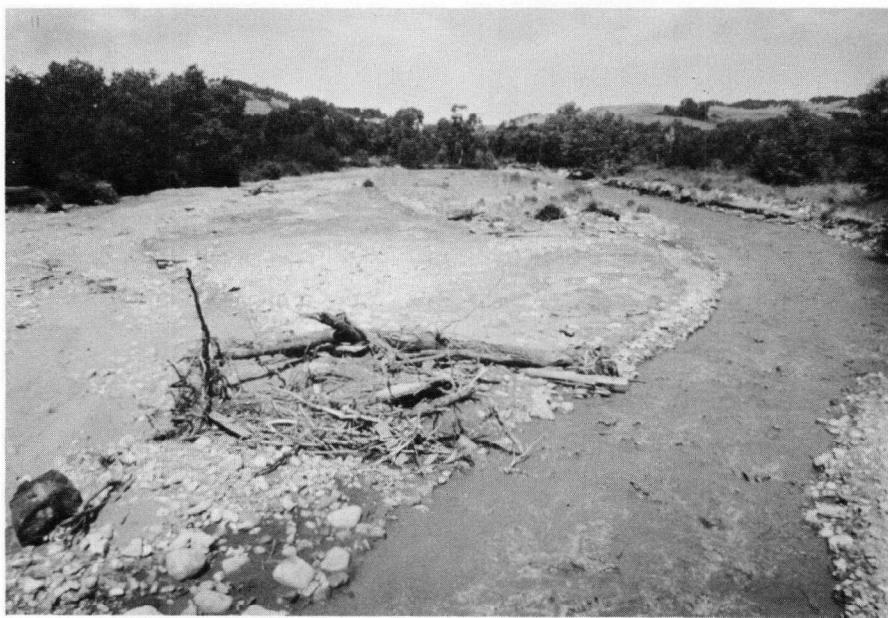
Photograph WC-2-5

Whitewood Creek looking downstream from Whitewood Valley  
Road bridge near sediment sampling Site WC-2 and at Water  
Sampling Site 19.

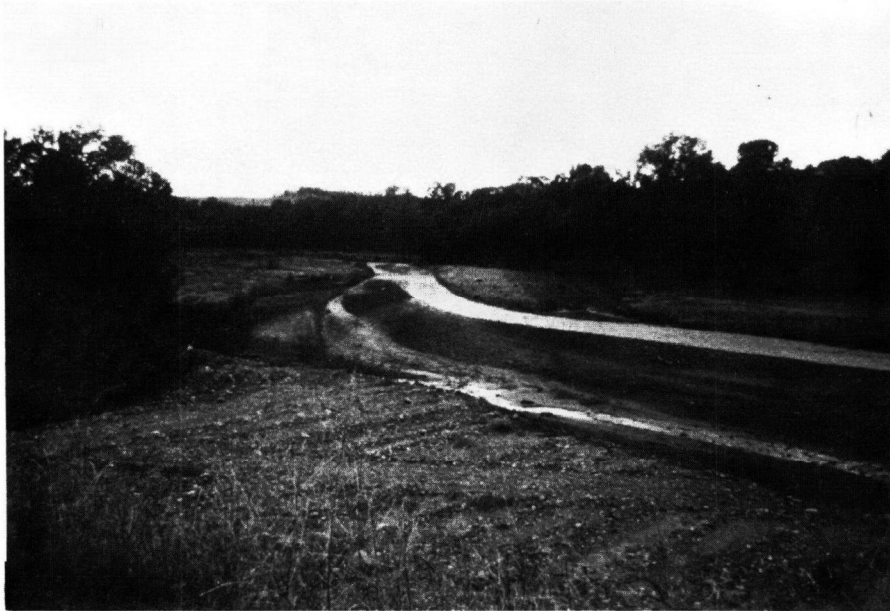
Photograph WC-3-1

Whitewood Creek at sediment site WC-3 looking upstream from Whitewood Valley Road. Samples SD-SED-14A through F collected along near (east) bank, primarily to left side of photo.

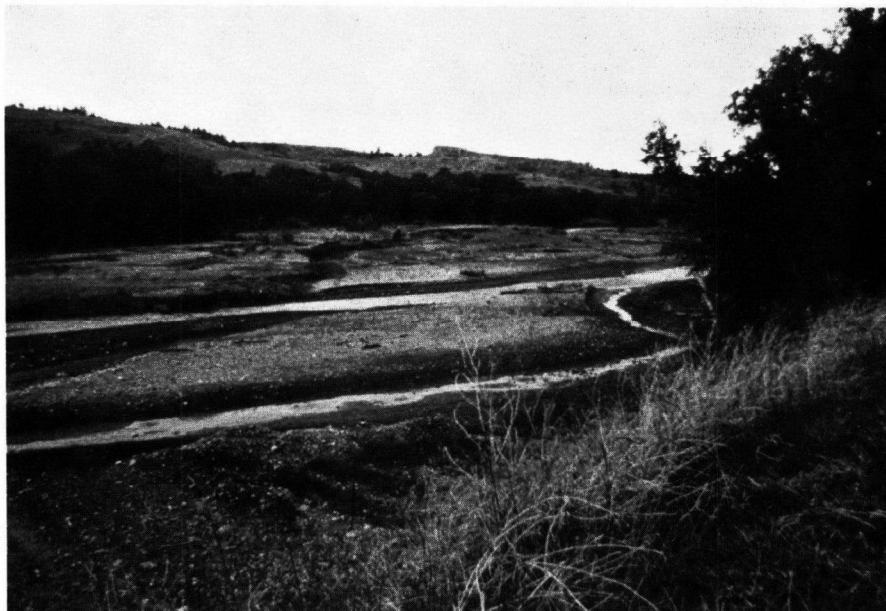
Photograph WC-3-2

Whitewood Creek near sediment site WC-3 looking downstream. Note apparent absence of gray silt over (and in) far (west) bank. Sample of organic material (SD-SED-14A) collected from bank below trees on right.

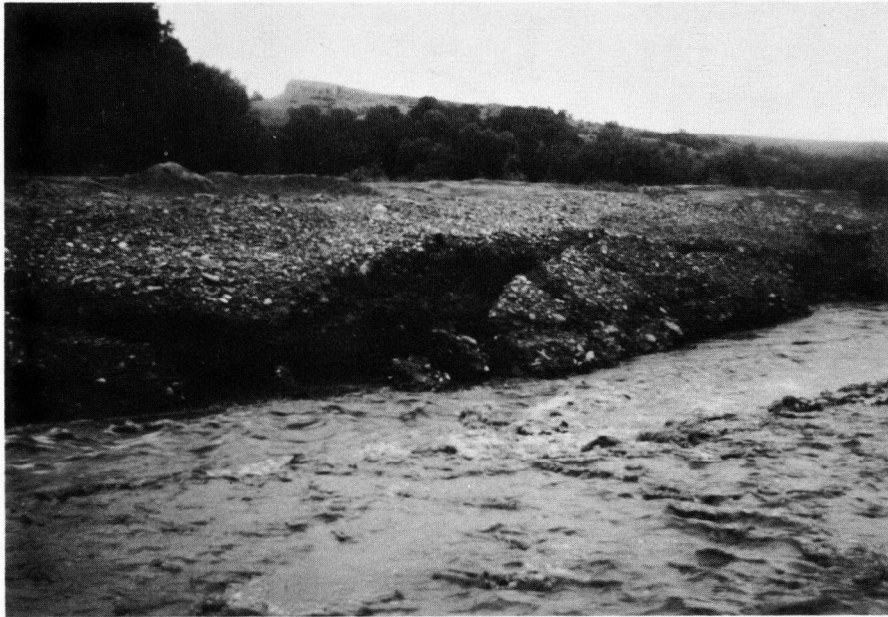
Photograph WC-3-3

Far (west) bank of Whitewood Creek across from sediment site WC-3. Note gray silt and staining on gravels but absence of silty beds in or on the poorly sorted gravels.

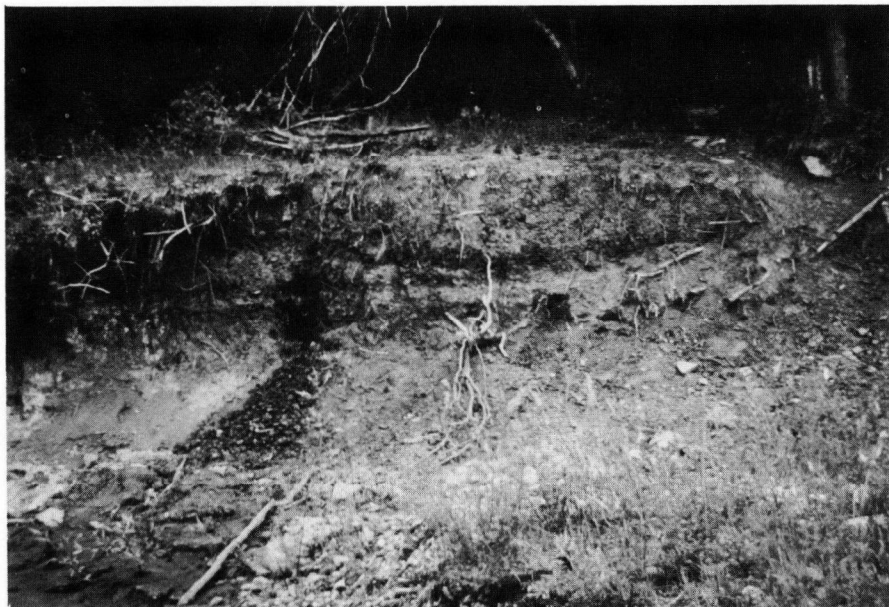
Photograph WC-3-4

East bank of Whitewood Creek showing dark layers of organic-like material buried well beneath the present surface. Sample SD-SED-14A collected from dark layers at left-center of photo.

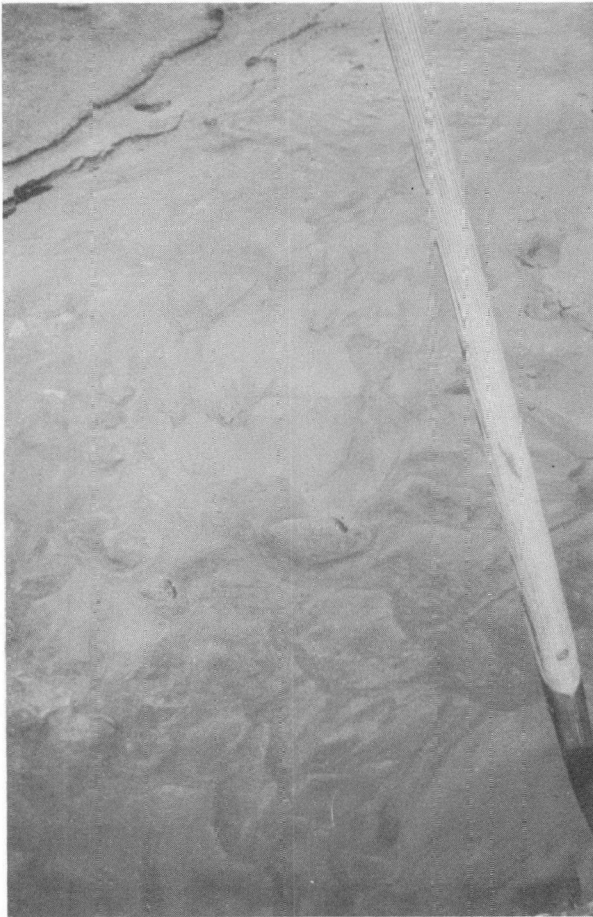
Photograph WC-3-5

Whitewood Creek at Site WC-3 showing thin layer of dark gray silt in minor channel of Creek. Sediment sample SD-SED-14B collected from this type of deposit.

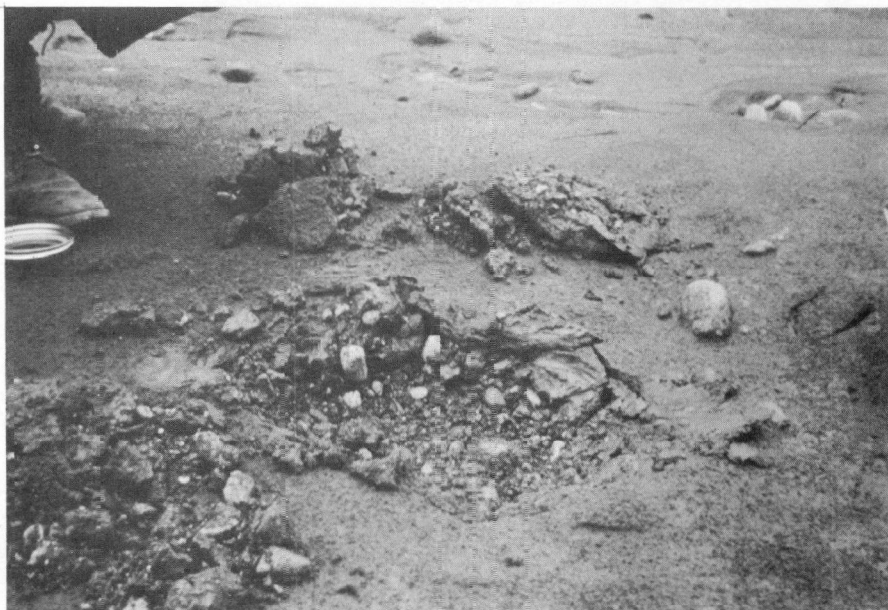
Photograph WC-3-6

Dark gray silt as thin layer over gravelly sand located on terrace/bar about 0.7 m. above stream. No silt found below gravelly sand. Sediment sample SD-SED-14C collected here.

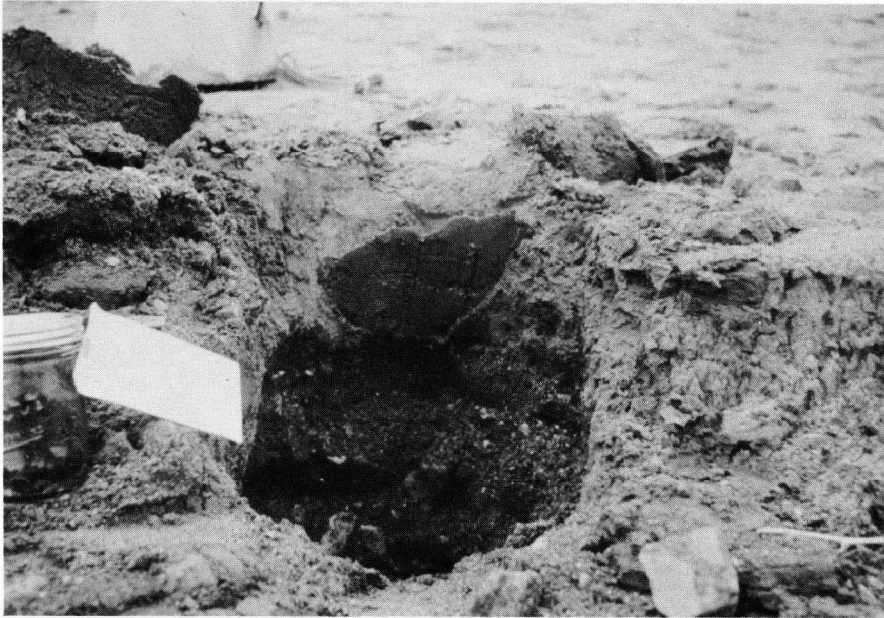
Photograph WC-3-7

East bank of Whitewood Creek at Site WC-3 showing gray silt overlying reddish-brown sands with minor gravel found sporadically over terrace about 0.6 m. above the Creek.

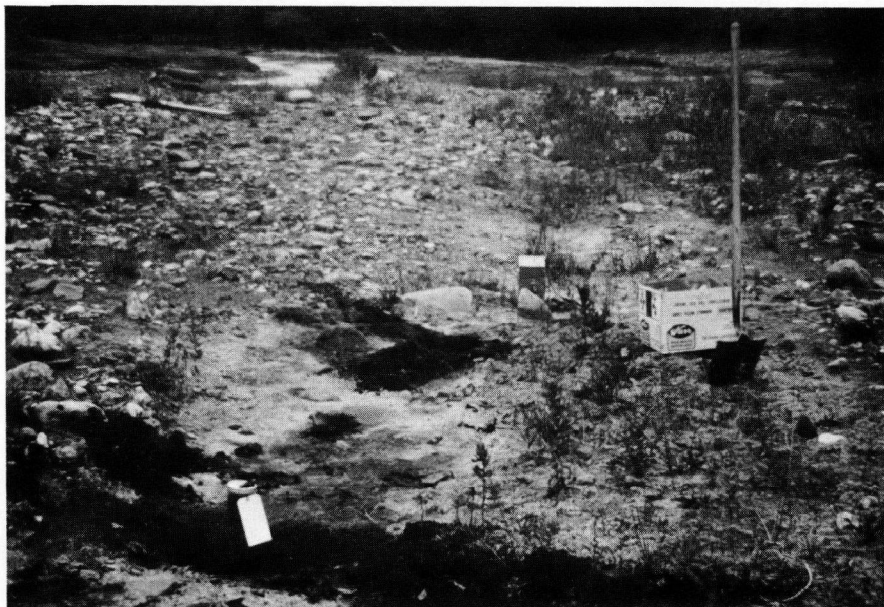
Photograph WC-3-8

Gravel-strewn terrace above Whitewood Creek at sediment sampling site WC-3 showing sampling locations for samples SD-SED-14D through F. Note somewhat varicolored sandy silts.

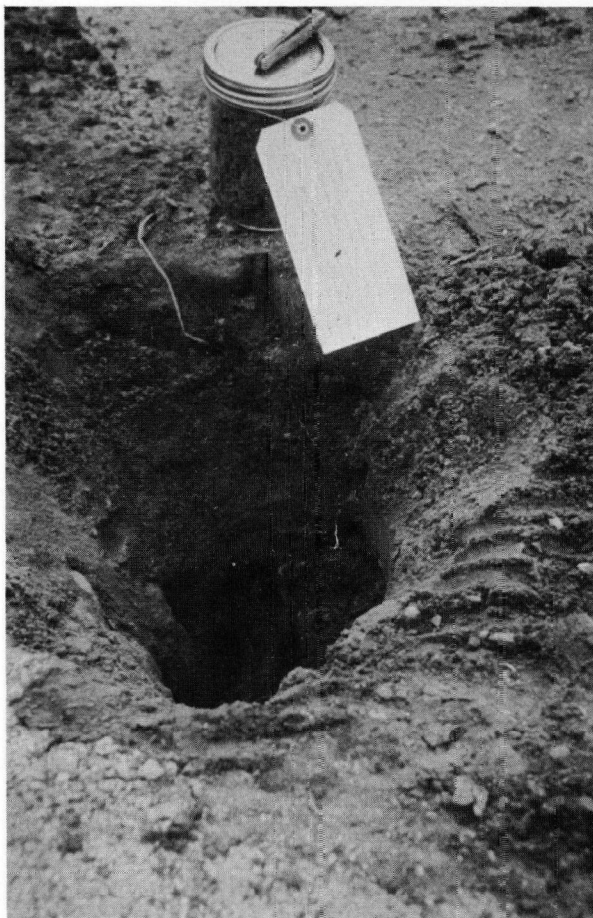
Photograph WC-3-9

Closeup of pit in foreground of Photograph WC-3-8, showing gray silt layer beneath reddish-brown sands. Silt layer sampled in SD-SED-14E as shown. Sample SD-SED-14F collected from beneath silt layer.

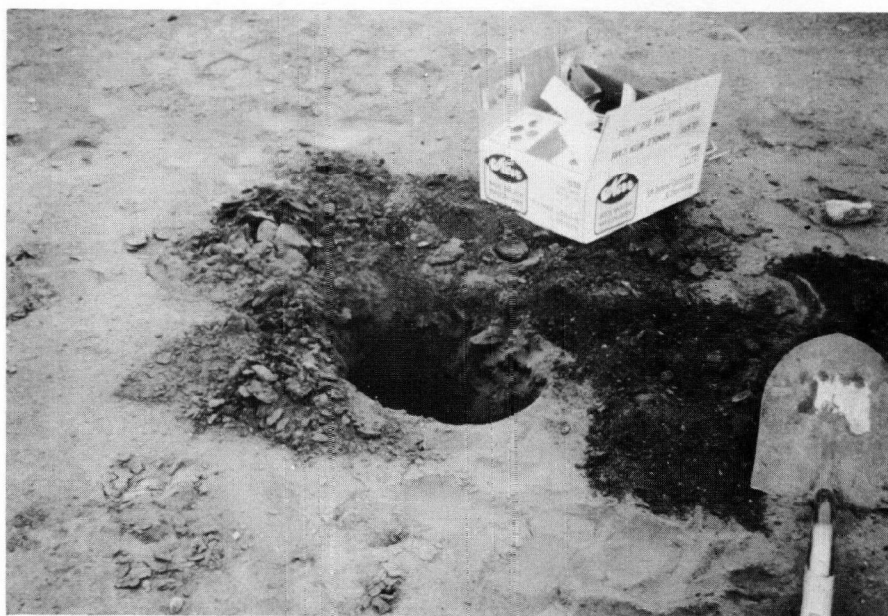
Photograph WC-3-10

Closeup of distant pit shown also in Photograph WC-3-8, showing some of light brown (to yellow in select strata) sand silt. Location sampled by sediment sample SD-SED-14D.

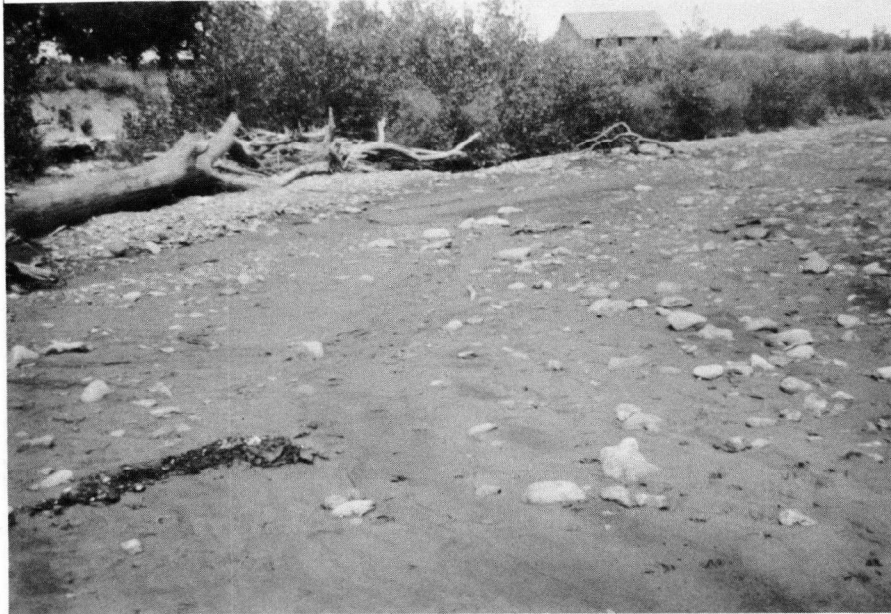
Photograph WC-5-1

South side of Whitewood Creek channel showing thin, dark gray silts (note gravels showing through gray silts in left foreground) found representative of deposits in area. Sample SD-SED-6B collected here.

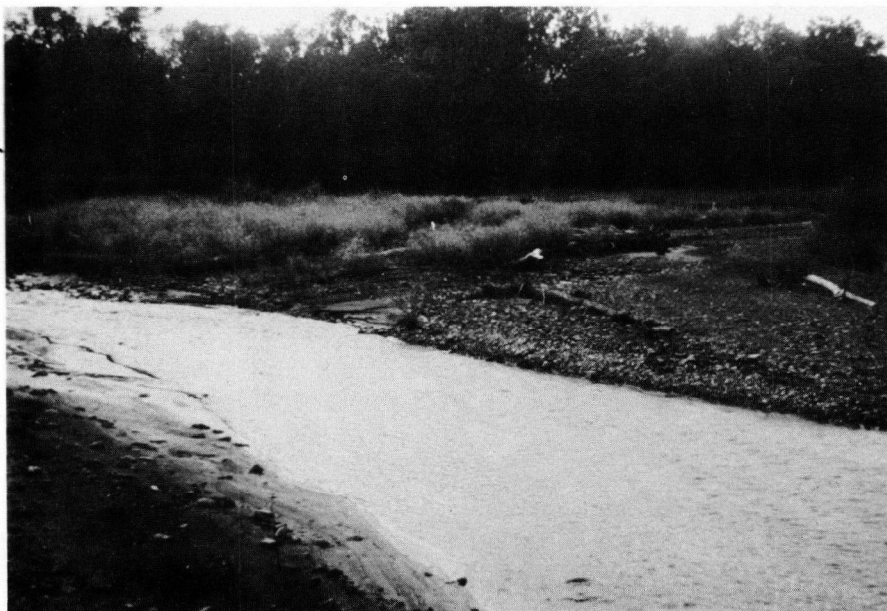
Photograph WC-5-2

Whitewood Creek upstream about 100 m. from Site WC-5, showing silt deposits in minor meander channel which cuts sandy gravel on far side of Creek.

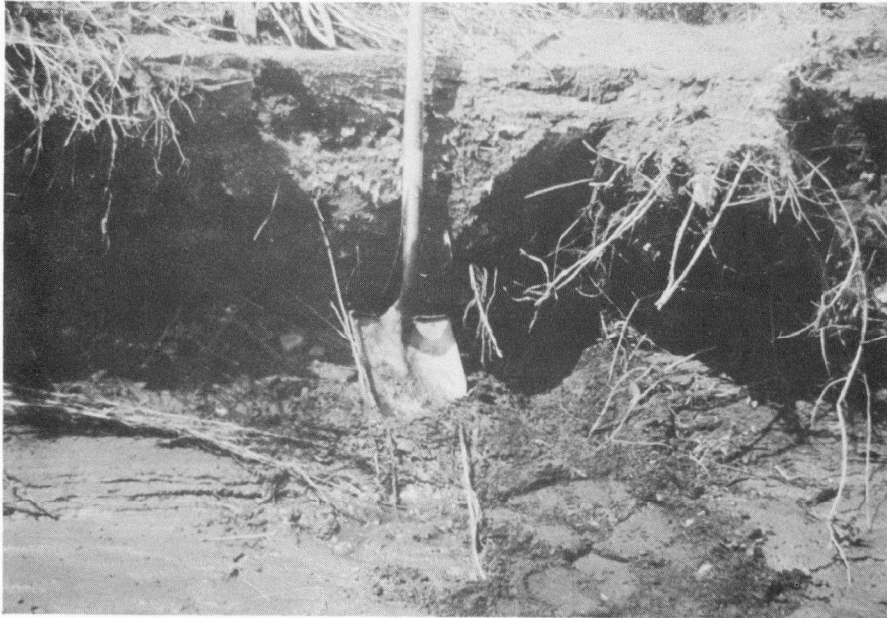
Photograph WC-5-3

Freshly-eroded bank in abandoned channel of Whitewood Creek at Site WC-5, where a dark-gray silt layer was found at a depth about equal to the top of the shovel blade.

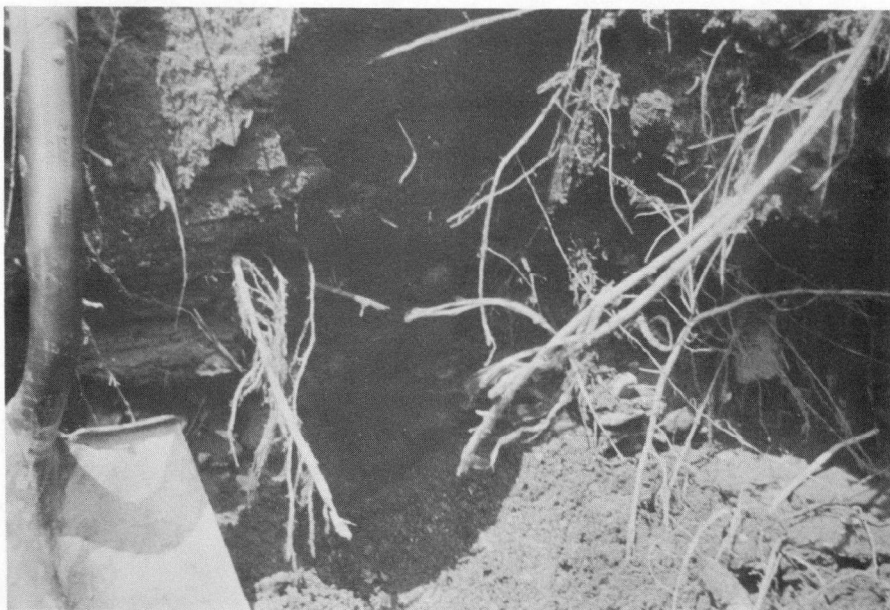
Photograph WC-5-4

Closeup of dark-gray silt layer sampled by sediment sample SD-SED-6A. Silt surrounded by brown sands. Roots were well-established.

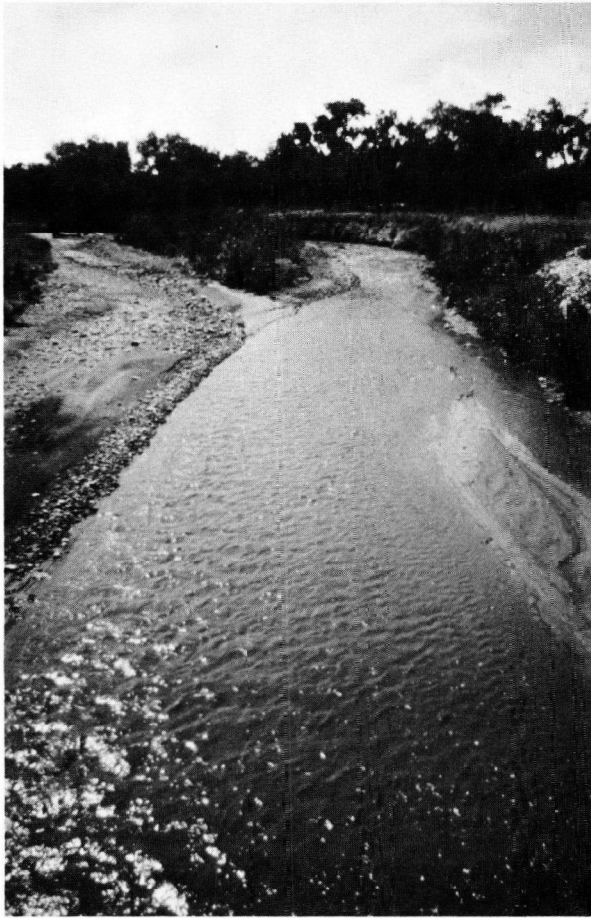
Photograph WC-6-1

Whitewood Creek looking downstream at thin layer of gray silt overlying gravel. Note smaller channel filled with silt at upper left of photo.

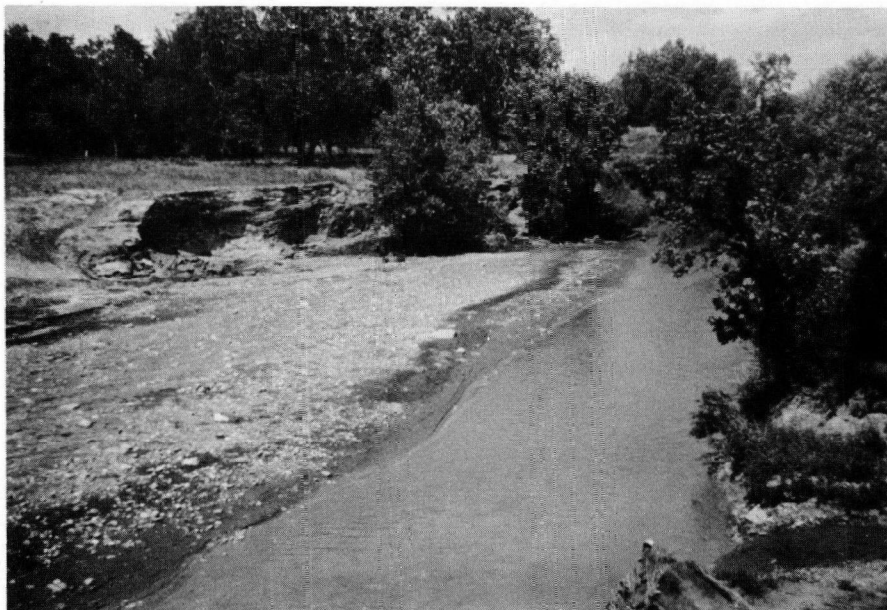
Photograph WC-6-2

View of west bank of Whitewood Creek near sediment sampling site WC-6, showing cut and slumped bank which showed no layers of gray silt.

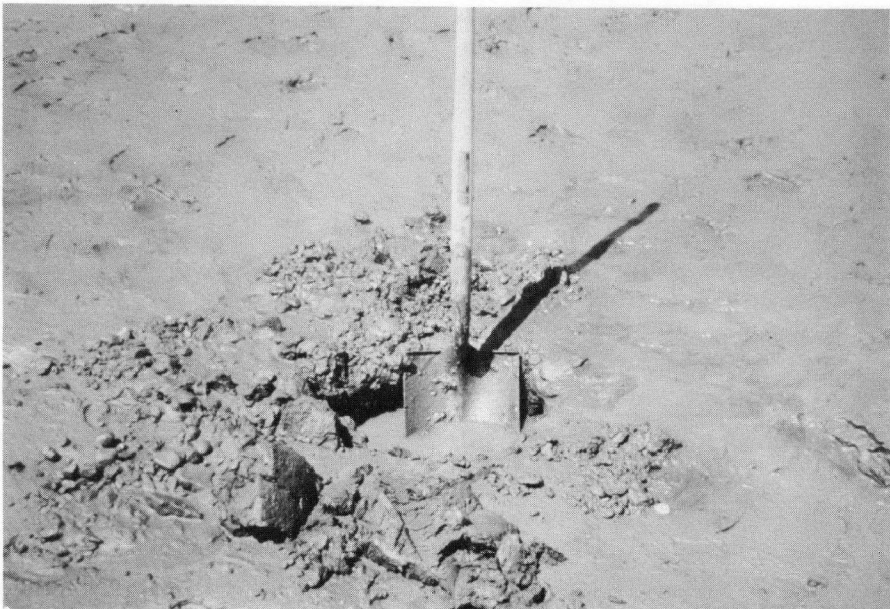
Photograph WC-6-3

Channel of Whitewood Creek at sediment sampling site WC-6, showing thin covering of dark gray silt covering saturated gravels. Note that gravels are better sorted than was the case at locations upstream on Whitewood Creek.

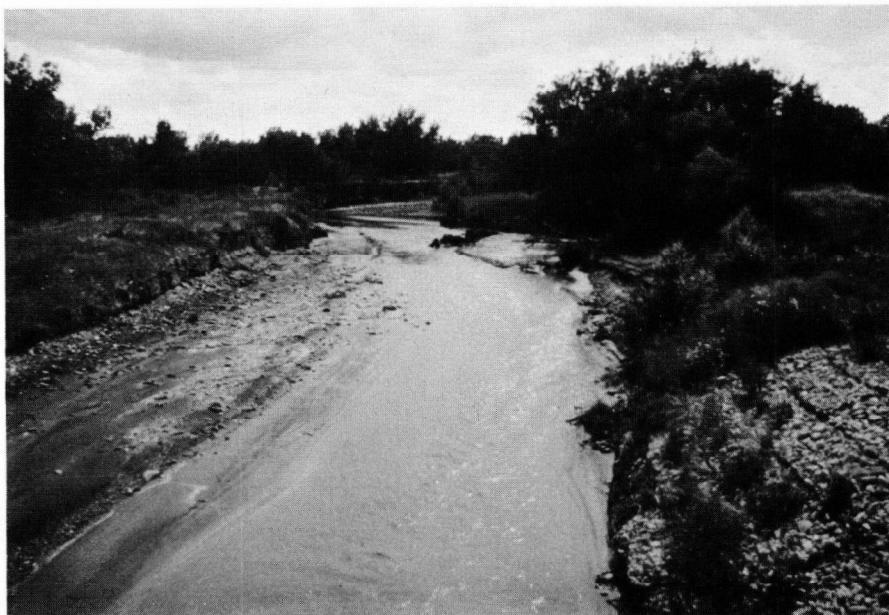
Photograph WC-7-1

Whitewood Creek looking upstream from road bridge, showing deposit of dark gray silt on right (north) bank, behind bushes and in front of cluster of trees; about 0.3 m. above active channel. Note also the water drain from the bank at the site of the silt deposit (see Photograph WC-7-3).

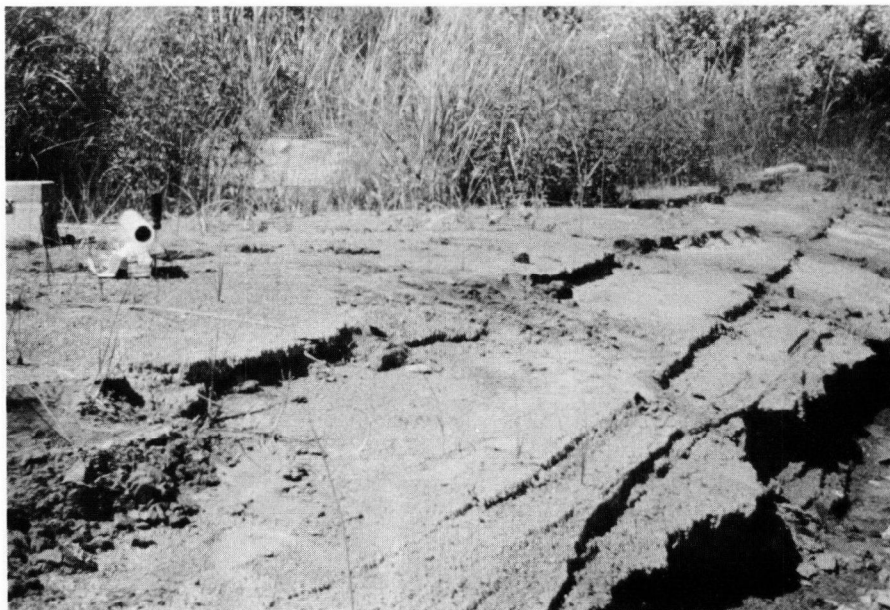
Photograph WC-7-2

Terrace/bank deposit of gray tailings at Site WC-7. Sediment samples SD-SED-8A through D, a 1.1 m.-long core, collected from foreground area. Silt alternates with brown sand toward base of core.

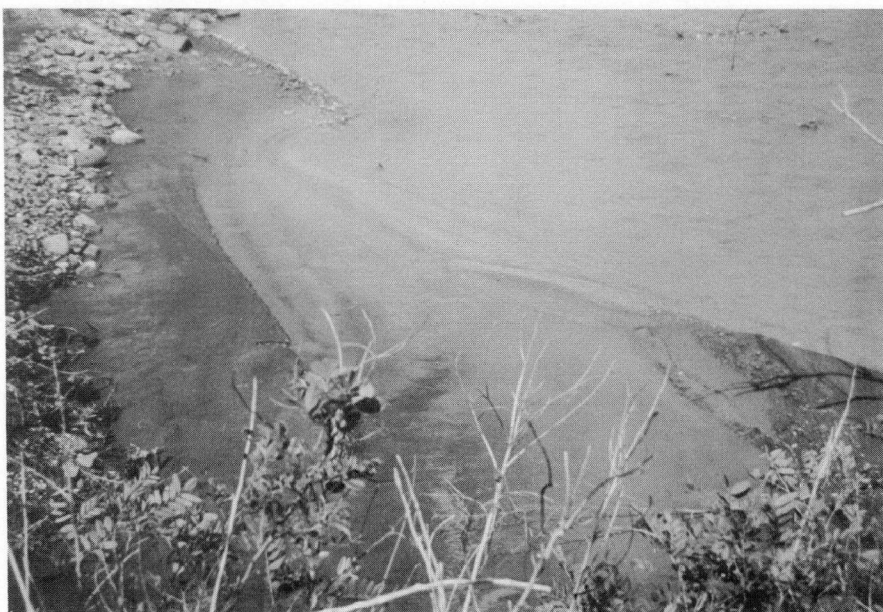
Photograph WC-7-3

Seep of iron-rich (?) water issuing from bank into Whitewood Creek at sediment site WC-7.

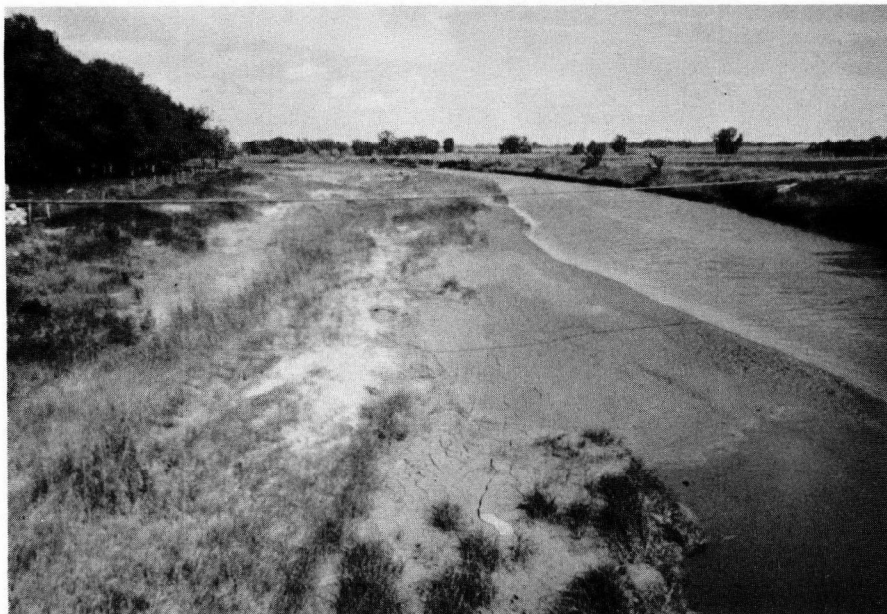
Photograph BF-3-1

North bank of Belle Fourche River looking downstream from State Highway 79 bridge and gray silt along present channel; gray silt in abandoned channel on left of photo. Samples SD-SED-9A and B collected near center of photo.

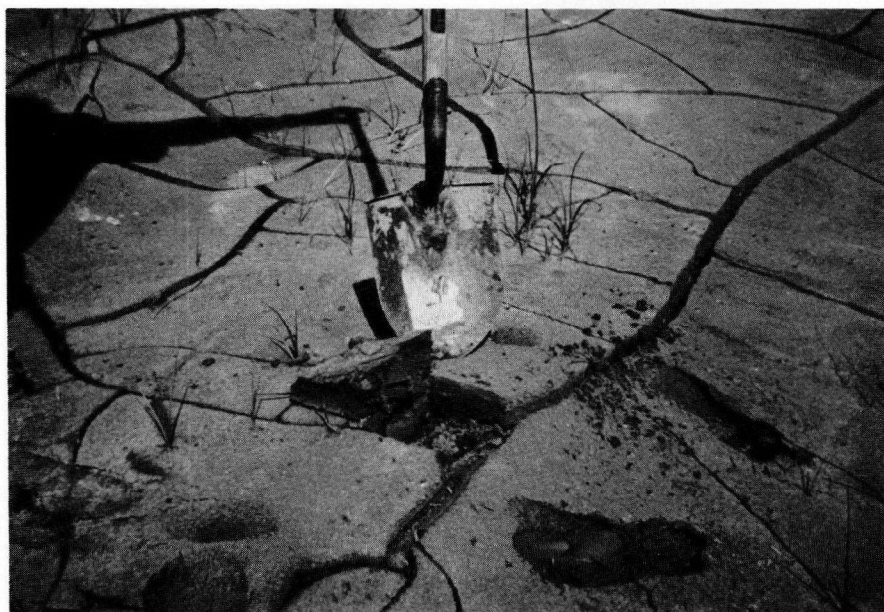
Photograph BF-3-2

Closeup of gray silt covering brownish sands at Site BF-3. No silt found beneath sand. Sample SD-SED-9C collected here.

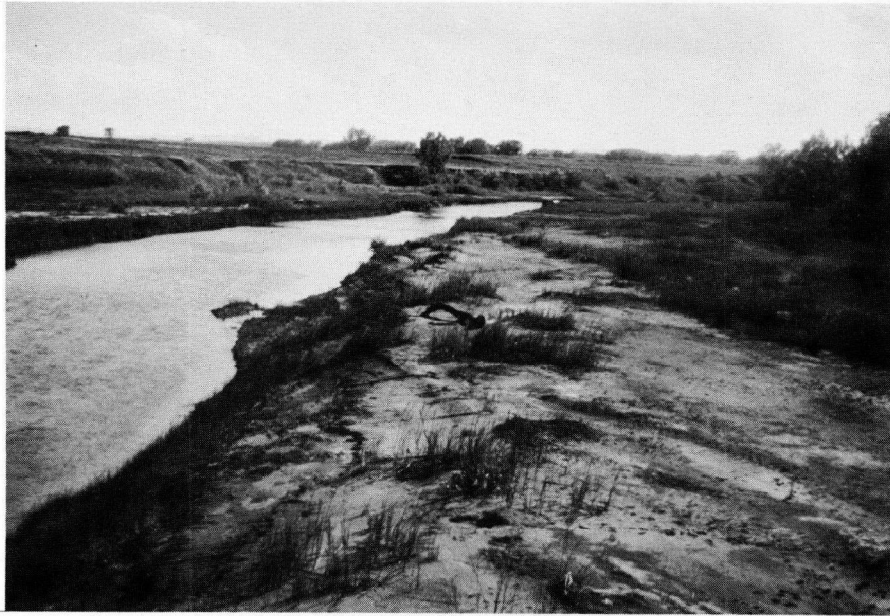
Photograph BF-4-1

North bank of Belle Fourche River at Site BF-4. Sediment sample SD-SED-10 (core) collected in foreground from 46 cm - thick deposit which appeared to thin to the right (north).

3. Occurrence of "Tailings": Tailings-like material found as relatively thick bank deposit covering small area upstream of bridge. Material is windblown and apparent thickness of 1 m. is caused by sloughing of material into channel. About 30 cm. of gray silt were encountered on top of the bank. The silt also contains brownish-red sandy material thought to differ from tailings. Core bottomed in sandy gravel at total depth of 46 cm.

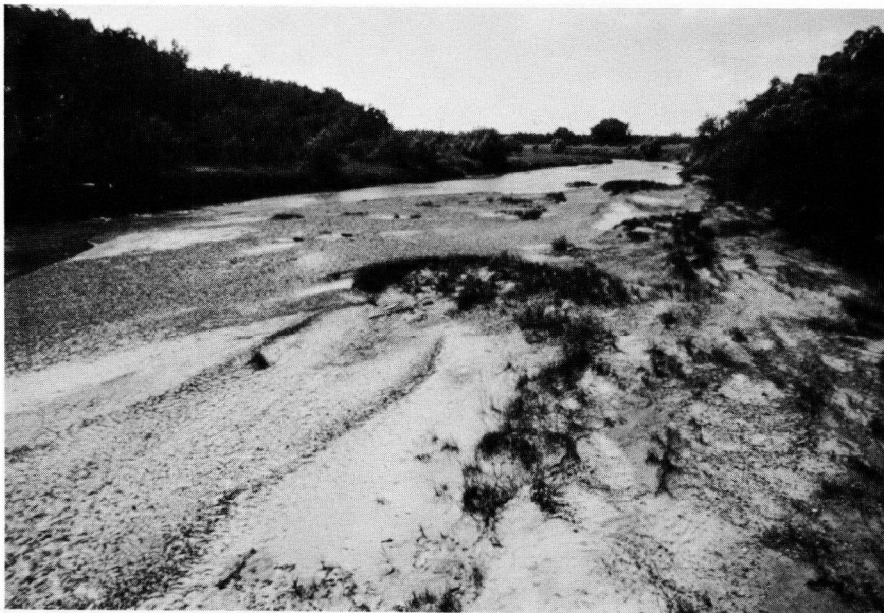
Photograph BF-4-2

Windblown gray silts along river bank.

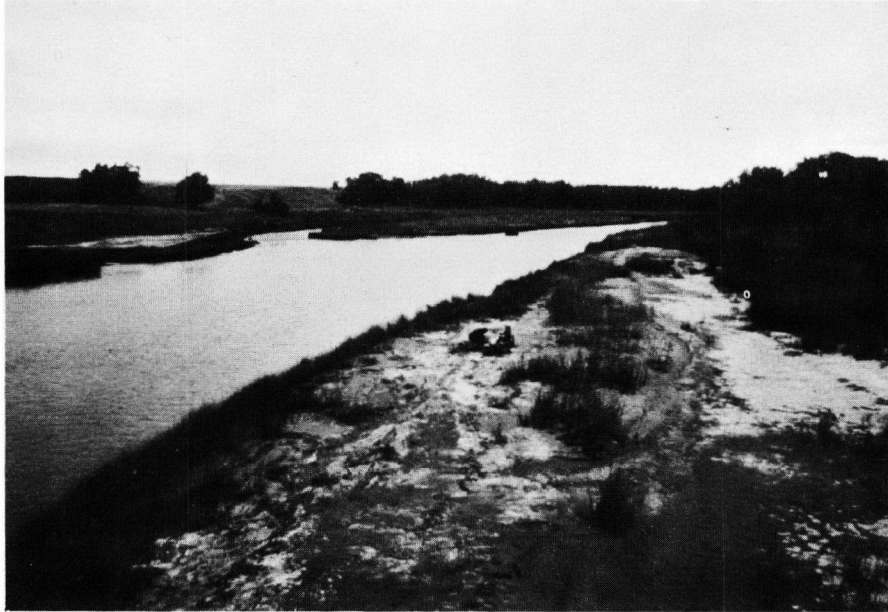
Photograph BF-5-1

Belle Fourche River, looking downstream from bridge toward sampling site for samples SD-SED-18A through F and ground water sample 20. Dark gray silt covers near bank to depth of about 1.7 m. (from core data) in series of layers.

contained essentially no arsenic ( $<0.01$  mg/l). The higher concentrations approach, but do not exceed, the recommended limit of 0.05 mg As/l for domestic and stock use. Site 12 may deserve periodic checking for arsenic. A well dug in tailings contained water with a dissolved concentration of 4 mg As/l (Site BF-5; sediment contained 2430 ppm As).

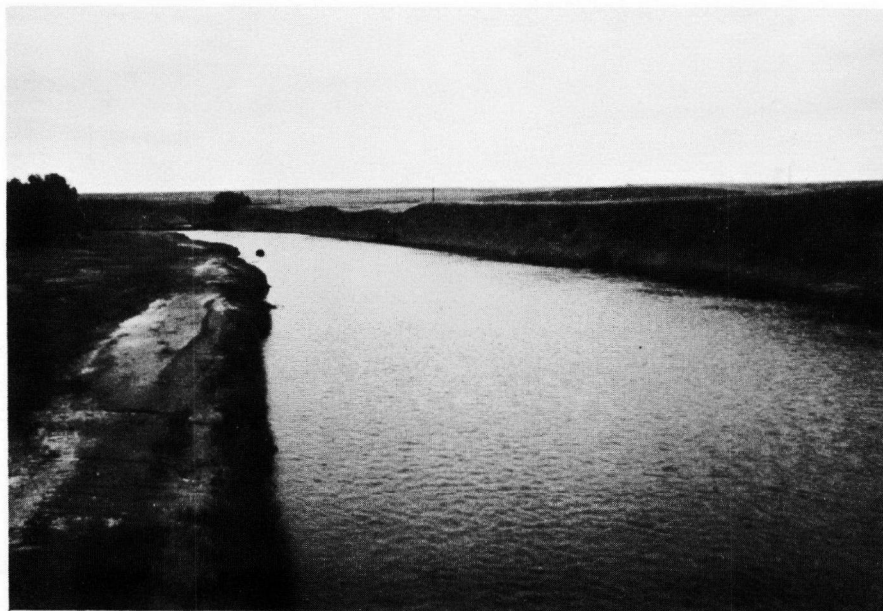
Photograph BF-5-2

Belle Fourche River viewed upstream from Site BF-5, showing gray silt on left bank and steep, eroding bank on right.

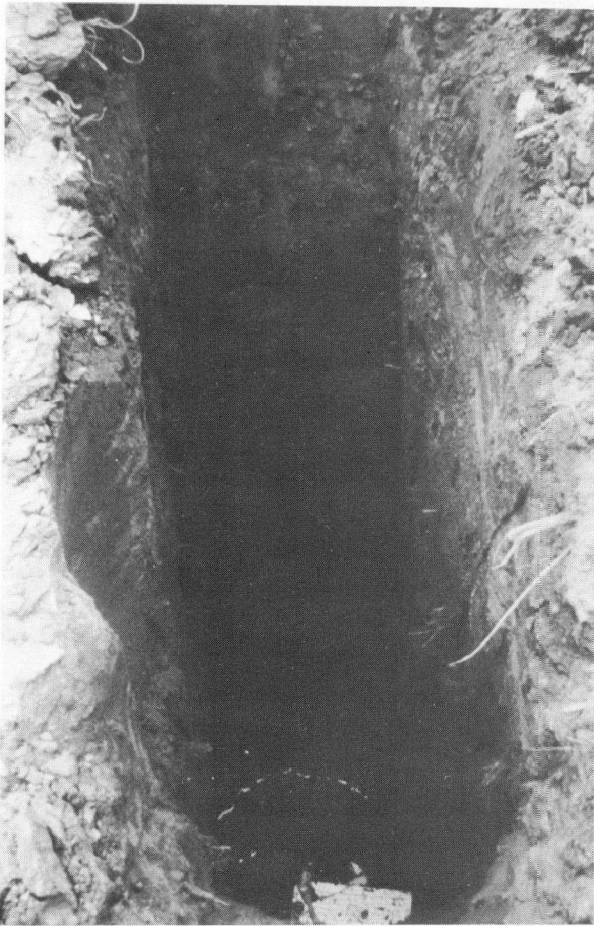
Photograph BF-5-3

Moderately exposed photo of pit dug to water at Site BF-5, showing alternating red-brown silty sand and gray silt.

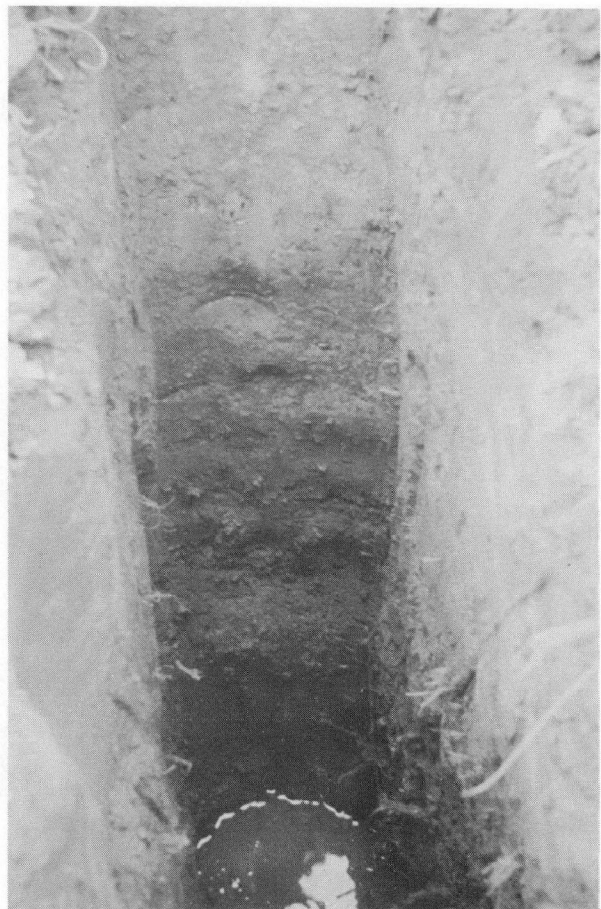
Photograph BF-5-4

Over-exposed photo of pit shown in previous photo to give clarity to water level and alternating gray silts and brownish silts at depth (~1 m.). Note that shovel blade has smeared gray silt over portions of the sands.

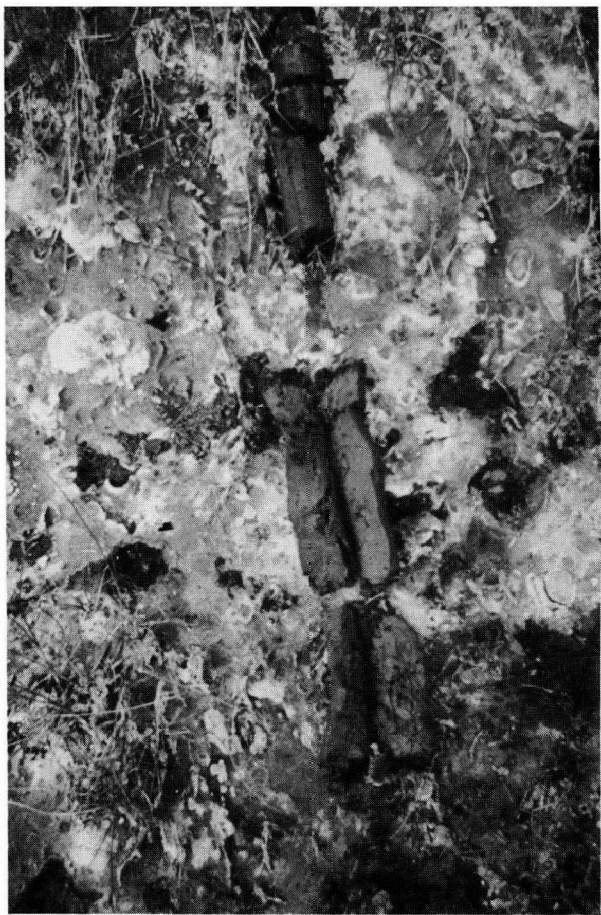
Photograph BF-6-1

Sediment core sampled as SD-SED-19A and B at "upstream" location. Total depth 1.1 m. Sample SD-SED-19A collected from bottom gap in core. Sample SD-SED-19B collected from upper gap in core. Note thick gray silt strata in lower two-thirds of core.

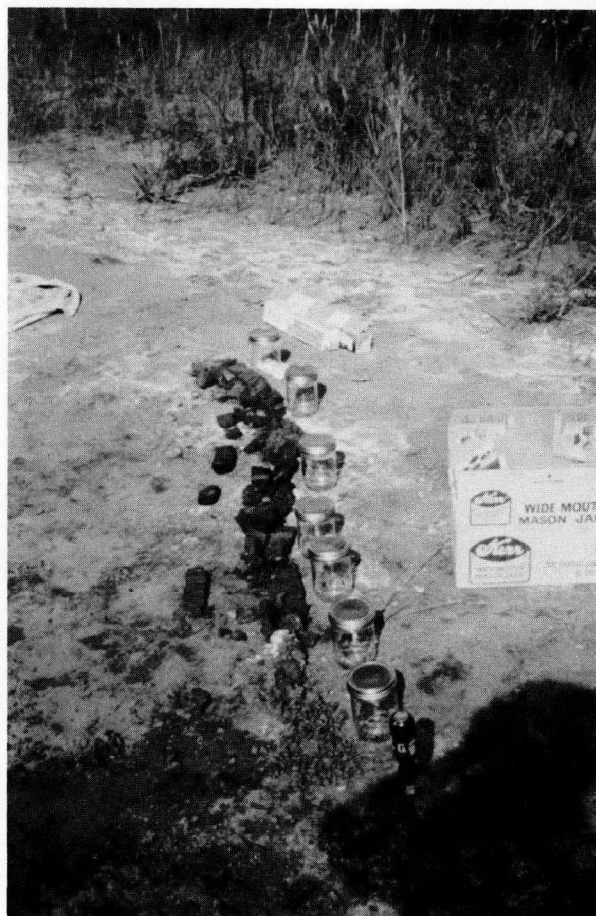
Photograph BF-6-2

Sediment core from downstream site at BF-6, from bottom to top. Seven pint samples (SD-SED-20A through G) shown located (lettered from top to bottom). Note dry, crumbly, gray, silty clay at bottom (foreground). Total depth: about 2.2 m.
