MERCURY, ZINC, COPPER, ARSENIC, SELENIUM,  
AND CYANIDE CONTENT OF SELECTED WATERS  
AND SEDIMENT COLLECTED ALONG WHITEWOOD  
CREEK, THE BELLE FOURCHE RIVER, AND THE  
CHEYENNE RIVER IN WESTERN SOUTH DAKOTA  
DECEMBER 1971 - OCTOBER 1972

MERCURY, ZINC, COPPER, ARSENIC, SELENIUM, AND CYANIDE  
CONTENT OF  
SELECTED WATERS AND SEDIMENT ALONG  
WHITEWOOD CREEK, THE BELLE FOURCHE RIVER, AND THE CHEYENNE RIVER  
IN WESTERN SOUTH DAKOTA

December 1971 - October 1972

TECHNICAL SUPPORT BRANCH  
SURVEILLANCE AND ANALYSIS DIVISION  
U. S. ENVIRONMENTAL PROTECTION AGENCY  
REGION VIII

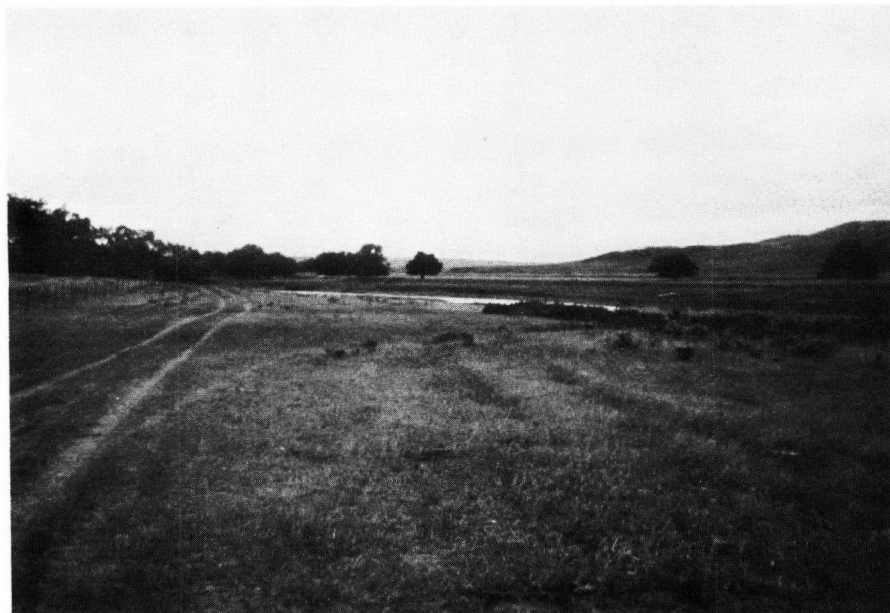
Photograph BF-8-1

General area of Sediment Sample Site BF-8, looking upstream along north bank of Belle Fourche River. Samples SD-SED-12A through C collected at far right of photo. Samples SD-SED-12D through H collected at river bank near distant trees at middle left of photo.

3. Occurrence of "Tailings": From experience of ranchers, gray silt occurs in "beds", separated by sand and gravel. Tailings - like material was found on the surface of bank deposits and was found in random widths. Samples were collected in close proximity (within 1 m.) to the River.

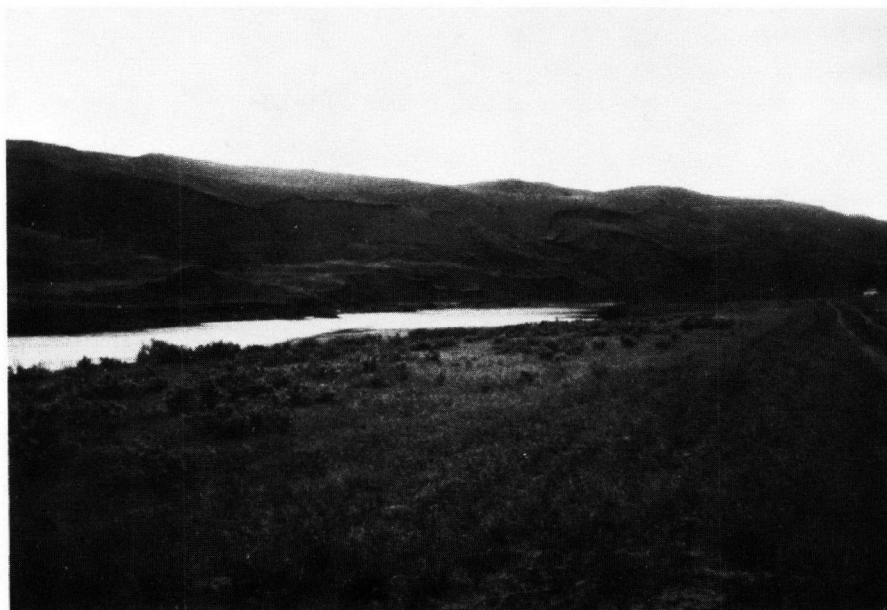
Photograph BF-8-2

General view looking upstream along Belle Fourche River at Site BF-8. Samples SD-SED-12A through C collected to left of vehicle in distance, along bank jutting out into river. Note slumping shales along far (south) bank of river.

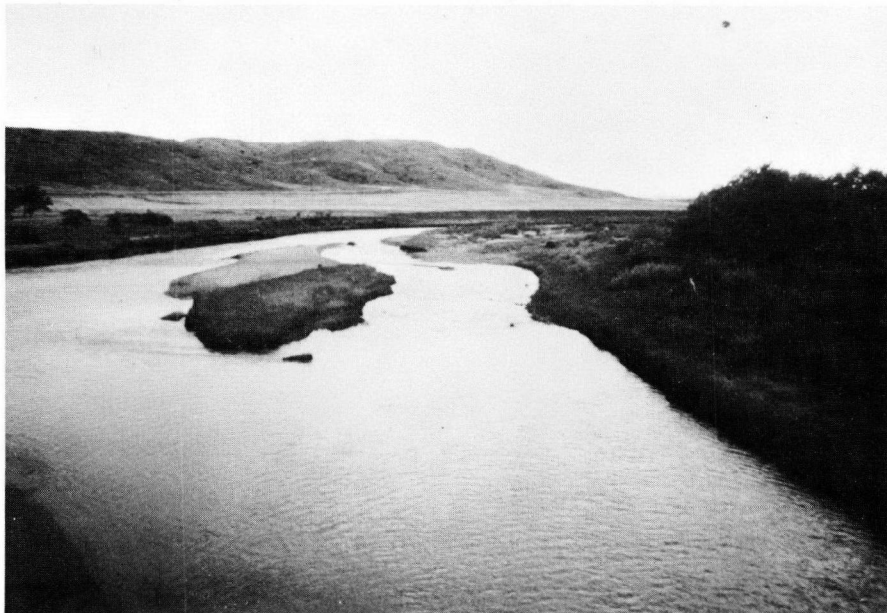
Photograph BF-9-1

Belle Fourche River in vicinity of Site BF-9. Gray silt found along bank at right. Looking downstream. Sediment site for sample SD-SED-11B located on right (south) bank.

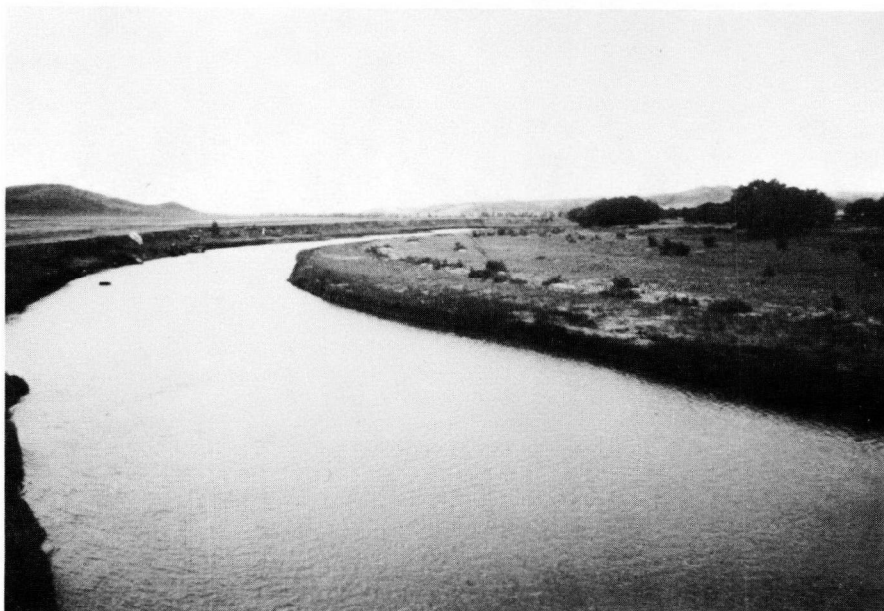
Photograph BF-9-2

Belle Fourche River in vicinity of Site BF-9. Looking upstream with sediment sampling location for sample SD-SED-11A on bank at right (north) bank.
