**Arsenic Removal from Drinking Water by Iron Removal
U.S. EPA Demonstration Project at Sabin, MN
Six-Month Evaluation Report**

**Wendy E. Condit
Abraham S.C. Chen**

**Battelle
Columbus, OH 43201-2693**

November 14, 2007

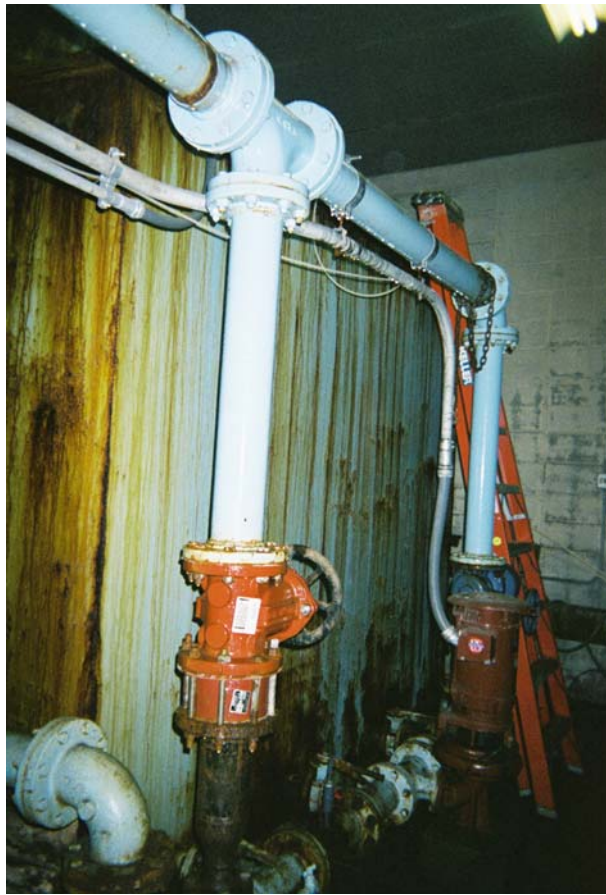
Figure 4-2. Preexisting Filtration System at Sabin, MN

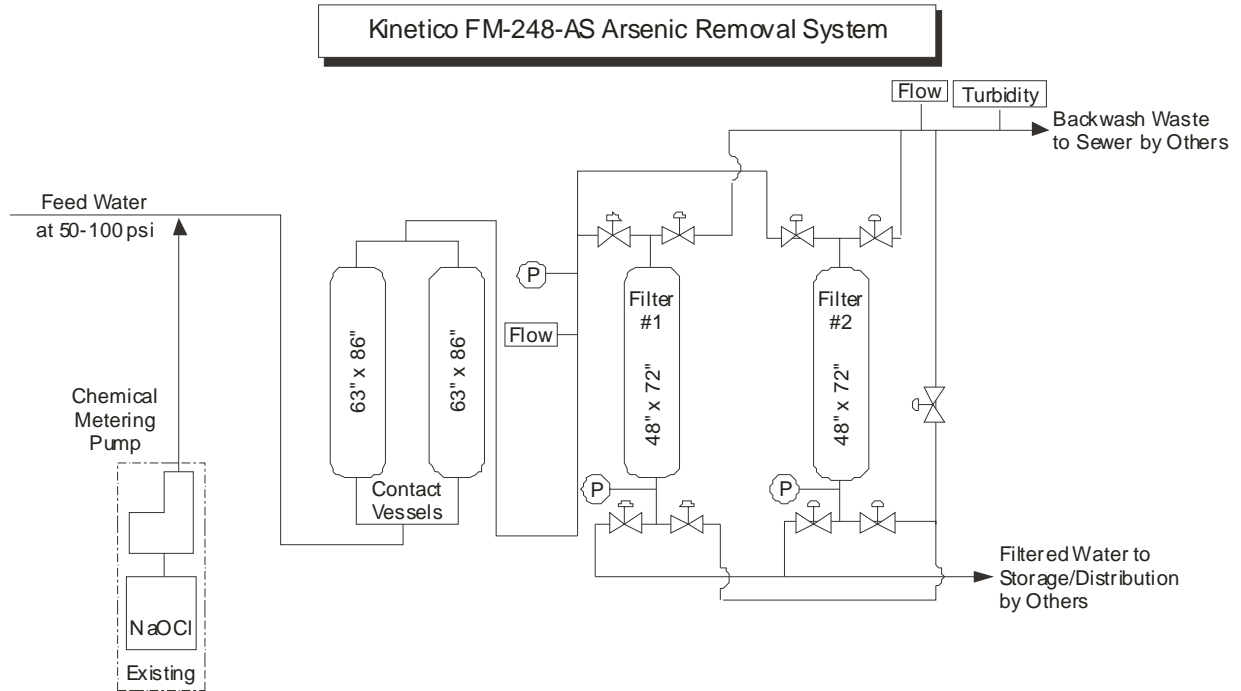
Figure 4-4. Schematic of Kinetico’s FM-248-AS Arsenic Removal System

- **Adsorption/Co-precipitation.** Two 63-in-diameter by 86-in-tall fiberglass reinforced plastic (FRP) tanks arranged in parallel were used to provide 6.8 min of contact time to enhance the formation of iron flocs prior to pressure filtration. Each 850-gal tank has one 4-in top flange and one 4-in bottom flange, which are connected to the exit and inlet piping, respectively, for an upflow configuration.

- **Pressure Filtration.** Iron floc removal from the contact tank effluent was achieved via downflow filtration through two 48-in-diameter, 72-in-tall pressure tanks configured in parallel. Each tank contained 25 ft³ (or 24 in) of 40 × 60 mesh Macrolite[®] media loaded on top of fine garnet underbedding filled to 1-in above the 0.006-in slotted, stainless steel wedge-wire underdrain. The FRP filtration tanks were rated for a working pressure of 150 psi and had two 10-in diameter side windows for media and backwash observations. The tanks were floor mounted and piped to a valve rack mounted on a welded, stainless steel frame. The flow through each tank was regulated to less than 125 gpm using a flow-limiting device to prevent filter overrun. System operation with both tanks in service could produce a total design flowrate of 250 gpm. Filtered water was sent to a 57,000-gal underground clearwell and then pumped to the water tower via two 20-hp high service pumps, which were operated on an alternating basis.

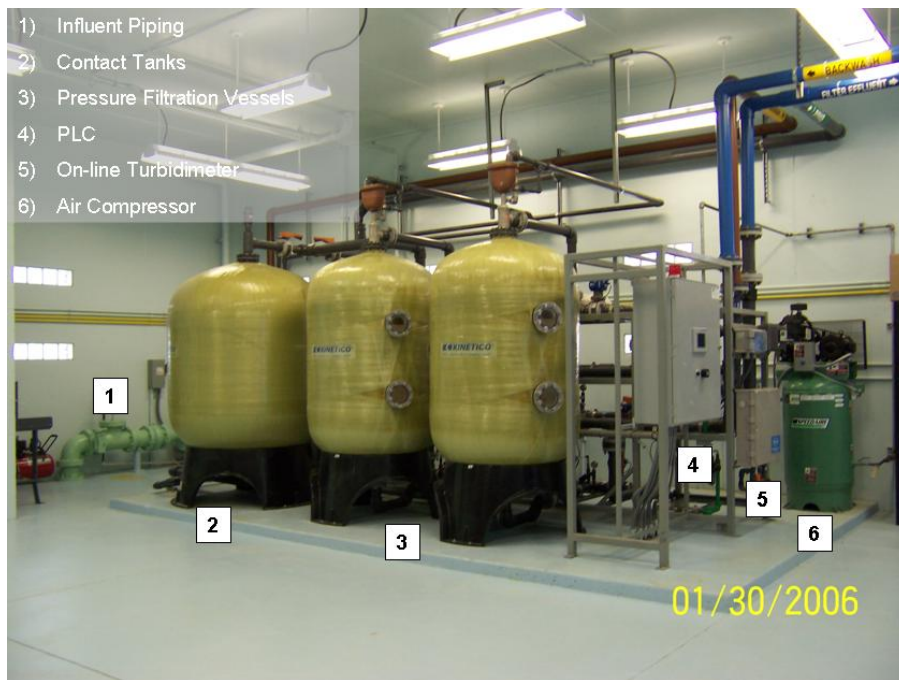
Figure 4-5. Treatment System Components

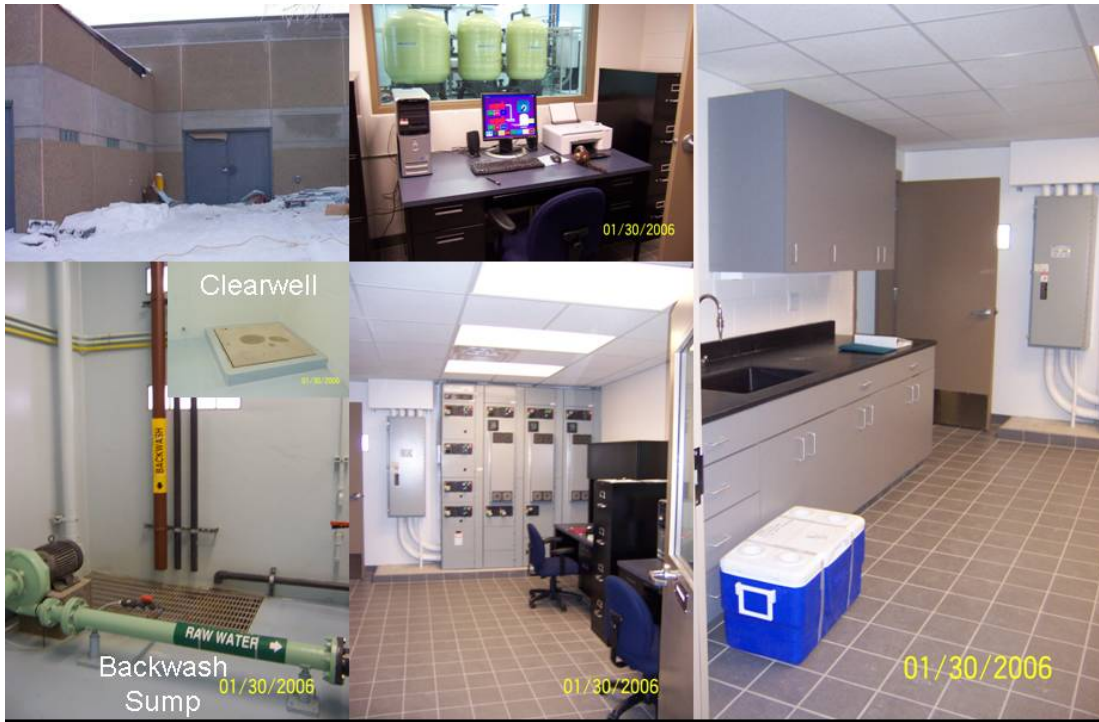
**Figure 4-6. New Building and Associated Infrastructure
(Clockwise from Top, Left: New Building, Adjacent Office/Laboratory Area, and Electrical Control Panel, Clearwell Lid [Inset], and Backwash Sump)**

4.3.2 Building Construction. Building construction began on July 5, 2005, with the excavation for the building foundation including a 57,000-gal underground clearwell located directly underneath the building and a 2,350-gal underground sump. The footprint of the building was 48 ft × 56 ft with a roof height of 17.5 ft. The building was fabricated from pre-cast concrete panels and included an 8-ft-wide double panel door at the entrance. Finished water from the arsenic removal system was stored in the clearwell and wastewater produced from filter backwash was discharged to the sump that emptied by gravity into the sanitary sewer. In addition to the filtration room that housed the treatment system, the building also had a chemical room, a mechanical room, a laboratory, an office, and a restroom (see Figure 4-6). The new building was largely completed prior to the start of the demonstration study on January 30, 2006. However, finishing work such as improvements to the building ventilation continued until June 5, 2006, when the building was officially turned over to the city of Sabin.

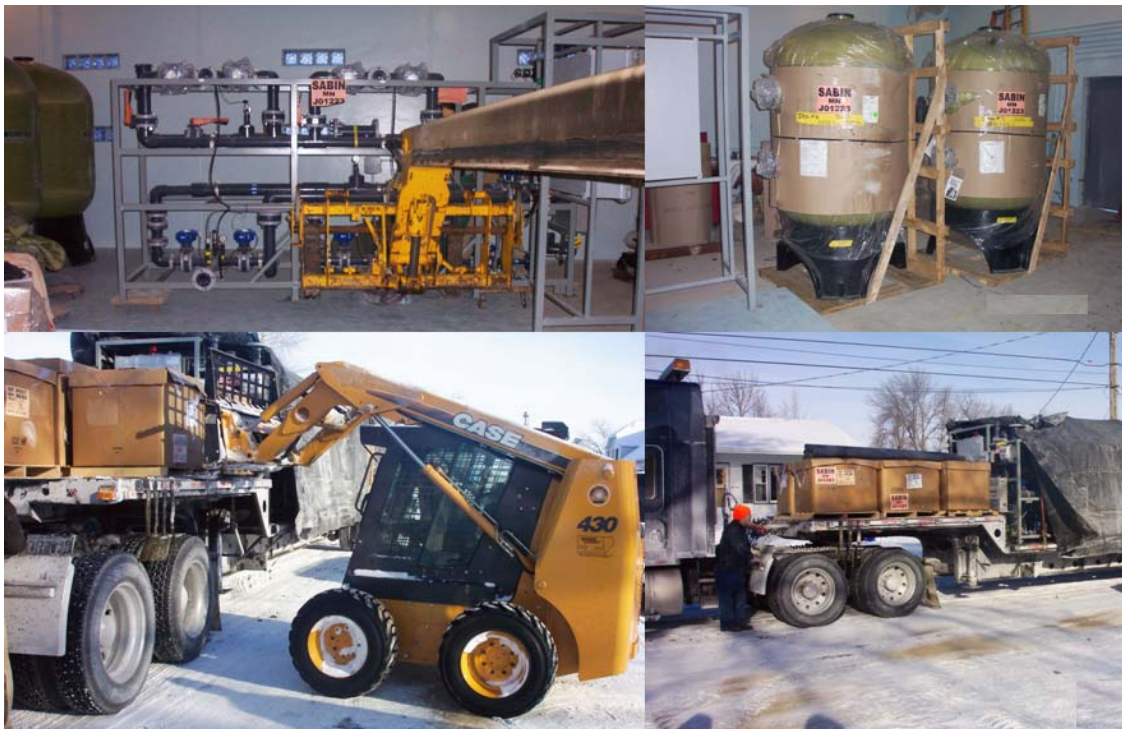
Figure 4-7. Delivery and Off-Loading of Macrolite[®] Treatment System Equipment

4.3.3 System Installation, Startup, and Shakedown. The FM-248-AS treatment system was delivered to the site on December 2, 2005. The vendor, through its subcontractor, off-loaded and installed the system (Figure 4-7). Installation activities included connections to the entry and distribution piping and electrical interlocking. Upon completion of system installation and before media loading, the vendor performed hydraulic pressure testing to ensure that there were no leaks and that the system was mechanically sound. Macrolite[®] media loading and initial backwashing (to remove fines) was completed by December 16, 2005. Work resumed after the holiday break with activities spanning from PLC testing to instrument calibration, additional backwash testing (to set flow rates), system sanitation (using chlorine), chlorine residual testing, and operator training (on system O&M). The system startup and shakedown work was completed by January 19, 2006.

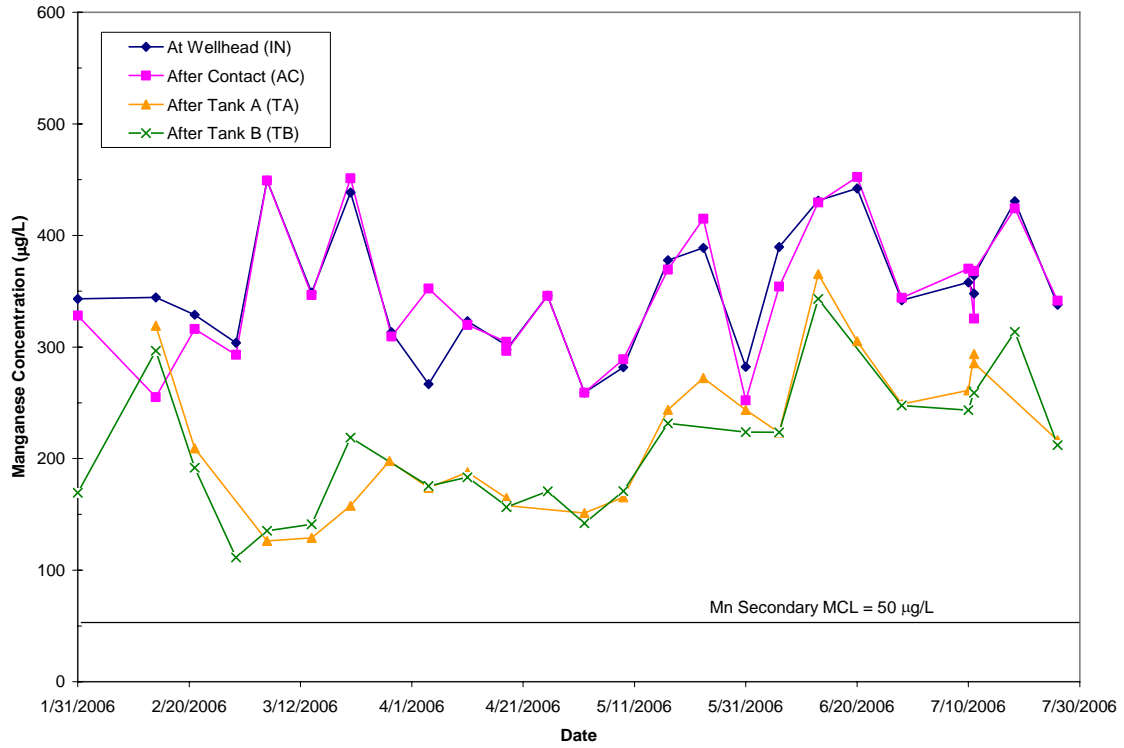
Figure 4-13. Total Manganese Concentrations Across Treatment Train

4.5.1.3 Manganese. Manganese concentrations in raw water ranged from 259 to 449 µg/L and averaged 350 µg/L, which existed almost entirely in the soluble form at 371 µg/L (on average). Figure 4-13 presents total manganese concentrations across the treatment train. With prechlorination and 7.1-min contact time, only 32% to 65% of soluble manganese was converted to particulate manganese after the contact tanks. These results suggest that, while being very effective for As(III) and Fe(II) oxidation, chlorine was not as effective in oxidizing Mn(II). Further, the rate of conversion from soluble to particulate manganese appears to vary with the chlorine dosage. As shown in Figure 4-14, total manganese removal across the filters varied widely from 14% to 72% and averaged 40%. The rate of removal was influenced by the chlorine dosage with higher total chlorine residuals after the contact tank associated with increased manganese removal across the filter. For example, on June 13, 2006, the total chlorine residual was low at only 0.2 mg/L and the manganese effluent levels were elevated at 343 to 365 µg/L, which represented only 15% to 20% removal. However, a 63% manganese removal rate was achieved earlier on February 28, 2006, with 1.2 mg/L of total chlorine residual. Previous studies also have found that incomplete oxidation of Mn(II) occurs using free chlorine at pH values less than 8.5 (Knocke et al., 1987 and 1990; Condit and Chen, 2006). Because Macrolite® filters removed only particulate manganese, the soluble fraction after the contact tanks (i.e., 202 µg/L on average) remained essentially unchanged after the pressure filters (i.e., 249 and 173 µg/L after Tanks A and B, respectively). However, as discussed in Section 4.5.3, precipitation of manganese might have occurred after the treated water entered the distribution system, given additional chlorine dosage, upon post-chlorination, and substantially longer contact time within the distribution system. During the next six-month study period, an increased chlorine dosage will be implemented to study its potential effect on manganese oxidation across the treatment train.
