Grand Plaza Site Investigation Using the Triad Approach and Evaluation of Vapor Intrusion

**National Risk Management Research Laboratory
Office of Research and Development
U.S. Environmental Protection Agency
Cincinnati, Ohio 45268**

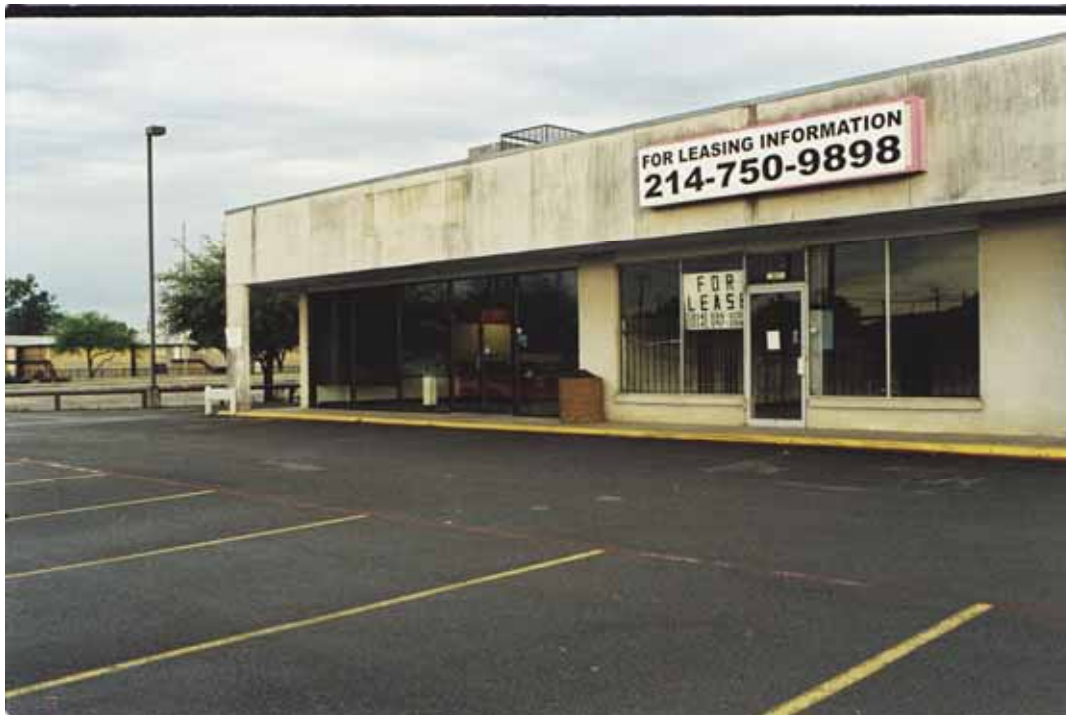
Figure 2-1. Front View of Former Dry Cleaning Facility

The strip mall has spaces for nine to ten tenants. A combined Laundromat and dry cleaning business originally occupied the southwestern-most portion of the strip mall in a space that was roughly 30 ft by 70 ft (9m by 21m). The front and back views of the former dry cleaning business are shown in Figures 2-1 and 2-2.

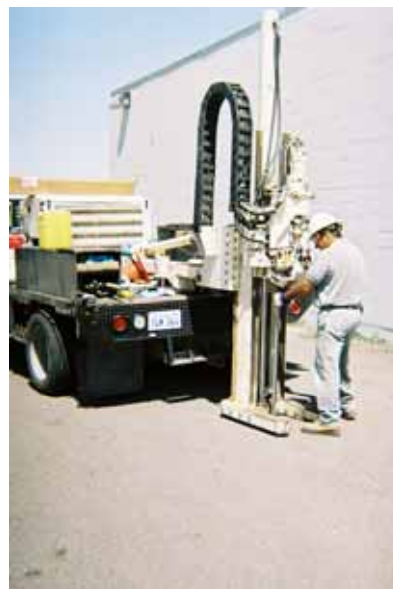
Figure 3-2. Large Direct-Push Rig

Direct-push drill rigs were used to collect samples. A 66DT unit mounted on a flat-bed truck was used outside the building and a dolly probe was used

indoors. The two rigs are shown in Figures 3-2 and 3-3. Drilling was performed by ESN South of Corpus Christi, Texas under the supervision of two URS geologists. The drillers decontaminated non-dedicated sample equipment with soap and water and used high-pressure washers for large equipment. A Triad approach was used (USEPA, 2003a)(ITRC,

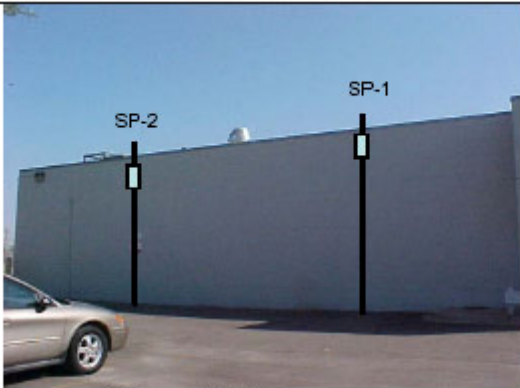
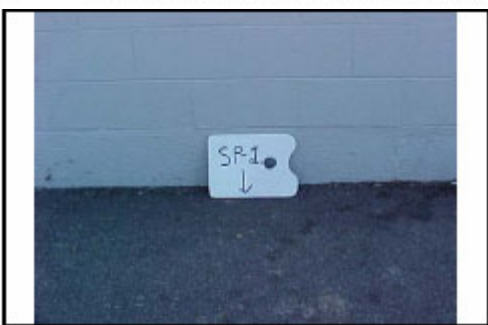
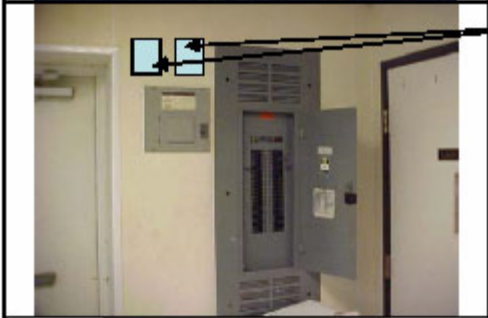
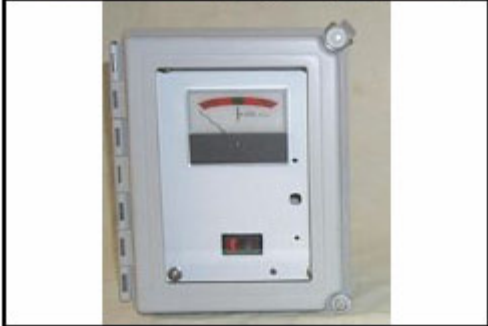
Figure 6-3. Pictorial Indication of System Locations and Details

<ul style="list-style-type: none"> ▪ Locate fan systems up high on building. ▪ Piping to be schedule 80 PVC for durability. ▪ Horizontal cores through foundation wall. ▪ Asphalt to be cut to allow access for core rigs and replaced. ▪ Pipe and shroud to be primed and painted. ▪ Suction point locations can be moved 2 feet either direction from point noted to avoid obstructions. ▪ Discharge points to be 10 feet from roof top air intakes.

<ul style="list-style-type: none"> ▪ Core horizontally through foundation wall. ▪ Avoid re-bar-patch if nicked or damaged. ▪ Patch asphalt, if disturbed. ▪ Location can be + 2 feet from specified location

<ul style="list-style-type: none"> ▪ Locate performance indicators on wall adjacent to circuit panel. ▪ Utilize existing circuit if not overloaded, otherwise install new circuit (fans rated for 150 watts each).

<p>System Performance Indicator</p> <ul style="list-style-type: none"> ▪ One per fan ▪ Could be mounted externally if desired. ▪ Matched to fan ▪ See specifications
