EPA Evaluation of the Inset Aftermarket Retrofit Device

Vechile Programs and Compliance Division
Office of Mobile Sources
U.S. Environmental Protection Agency

EPA Laboratory Evaluation of the Inset Fuel Stabilizer Aftermarket Retrofit Device for Motor Vehicles

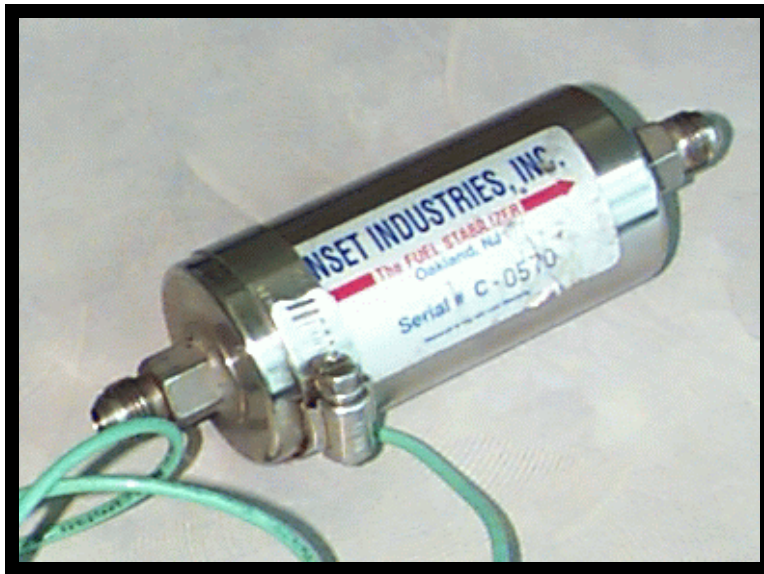
Figure 1

The Inset device employed in the emissions and fuel economy evaluation reported herein gave the appearance of having been made from a silver colored bar of metal which was just under 4 and 1/4 inch in length by just under 2 inches in diameter. A smooth rounded transition was present between each of the ends and the tubular side of the unit. Threaded nipples were welded to each end. There are no other readily identifiable marks or lines on the surface of the unit which could be used in identifying its method of construction. The coloring and general appearance of the device is consistent with the statement by Inset Industries, Inc. that stainless steel is used in the construction of Inset devices. The word "in" is stamped on one end of the unit and "out" is stamped on the other end. Light shone into a nipple at one end of the unit cannot be seen at the other end. Fuel does, however pass through the unit. A label attached to the unit shows the name "Inset Industries, Inc."; the name of the device, "The Fuel Stabilizer" with an arrow pointing from the end of the unit identified as "in" to the end identified as "out"; a partial address "Oakland, NJ"; the serial number of the unit employed in this evaluation, "C - 0570"; and the following disclaimer "Removal of tag will void Warranty". A piece of electric wire for grounding the unit, a hose clamp to attach the wire to the unit, and a piece of fuel hose and fitting came with the unit. A photograph of this unit is shown in Figure 1.

Inset device. Unit used in the vehicle test program covered in this report

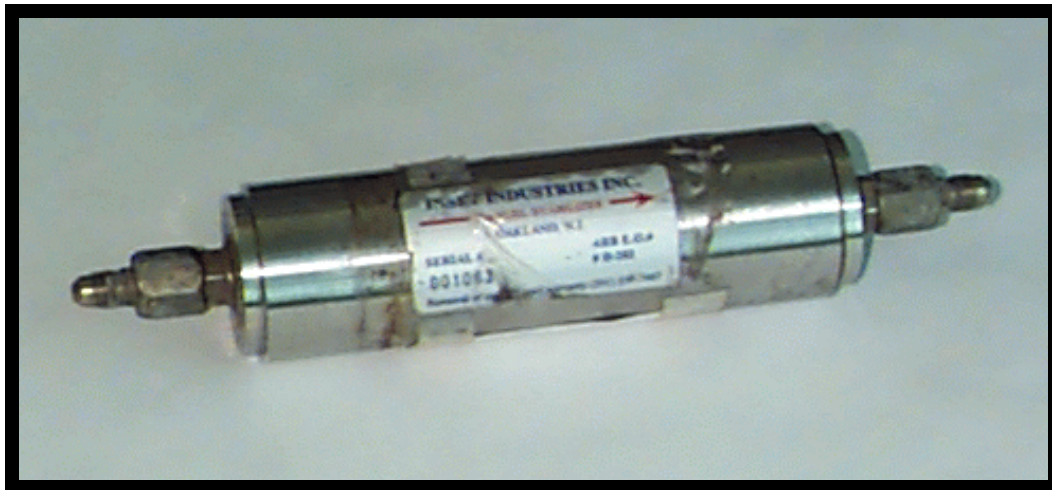
Figure 2

Inset device. During opening process. With end caps freed from tubular body of the device.

The overall appearance of the six Inset units provided by the Division of Fleet Management, Essex County, New Jersey was the same as that of the Inset unit used in the testing program. These units were just under seven inches long, and were just under two inches in diameter; i.e. they were longer than, and essentially the same diameter as the unit used in the testing program. The labels contained the same language as that previously detailed for the unit used in emissions and fuel economy testing. The labels contained two additional items. These items were a telephone number ((201) 337-7447), and a California Air Resources Board Executive Order number as follows; ARB E.O. #D-282. Two of these six Inset units were opened to allow viewing of the interior of the units. The serial number of the unit shown in Figures 2, and 3 was 001063. Opening of the units was achieved by cutting just enough material away at each end, on a lathe, to free the end caps from the tube that formed the outer longitudinal shell of the unit. The unit at this level of disassembly is shown in Figure 2. Within the outer shell, and welded to each end plate and the external nipples was a straight piece of 1/2 inch stainless steel tube (Figure 3). Within this tube was a thin piece of stainless steel plate which was twisted around its longitudinal axis (Figure 3). The width of the plate was such that it was essentially an interference fit with the inside surface of the tube, i.e. it was held firmly in place. By being twisted, the plate prevents the passage of light through the unit. The inner surface of the 1/2 inch tube, and of the nipples, and the surfaces of the twisted plate are the only parts of the Inset device which come into contact with fuel as it flows through the device. Also within the shell was a spiral of stainless steel tubing (Figure 3). The pitch of the spiral was not uniform, but averaged approximately 3/4 inch. The interior diameter of the spiral was approximately one and one quarter inch. Since flattening of the tube occurred during forming of the spiral, a precise determination of the size of the tube was not possible. The most probable diameter of the tube used in manufacturing the spiral was 1/4 inch. Both ends of the spiral were sealed. One end by what appeared to have been heating followed by being squeezing or hammering flat, the other by squeezing or hammering flat, folding and then again hammering or squeezing flat. Within the spiral was approximately 5 ml of a fairly fine greenish black powder. The spiral was held in place, and prevented from rattling around within the shell and between the end plates by a coarse powdery material. This material was brownish green in color and gave off an unpleasant odour. There were
