# **Evaluation of Field-deployed Low Cost PM Sensors**

**Ron Williams**  
National Exposure Research Laboratory  
Office of Research and Development  
U.S. Environmental Protection Agency  
Research Triangle Park, NC, USA 27711

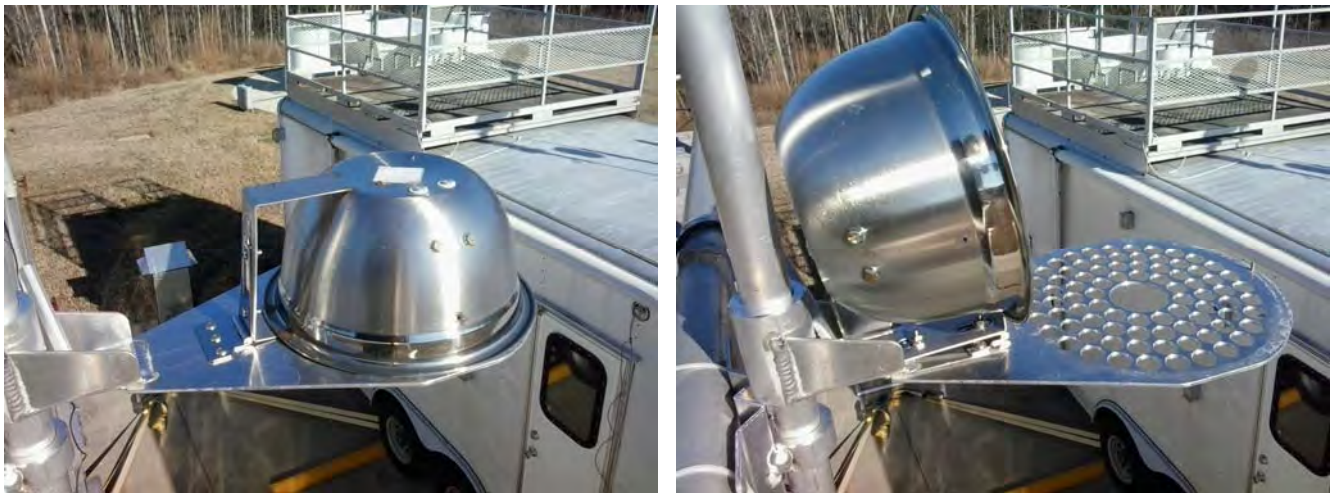
**Figure 2-1.** “Bowl on pole” sensor enclosure in closed (left) and open (right) positions.

“Bowl on pole” sensor shelters were devised and constructed for the field evaluations. The shelters, shown in Figures 2-1 through 2.1-2, were constructed in-house of aluminum. Thermostated thermal heating pads were attached to the tops of the bowls in an attempt to maintain interior shelter conditions where the sensors were housed at or above 6° Celsius. Even so, it must be recognized that these heaters were purposefully selected to provide for a minimal degree of general heating and that internal temperatures of the sensors registering at or just below freezing were sometimes observed. These aforementioned enclosures were constructed to ensure sensor protection from windblown rain as well as direct sunlight upon the inlets of the devices. The shelters did not fully protect the inlets of the devices from the effects of any face velocity issues (wind speed and/or its direction). Even so, the interface of the sensor inlet did attempt to place a shield between the immediate sensor inlet opening and the ambient atmosphere. That shield is viewable in Figure 2-1 with the sensor often placed directly above or its inlet in one of the openings to provide unencumbered access to ambient conditions. Effects of sensor PM starvation or stagnation would not be expected to have occurred under the test conditions.

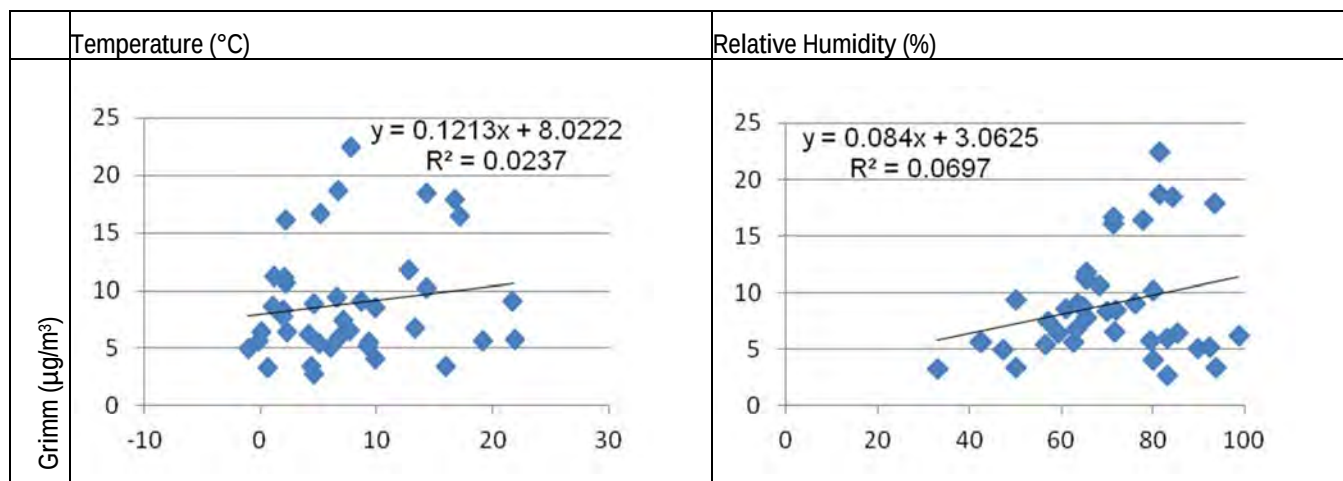
**Figure 2.1.1-1.** Grimm data vs. temperature and RH.

covered under a QAPP for that study<sup>8,9</sup>. Data from the Grimm were available during the data collection period of the sensor evaluation as 1-min, 5-min, or 60-min averages. Sensors tested in this study featured time resolutions between 1-s and 5-min. We selected a matched data integration period (average) of 5 minutes for comparison with the sensors. General relationships between the Grimm response and environmental conditions are reported in Figure 2.1.1-1.

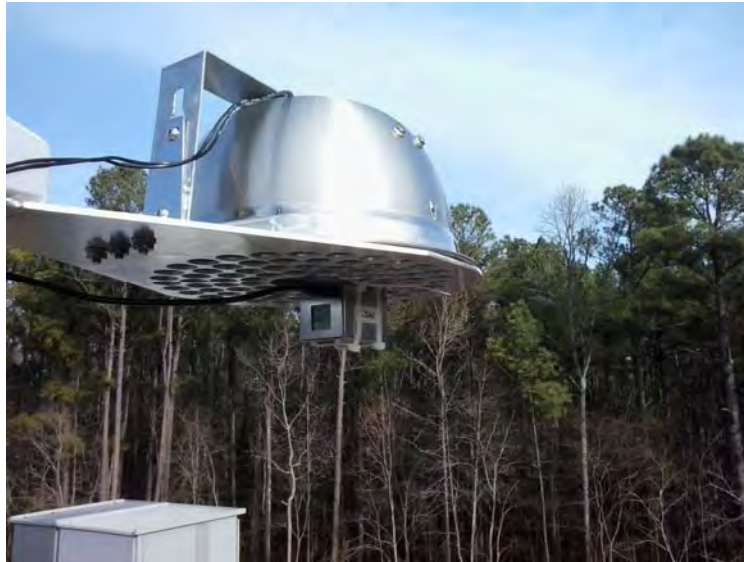
**Figure 2.1.3-1.** CairClip PM sensor suspended beneath shelter grating.

The CairClip was originally placed on top of the shelter grating with the inlet flush to a hole in the grating. On December 13, 2013, following a review of the data in hand (relatively low concentrations being reported), it was suspended underneath the grating with zip ties, as shown in Figure 2.1.3-1, to maximize airflow. The reason for this being the concern that inadequate fresh air supply (stagnation) might be the cause of a lack of observed day-to-day PM concentration variability with this sensor. The repositioning of the sensor to a fully open nature

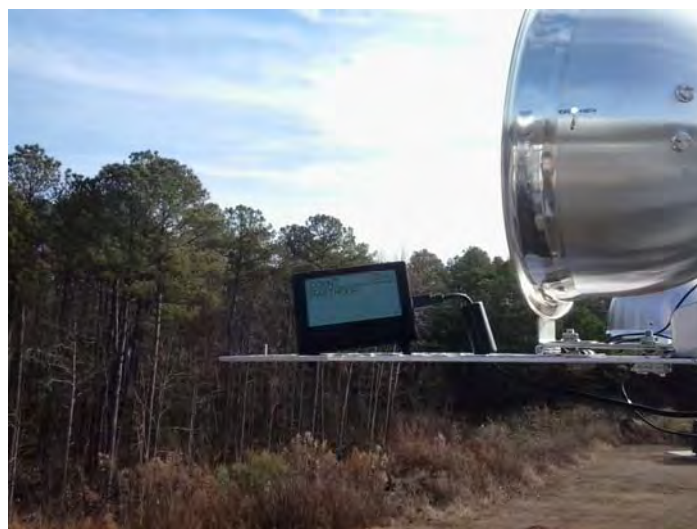
**Figure 2.1.4-1.** Carnegie Mellon Speck oriented in its shelter with the lid up.

Because the Carnegie Mellon Speck's inlet is on its bottom surface, it was simply placed on the grating as shown in Figure 2.1.4-1. The Speck experienced two interruptions in data collection, both of which began while the operator was in the field. This suggests that it failed to restart data collection after a data download was completed. This might be the result of operator error and not necessarily the fault of the device.

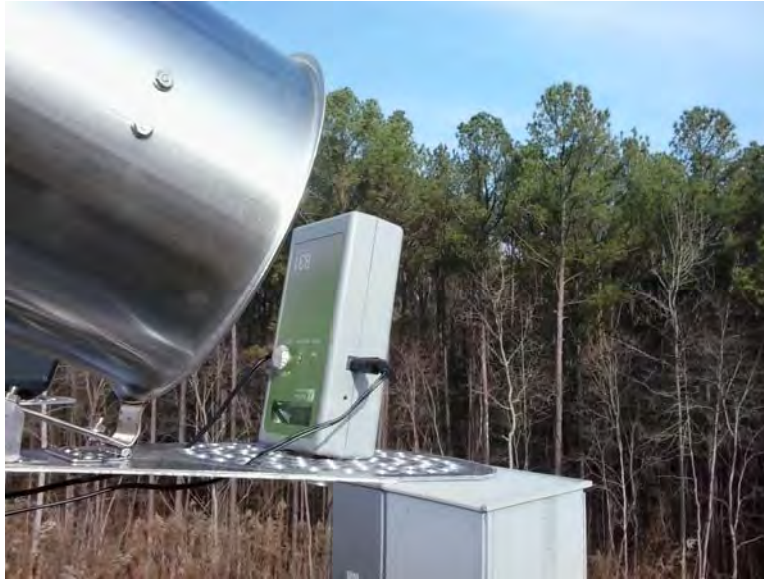
**Figure 2.1.6-1.** Met One model 831 oriented in its shelter with the lid up.

The Met One model 831 was positioned upside down so that its inlet protruded beneath the grating of its shelter as shown in Figures 2.1.6-1 and 2.1.6-2. The Met One experienced one interruption in sampling, which began while the operator was in the field. This suggests that it failed to restart data collection after a data download was completed. This might be the result of operator error and not necessarily the fault of the device.

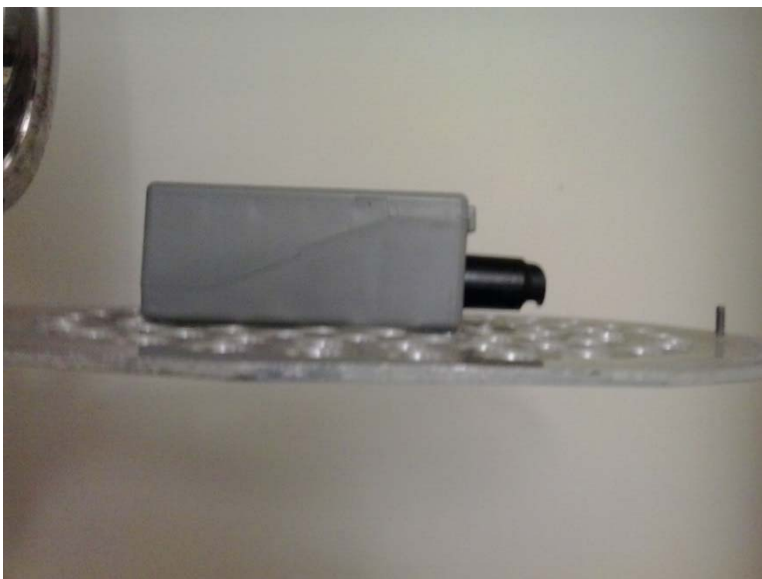
**Figure 2.1.7-1.** RTI MicroPEM orientation on the plate of a bowl-on-pole shelter.

The RTI MicroPEM is an optical particulate matter sensor that uses a size-selective inlet to measure PM<sub>2.5</sub>. Three RTI MicroPEM units were simultaneously tested from July 29 through September 2, 2014 at the AIRS sampling site. On the advice of the manufacturer, they were arranged in the bowl-on-pole shelters as shown in Figure 2.1.7-1. As shown, they are placed on the grating on their side with the opening to the nozzle facing down. Each MicroPEM unit was

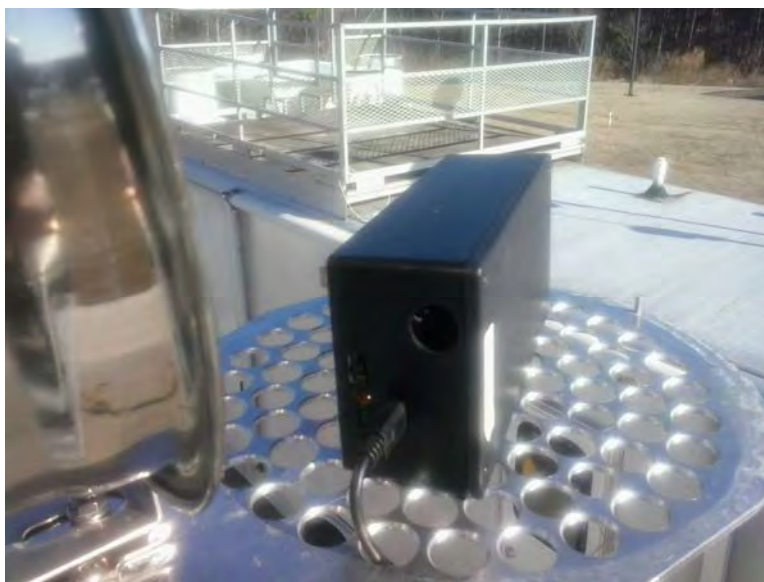
**Figure 2.1.8-1.** Sensaris Eco PM oriented in its shelter with the lid up.

The Sensaris Eco PM was placed on its side so that one of its several ventilation holes would be in contact with the grate. The AIRS platform proved to be too far away from the only WiFi hotspot at the AIRS monitoring site. As such, the Sensaris Eco PM was relocated first to a hi-vol shelter and then to a “bowl on pole” shelter on top of the trailer containing the AIRS WiFi hotspot. This relocation placed it approximately 50 m from the other sensors but still in close proximity ( $< 10$  m) to the collocated Grimm FEM analyzer. Care was taken to place it at approximately the same altitude as the other sensors. The Sensaris Eco PM orientation and location are shown in Figures 2.1.8-1 and 2.1.8-2. The Sensaris Eco PM suffered from many interruptions in overall data collection. Connectivity problems were believed to have influenced overall data collection rates for this device.

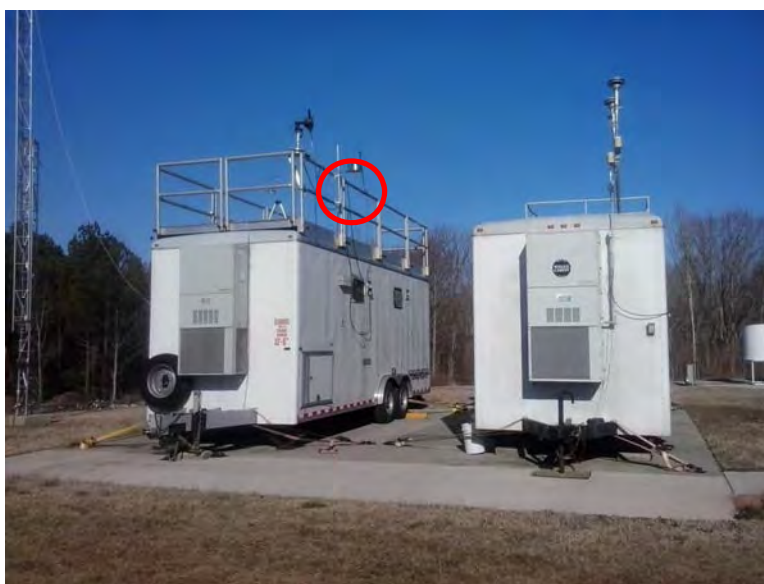
**Figure 2.1.8-2.** Sensaris Eco PM sampling location (circled above).

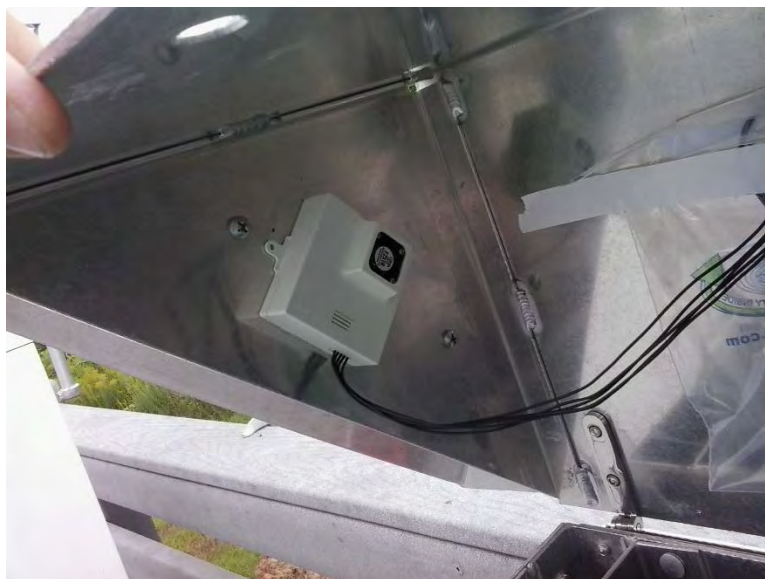
**Figure 2.1.9-1:** Shinyei in a Hi-Vol shelter. Note that the lid to the Hi-Vol shelter was closed during sampling.

interference. Whenever the sun was shining, the unit reported nearly  $800 \mu\text{g}/\text{m}^3$ . As such, the initial test was discarded and the unit relocated to a Hi-Vol shelter where it would be better protected from sunlight. The position and orientation of the unit in the second test is shown in Figure 2.1.9-1. The unit was attached to the lid of the Hi-Vol shelter via double-sided tape.

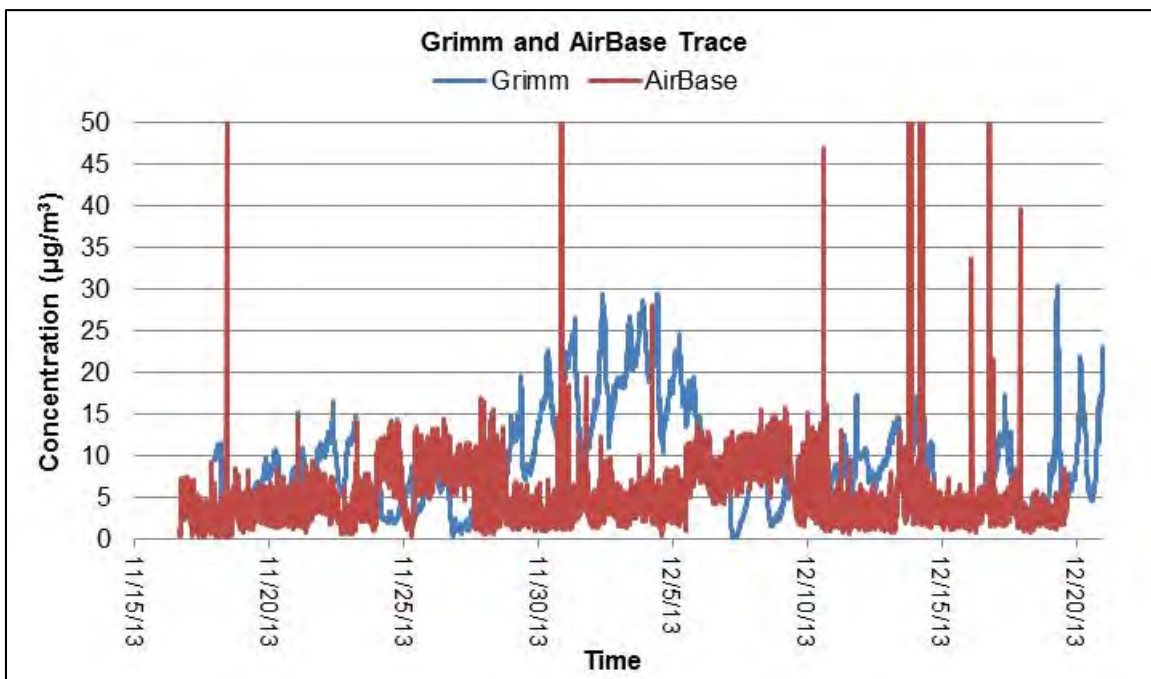
**Figure 3.1.1-1.** Grimm and AirBase data over time.

The trace of the AirBase PM sensor data does not appear to follow that of the Grimm FEM analyzer. Scatter plots show that the AirBase PM data had minimal correlation with the Grimm or with any other factors. No speculation can be provided as to why this lack of agreement was observed.

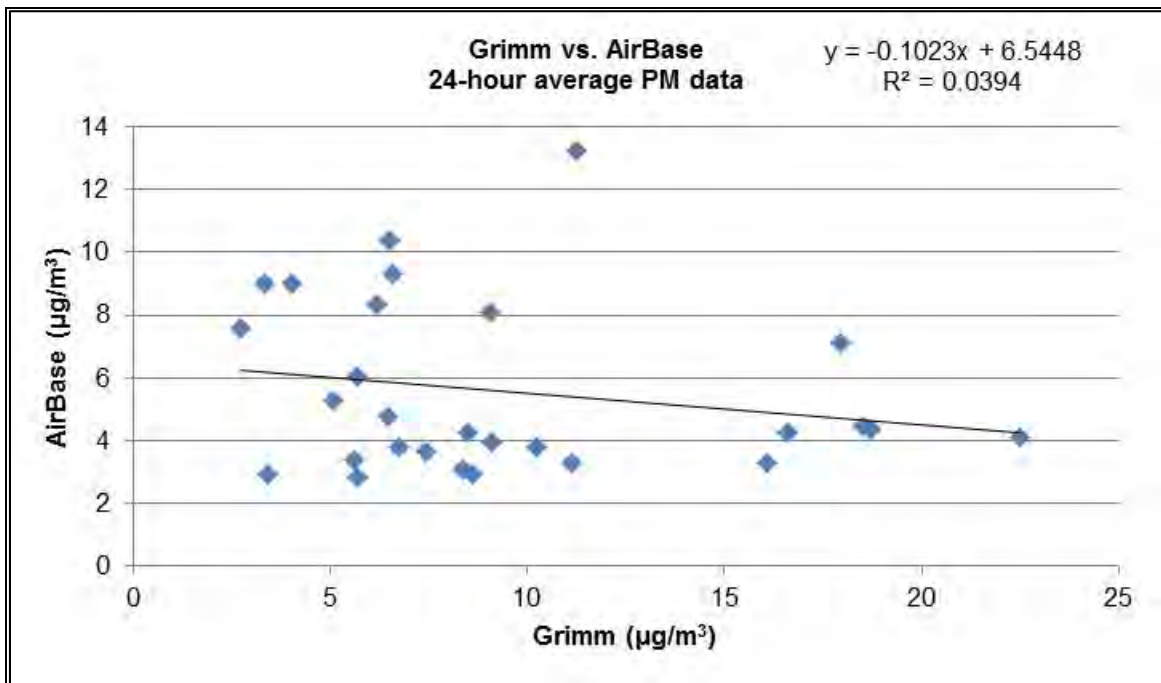
**Figure 3.1.1-2.** 24-hour time-averaged PM data comparing the Grimm reference sampler with the AirBase CanaIT PM sensor.

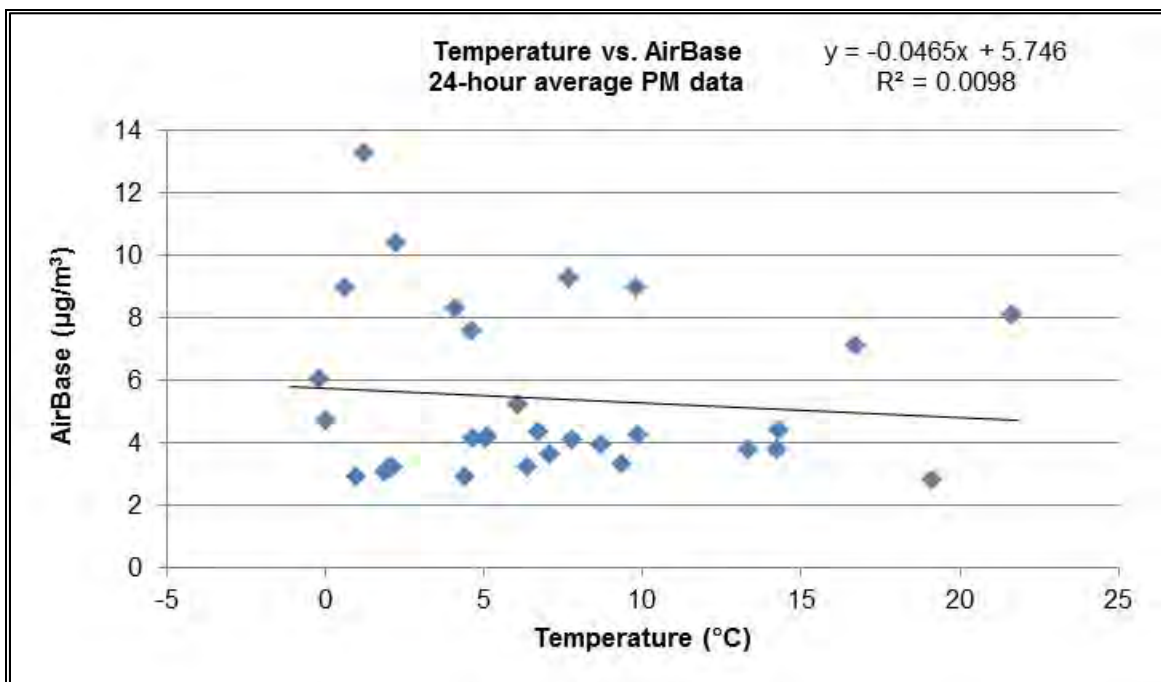
**Figure 3.1.1-3.** Temperature vs. AirBase 24-hour averaged data.

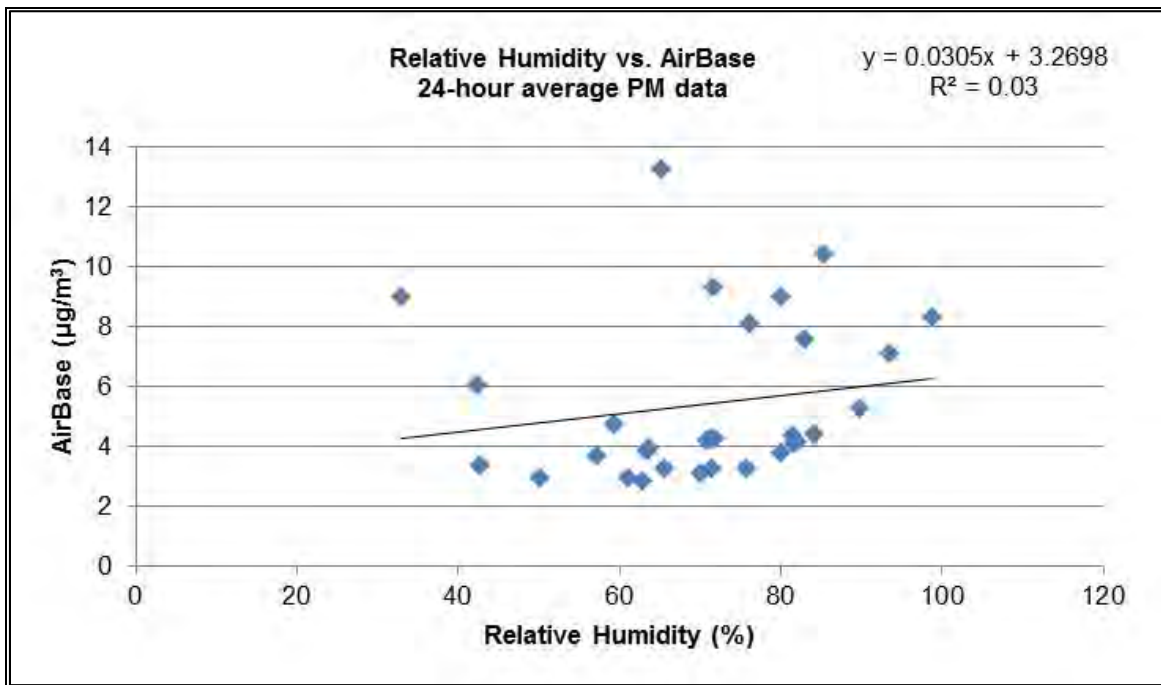
**Figure 3.1.1-4.** RH vs. AirBase 24-hour averaged data.

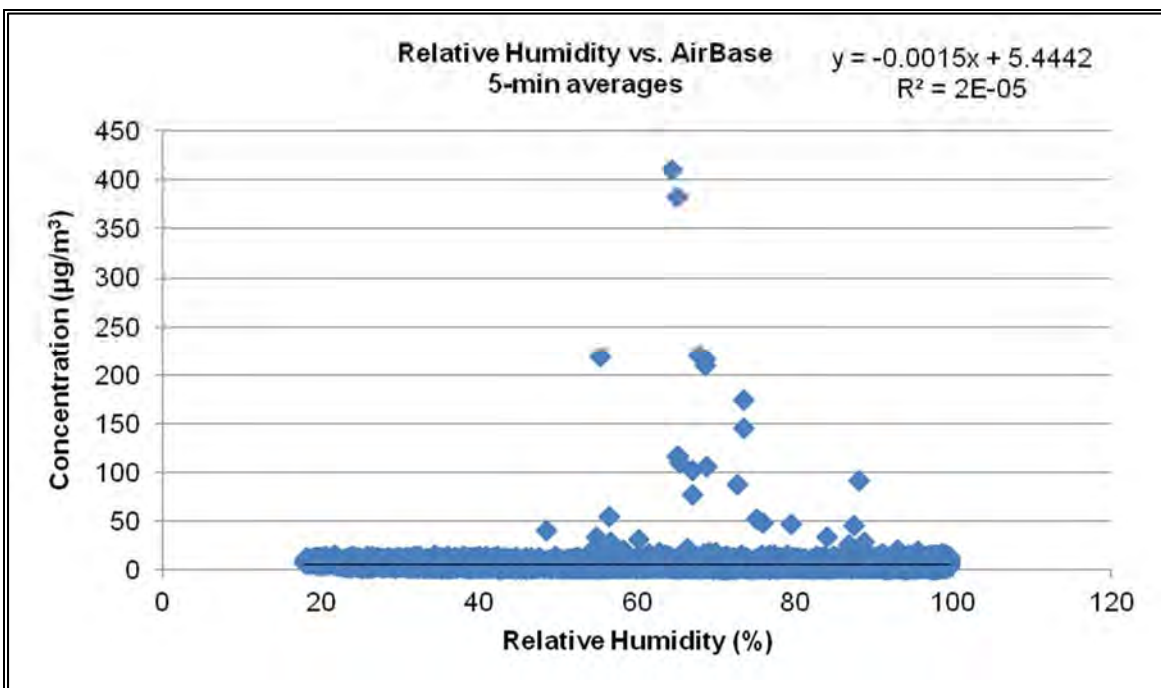
**Figure 3.1.1-5.** RH vs. AirBase (5-min averages).

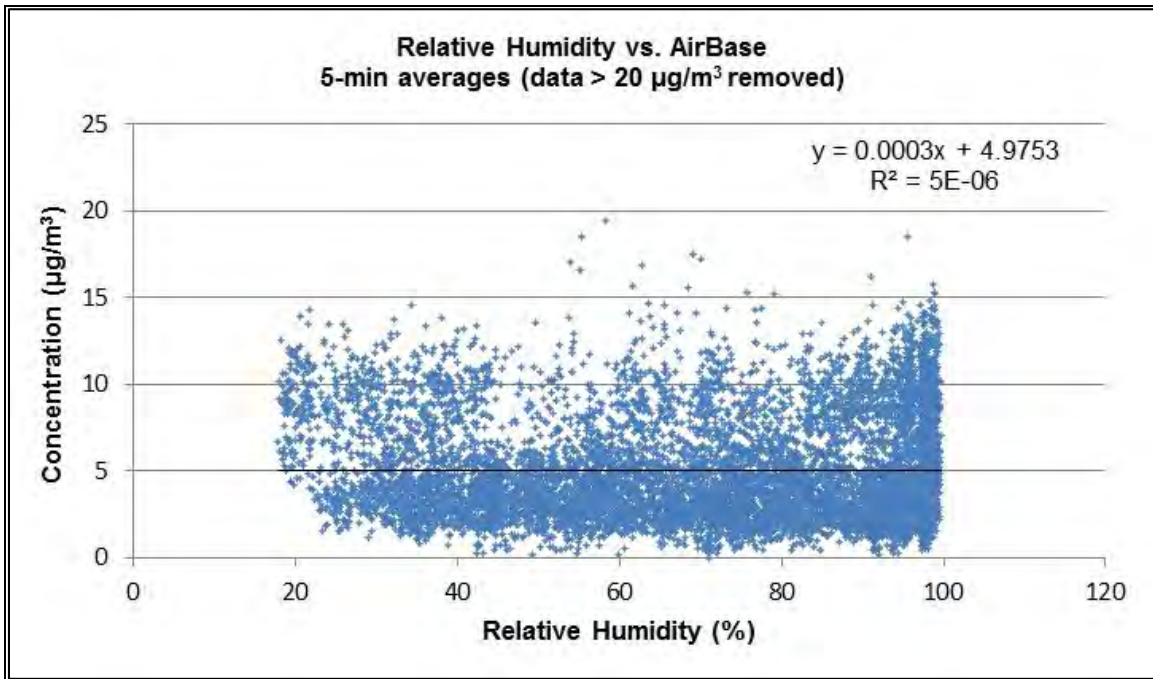
**Figure 3.1.1-6.** RH vs. AirBase (5-min averages) with data > 20 µg/m<sup>3</sup> removed.

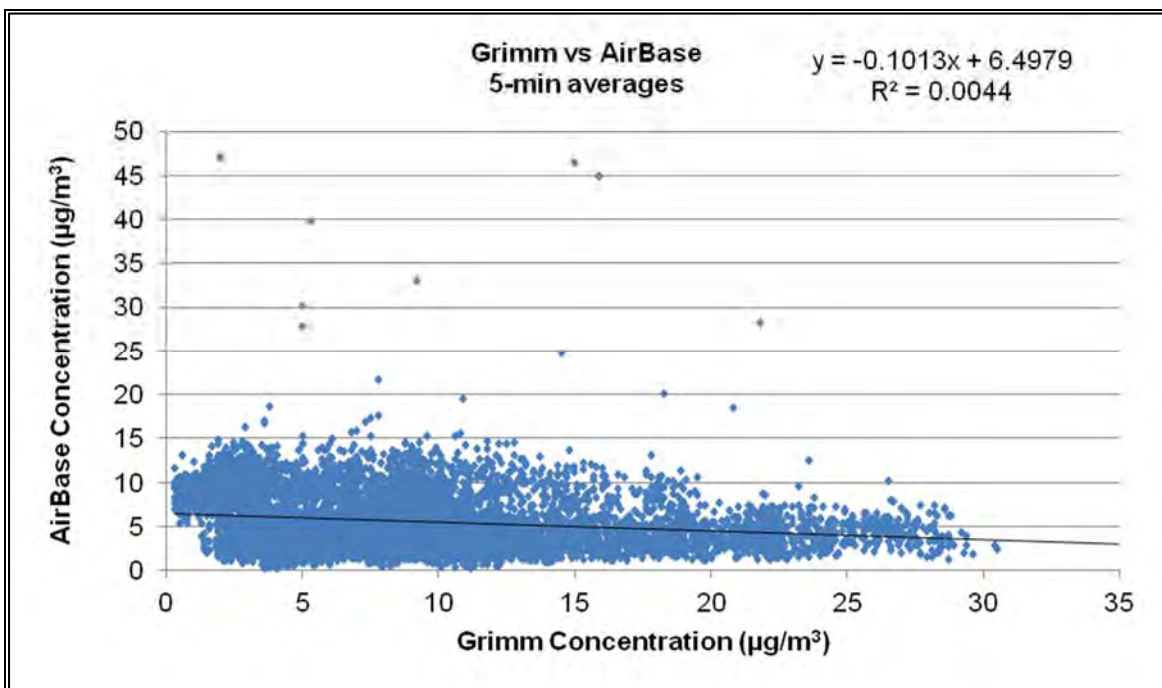
**Figure 3.1.1-7.** Grimm vs. AirBase (5-min averages).

Given the data detailed above, no basis for any correction factors or removal of outliers can be found. The final scatter plot of Grimm vs. AirBase data is shown below in Figure 3.1.1-7. The scale has been chosen manually to better illustrate the bulk of the data.

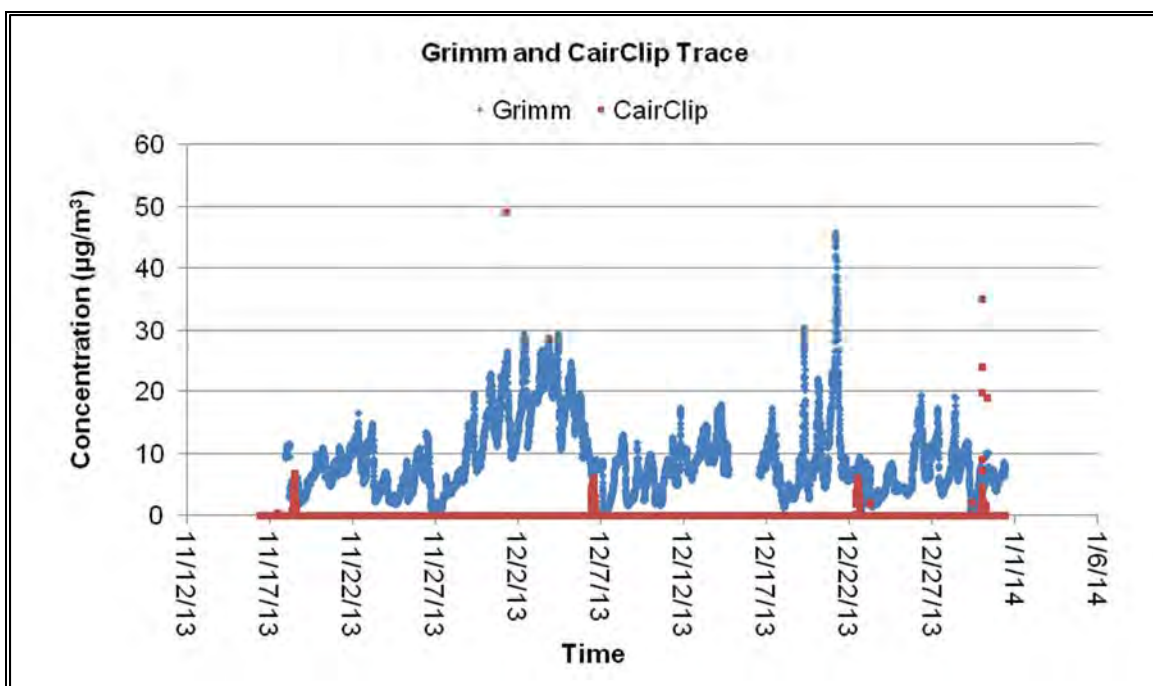
**Figure 3.2.1-1.** Grimm data and CairClip data over time.

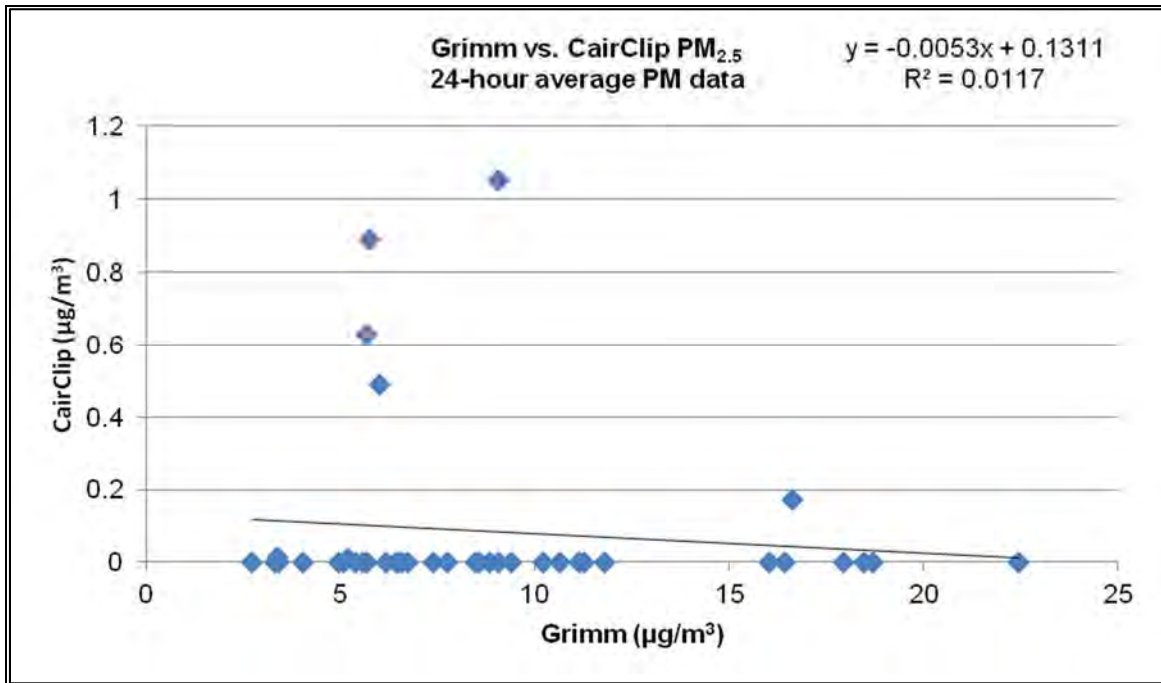
**Figure 3.2.1-2.** 24-hour time-averaged PM data comparing the Grimm reference sampler with the CairPol CairClip PM sensor.

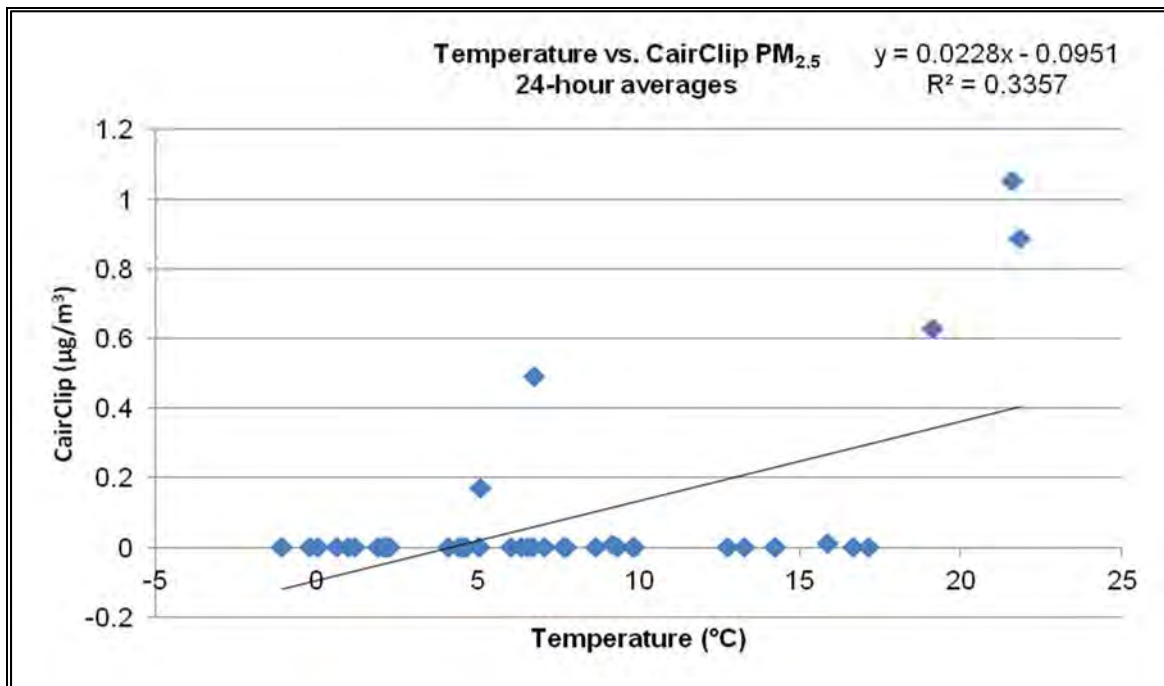
**Figure 3.2.1-3.** Temperature vs. CairClip 24-hour averaged data.

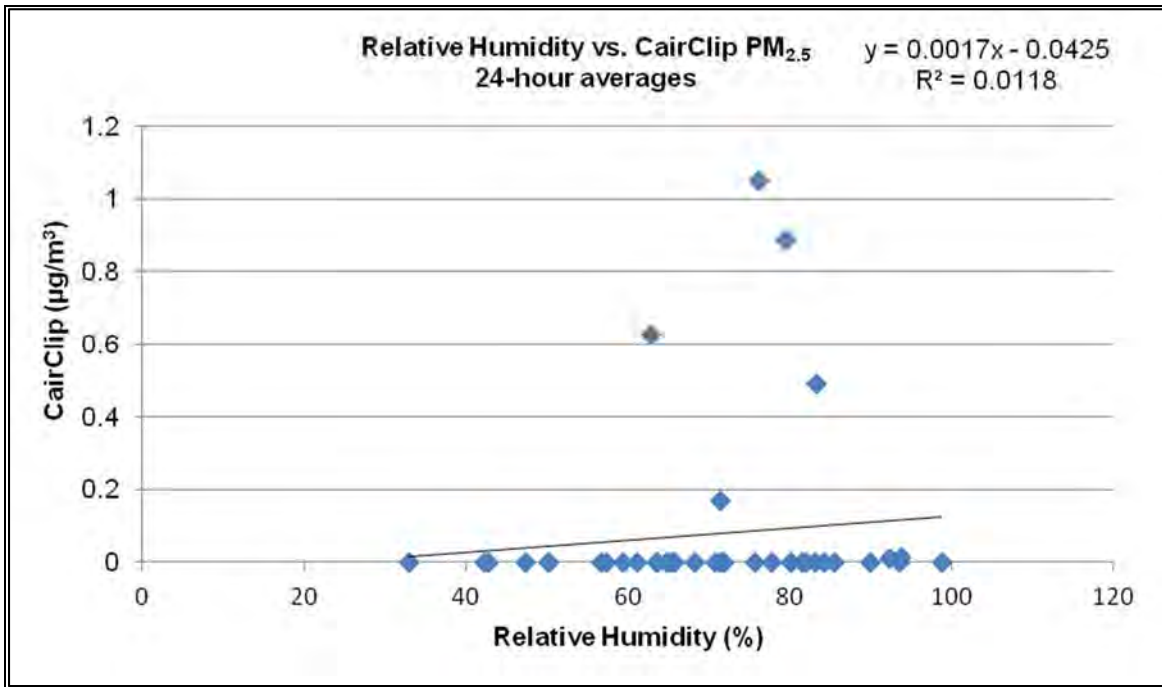
**Figure 3.2.1-4.** RH vs. CairClip 24-hour averaged data.

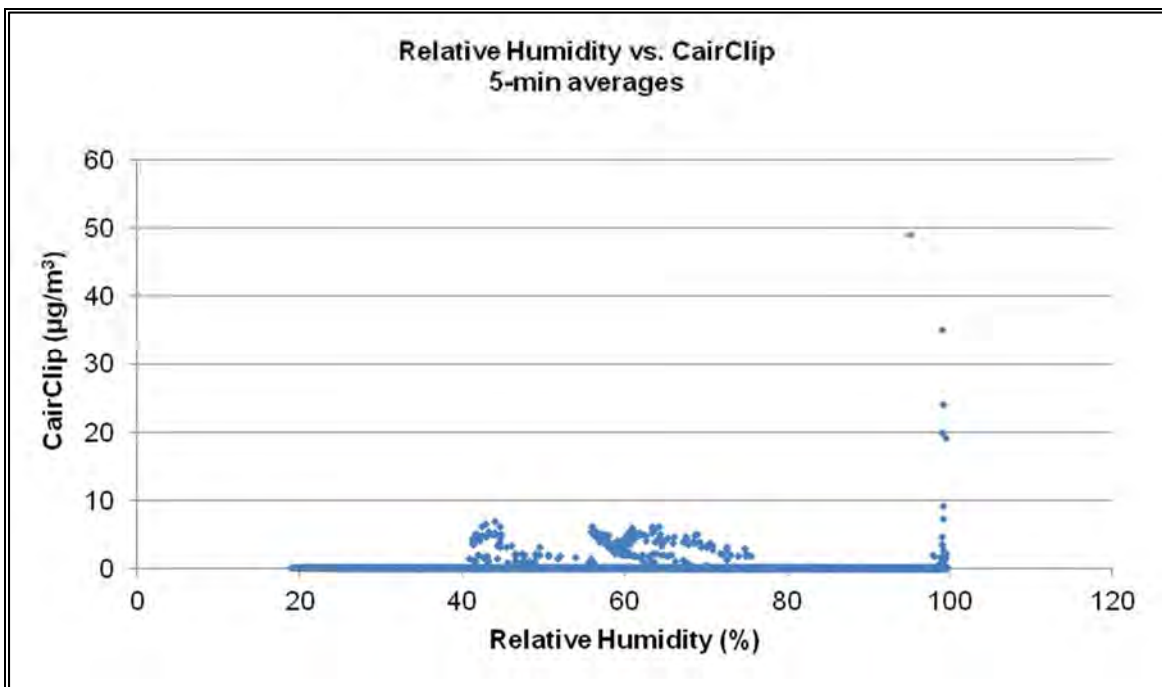
**Figure 3.2.1-5.** RH vs. CairClip (5-min averages).

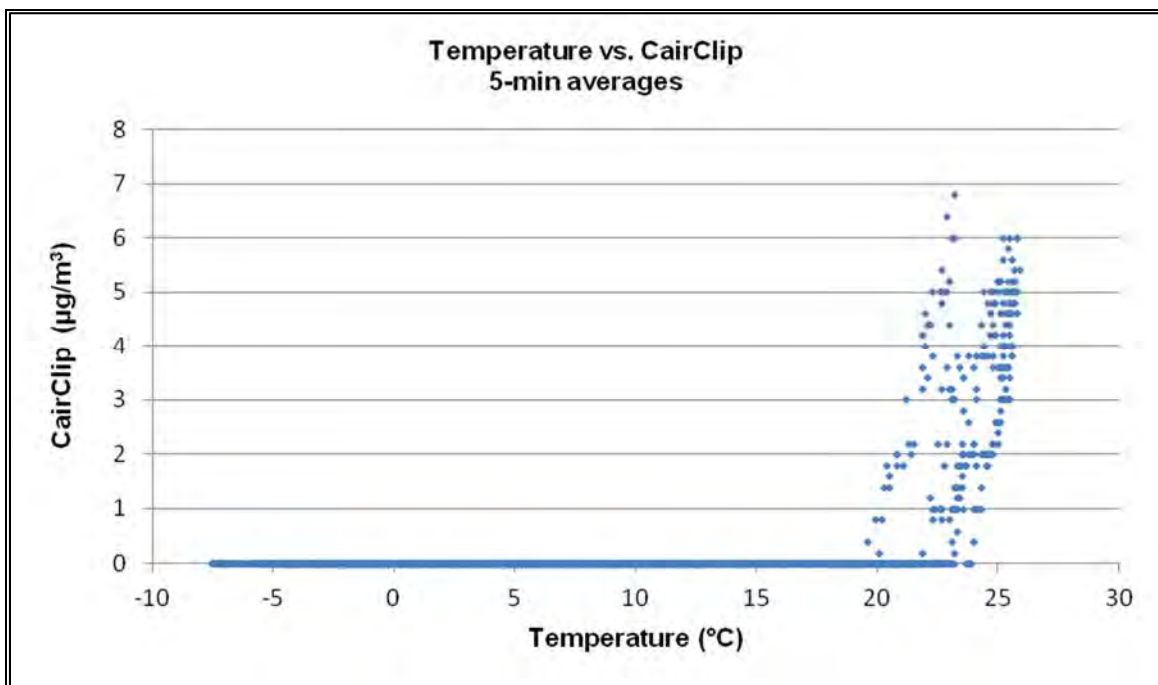
**Figure 3.2.1-6.** Temperature vs. CairClip (5-min averages). All data taken at humidities > 95% were removed.

As shown in Figure 3.2.1-6, the CairClip produced detectable responses only at temperatures above 19.8 °C. Figure 3.2.1-7 is the same graph using only data at temperatures above 19.8 °C. This clearly shows correlation between temperature and the CairClip signal. Figure 3.2.1-8 shows that even with high humidity and low temperature data removed, no clear correlation is observed between the CairClip and the Grimm FEM data.

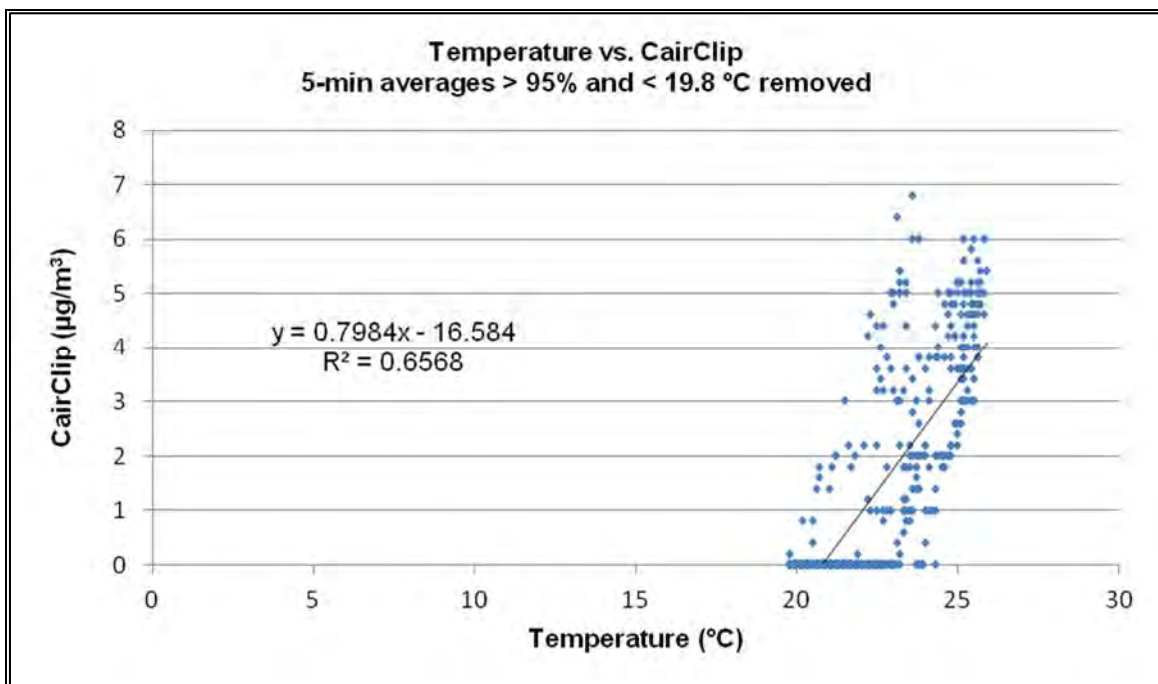
**Figure 3.2.1-7.** Temperature vs. CairClip (5-min averages). All data taken at humidities > 95% and temperatures < 19.8 °C were removed.

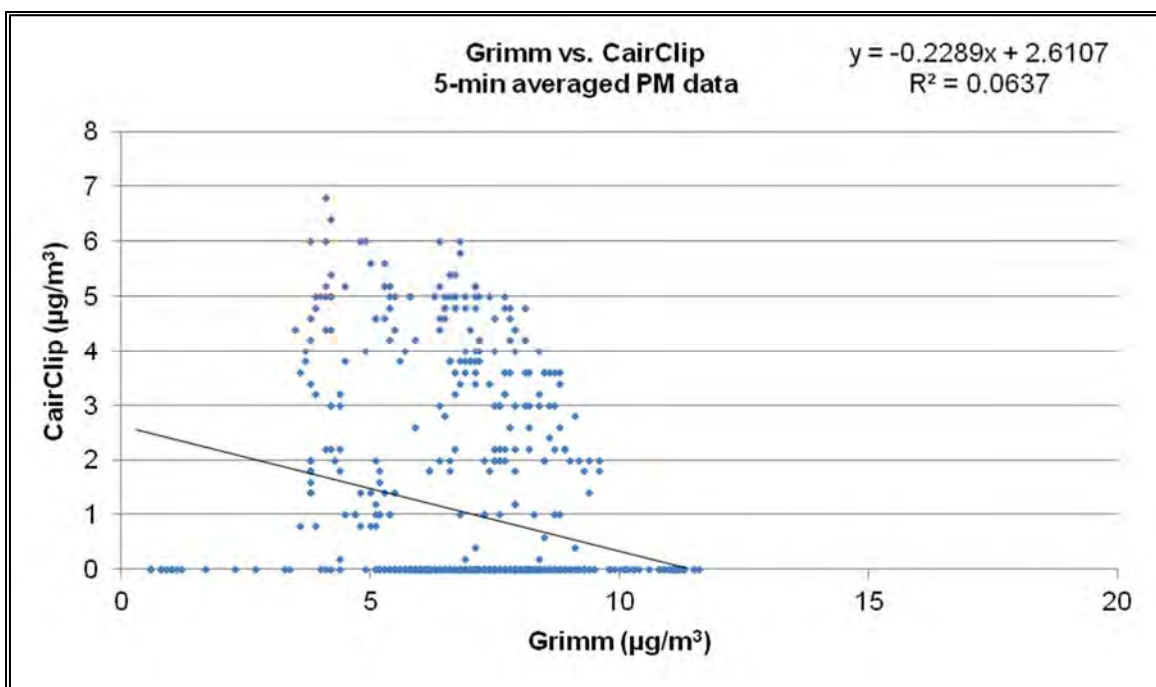
**Figure 3.2.1-8.** Grimm vs. CairClip (5-min averages).

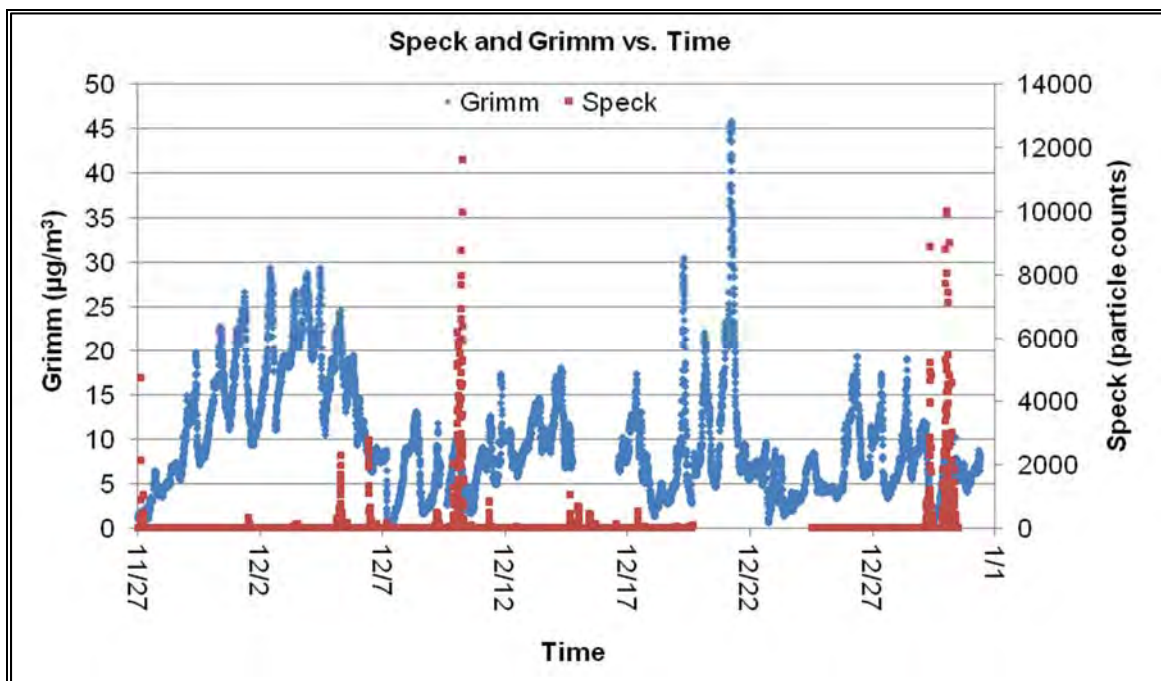
Figure 3.3.1-1. Speck data and Grimm data over time.

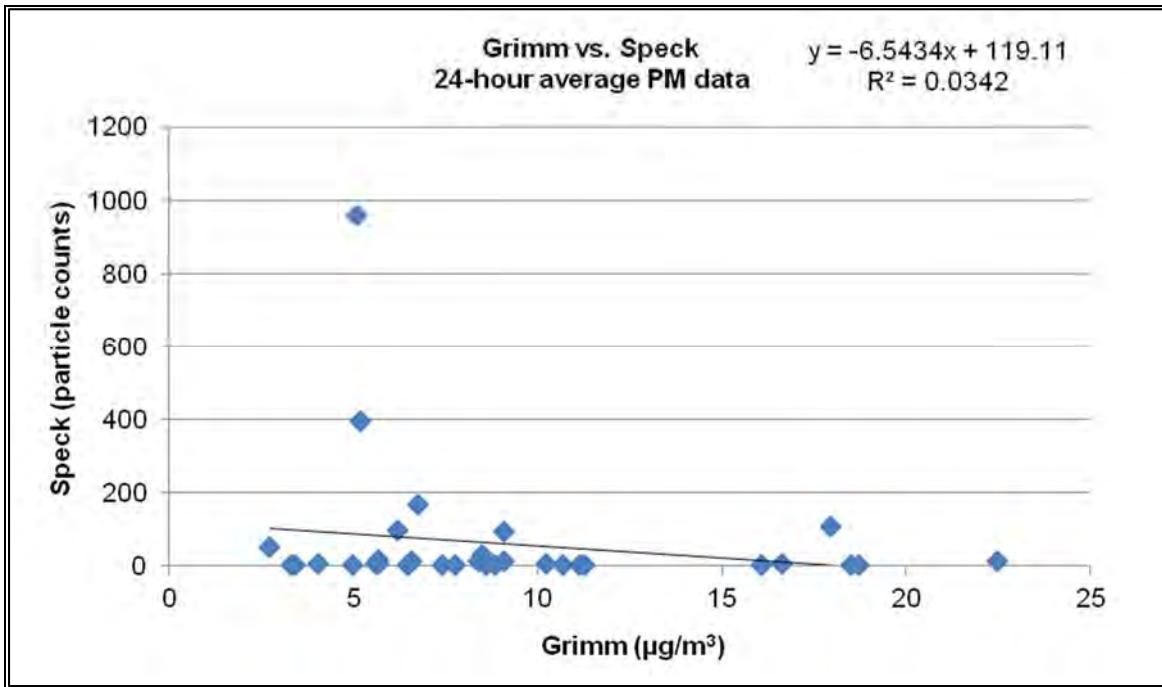
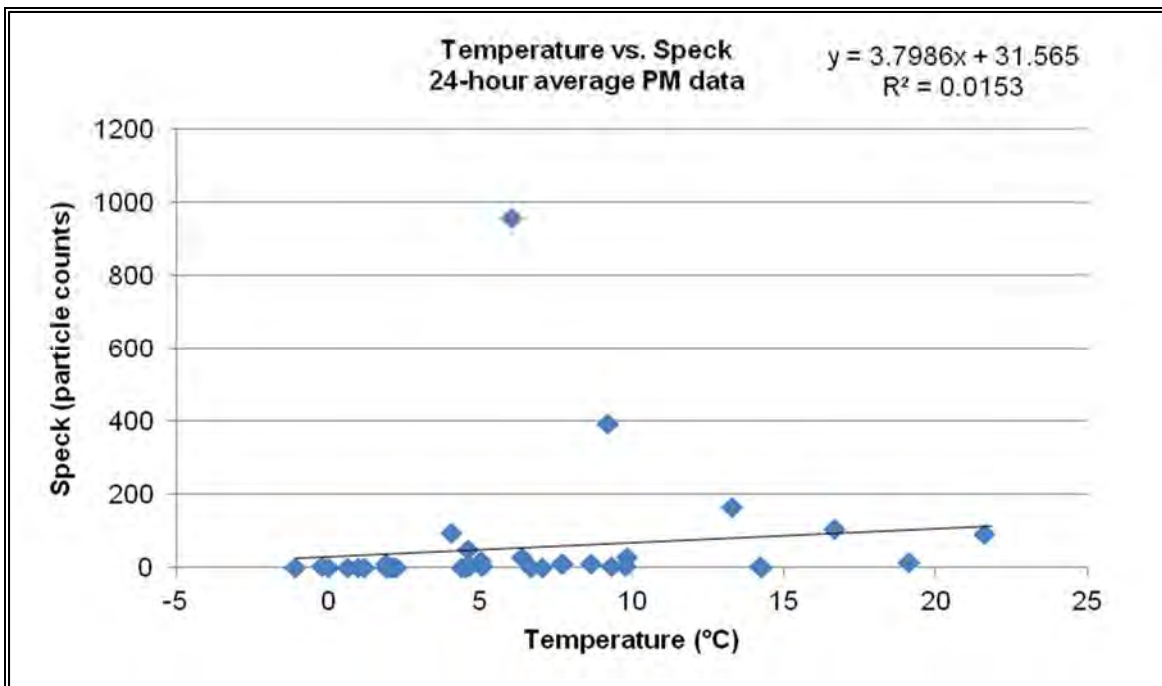
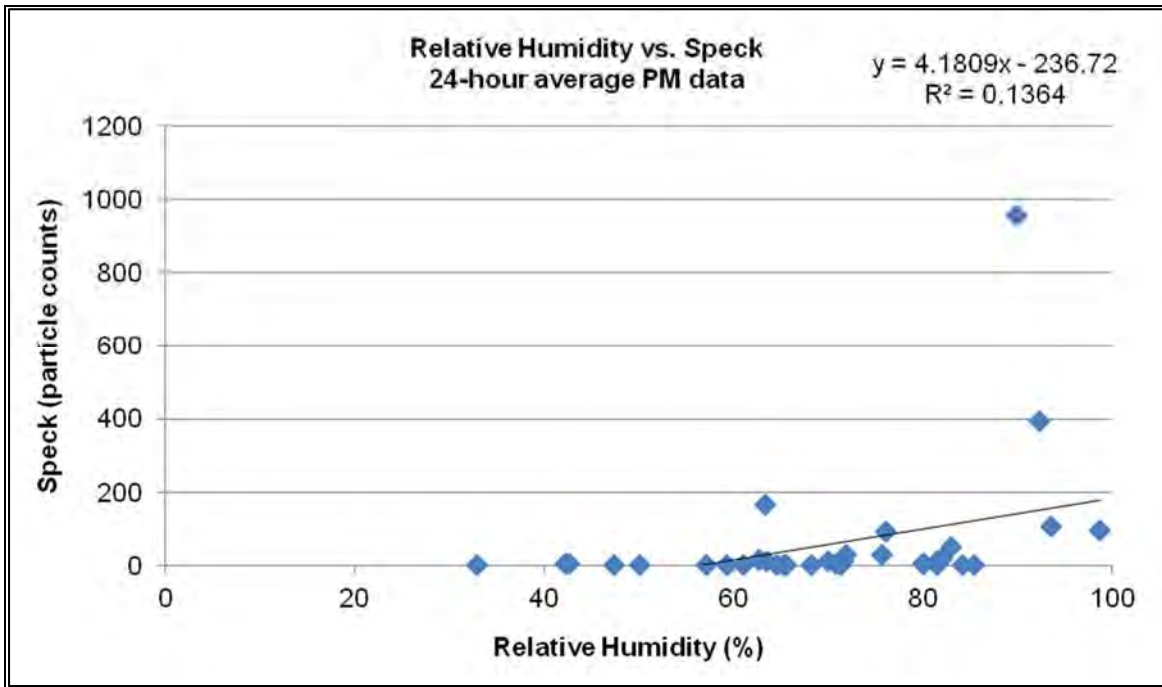
**Figure 3.3.1-2.** 24-hour time-averaged PM data comparing the Grimm reference sampler with the Speck.

**Figure 3.3.1-3.** Temperature vs. Speck 24-hour averaged data.

**Figure 3.3.1-4.** RH vs. Speck 24-hour averaged data.

The 24-hour averaged data depicted in Figures 3.3.1-2 through 3.3.1-4 suggest a strong correlation with humidity that is likely obscuring any correlation that might be present with temperature and the Grimm. Relative humidity can change rapidly over the course of a day, necessitating a further examination of the correlation between humidity and sensor response at the 5-min averaged time resolution, as shown in Figure 3.3.1-5.

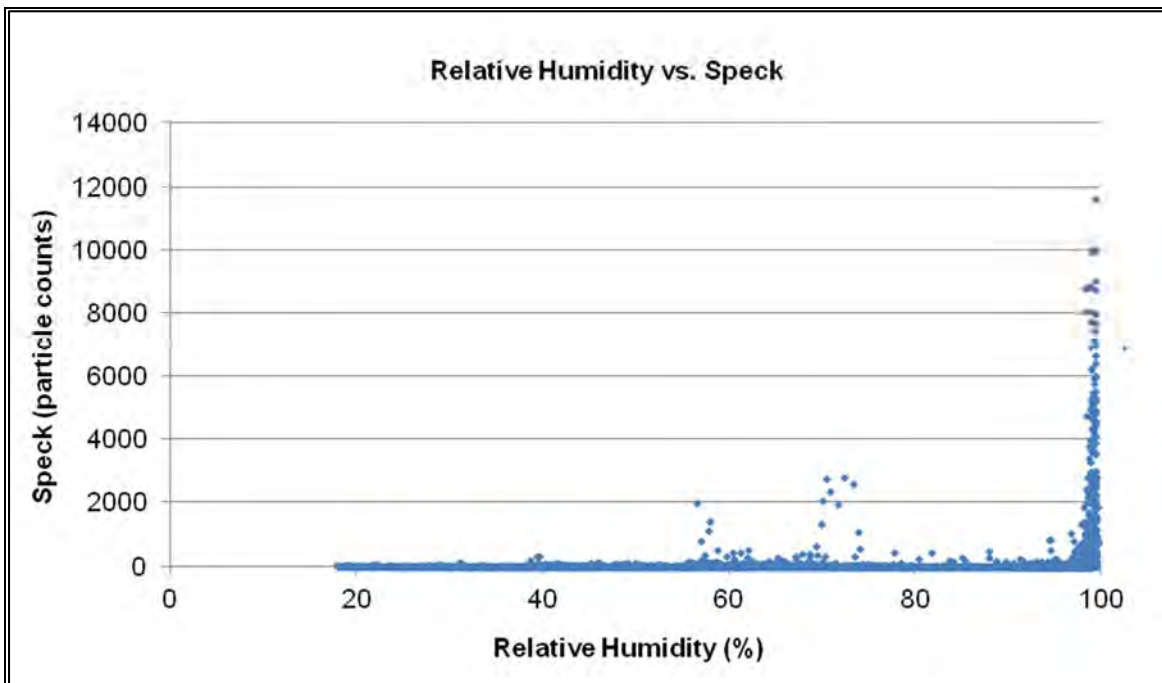
**Figure 3.3.1-5.** RH vs. Speck (5-min averages).
