# **Evaluation of Field-deployed Low Cost PM Sensors**

**Ron Williams**  
National Exposure Research Laboratory  
Office of Research and Development  
U.S. Environmental Protection Agency  
Research Triangle Park, NC, USA 27711

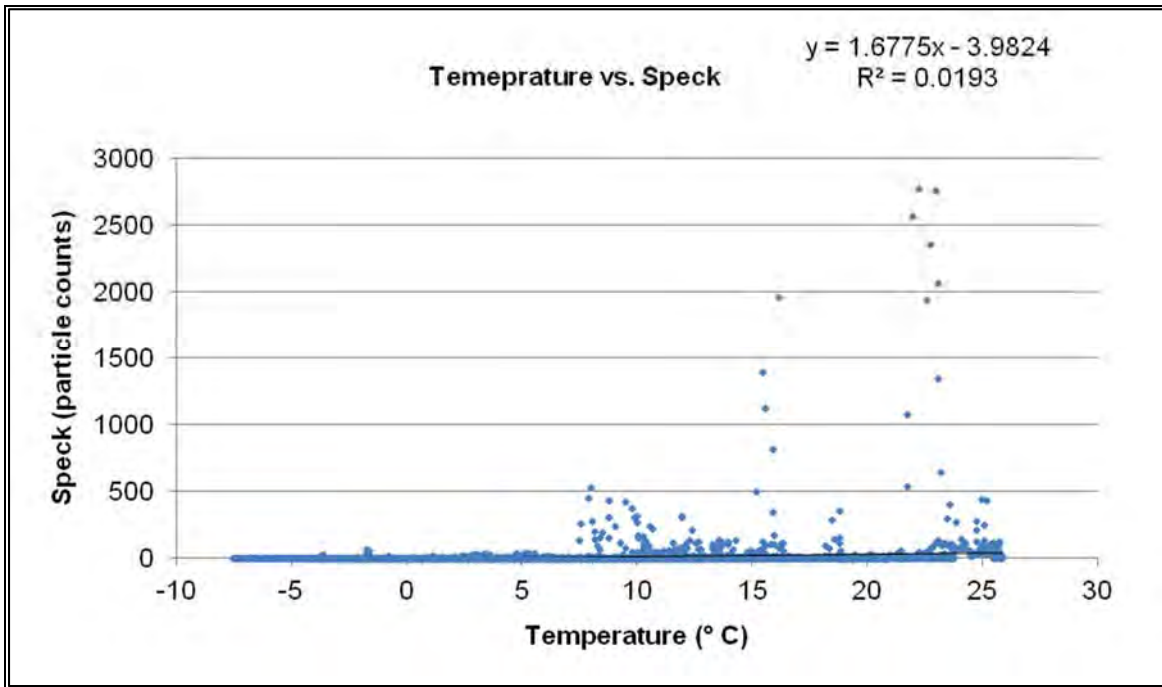
**Figure 3.3.1-6.** Temperature vs. Speck (5-min averages).

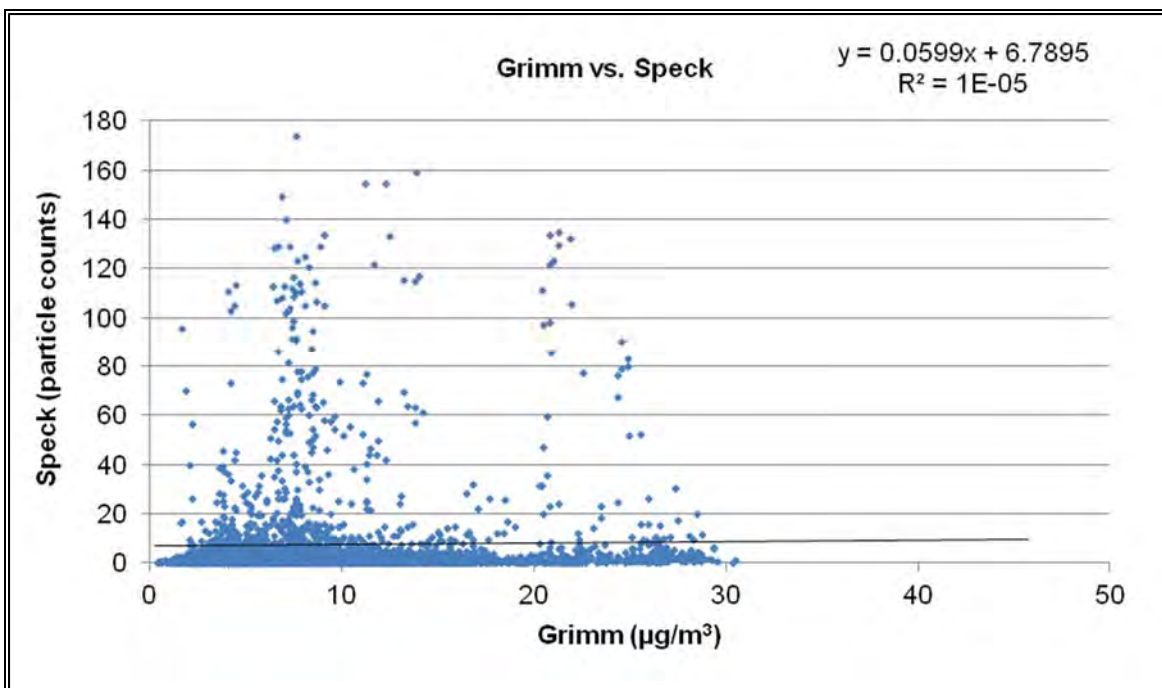
**Figure 3.3.1-7.** Grimm vs. Speck (5-min averages).

Many attempts were made to associate the remaining spikes to a factor that could be corrected for or removed, but these attempts were unsuccessful. Taking the square root or the log of the Speck data was also futile. With no clear method to identify additional outliers, the plot of Speck vs. Grimm data in Figure 3.3.1-7 shows no correlation.

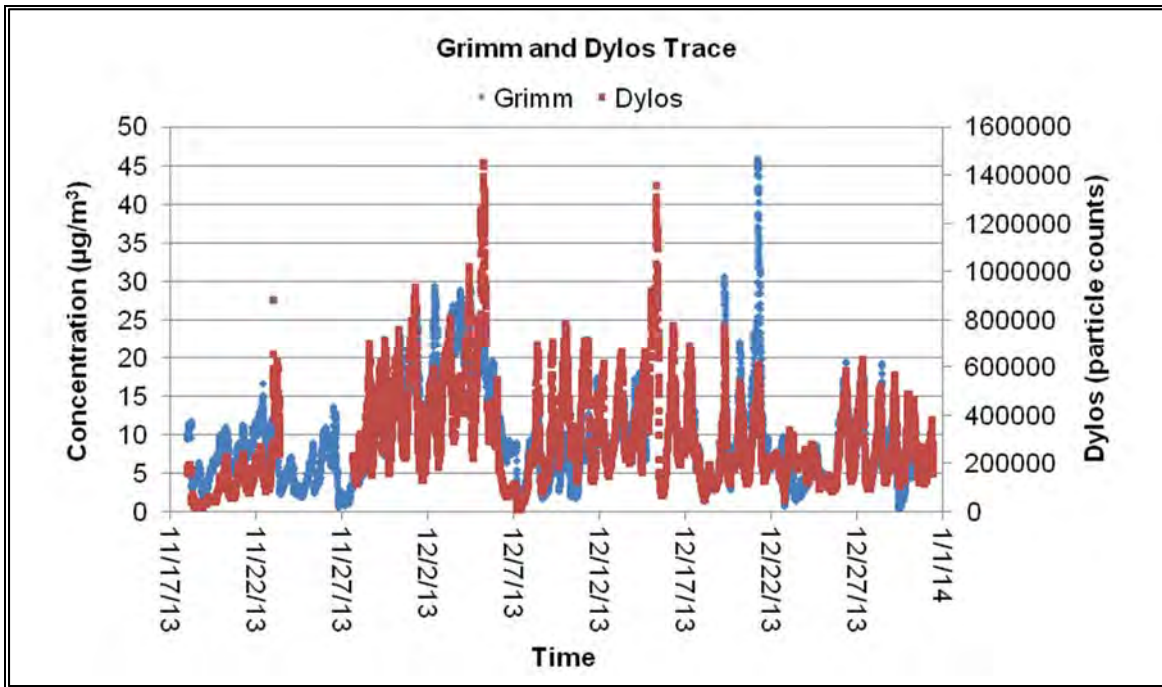
**Figure 3.4.1-1.** Grimm data and Dylos data over time.

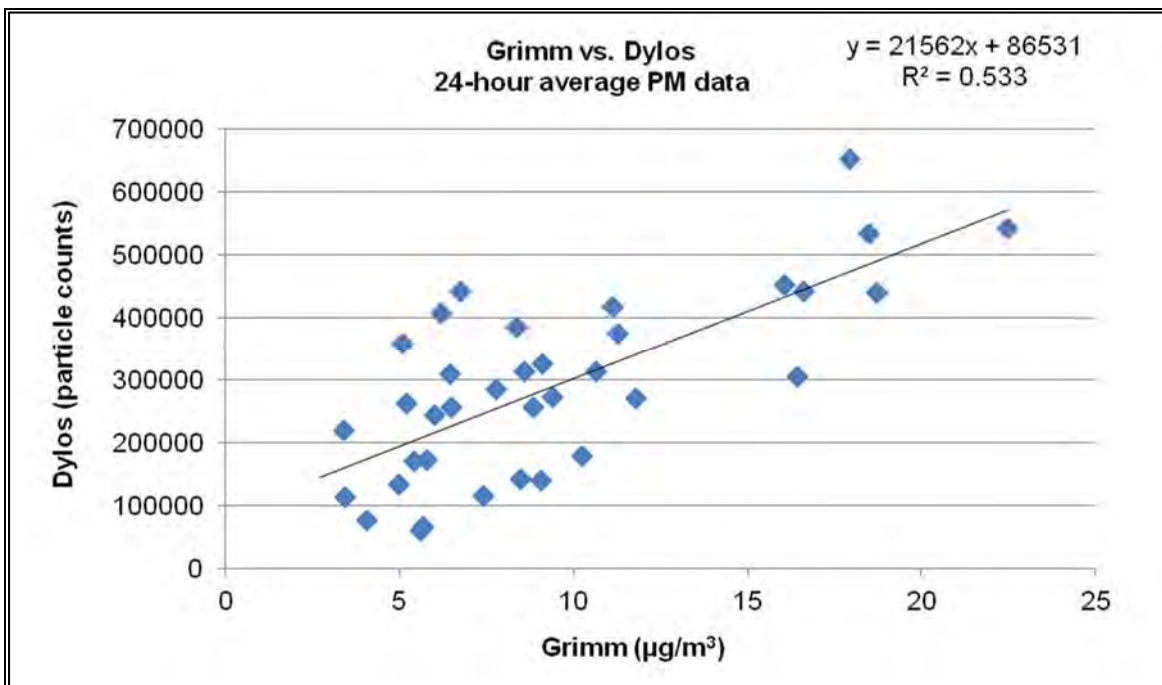
**Figure 3.4.1-2.** 24-hour time-averaged PM data comparing the Grimm reference sampler with the Dylos DC1100 PM sensor.

different units on dramatically different scales. This comparison is further explored quantitatively with the DC1100 24-hour averaged data plotted against the Grimm reference data (Figure 3.4.1-2) as well as temperature (Figure 3.4.1-3) and RH (Figure 3.4.1-4). The 24-hour average data suggest a strong correlation with the Grimm reference data. No correlation with temperature was observed while a potential correlation with humidity was evident.

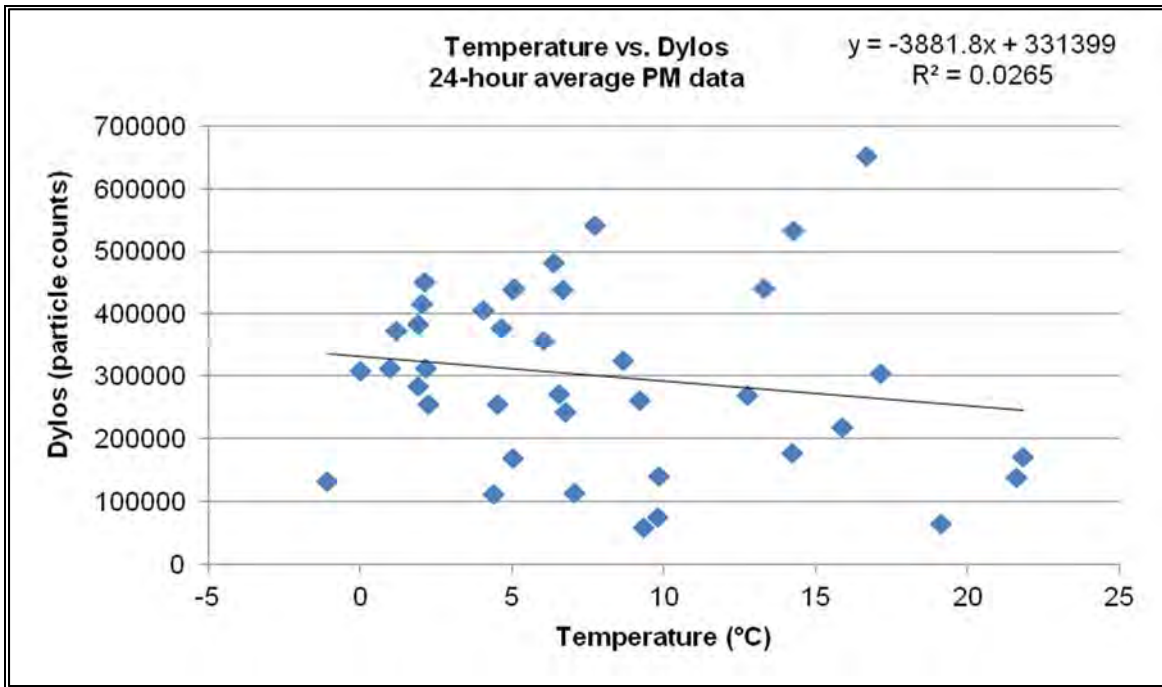
**Figure 3.4.1-3.** Temperature vs. Dylos 24-hour averaged data.

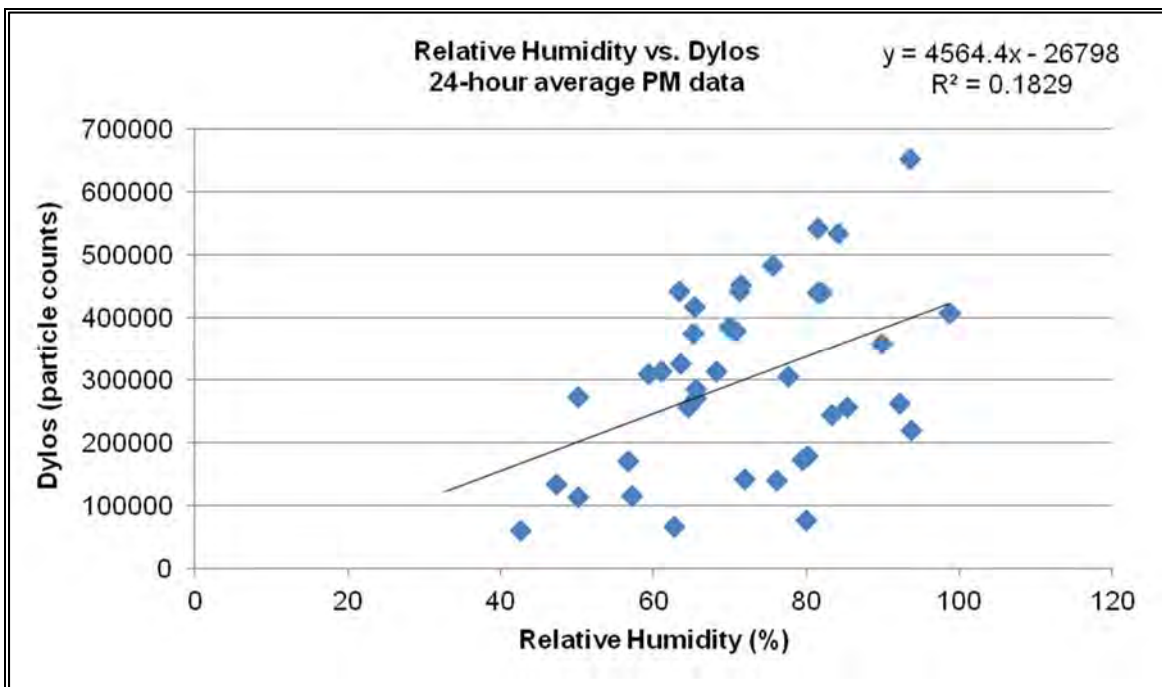
**Figure 3.4.1-4.** RH vs. Dylos 24-hour averaged data.

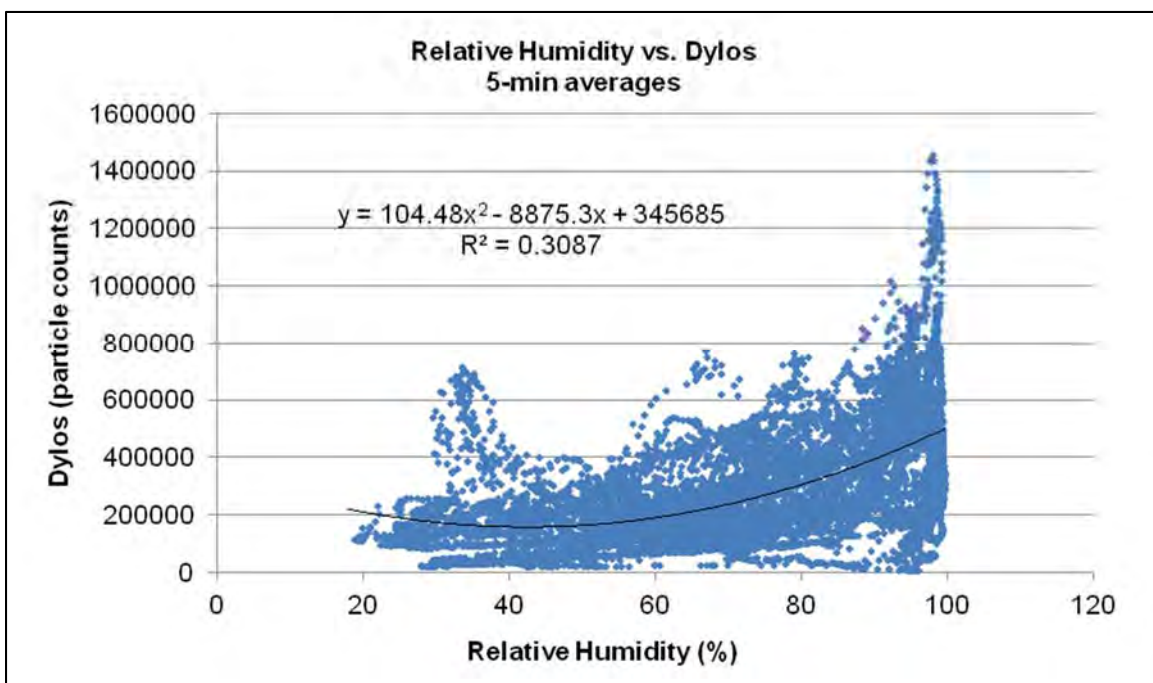
**Figure 3.4.1-5.** RH vs. Dylos (5-min averages).

RH fluctuates over the course of a day, necessitating a further look at the correlation between RH and sensor response at a 5-min averaged time resolution (Figure 3.4.1-5). The Dylos signal showed increased variability at high humidity. The upper bound of this variability appears to increase exponentially with RH. The production of artificially high results in the presence of high RH is a well-documented phenomenon with optically based particulate monitors<sup>11</sup>. As such, all data at RH greater than 95% were removed.

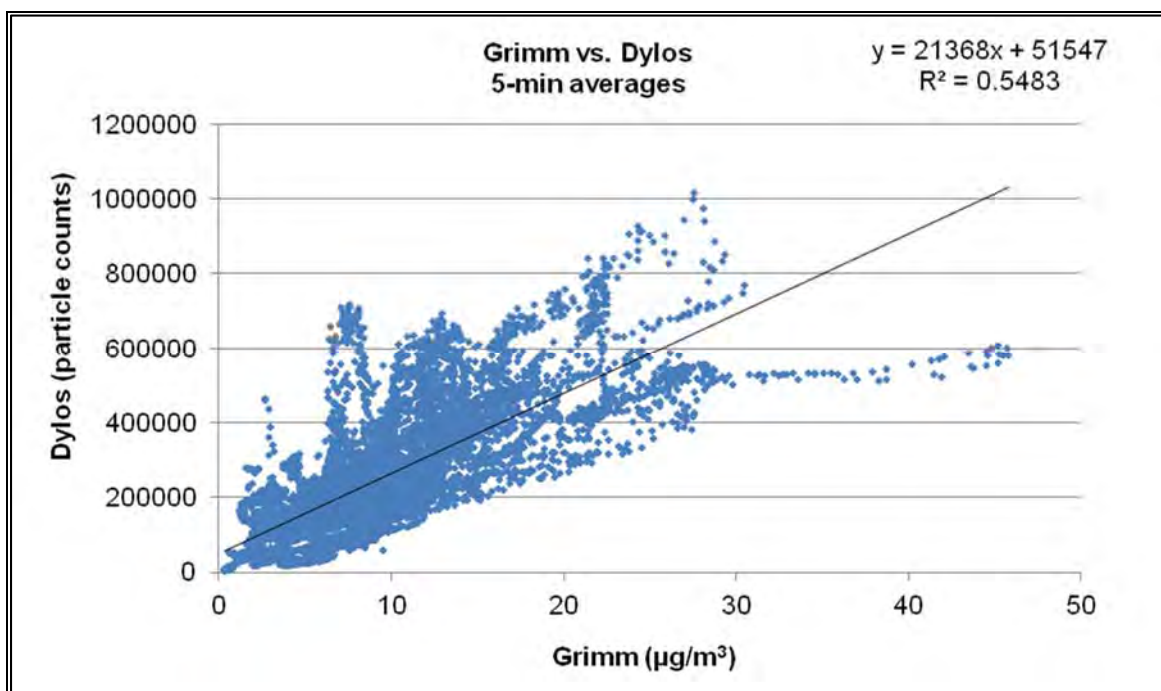
**Figure 3.4.1-6.** Grimm vs. Dylos (5-min averages).

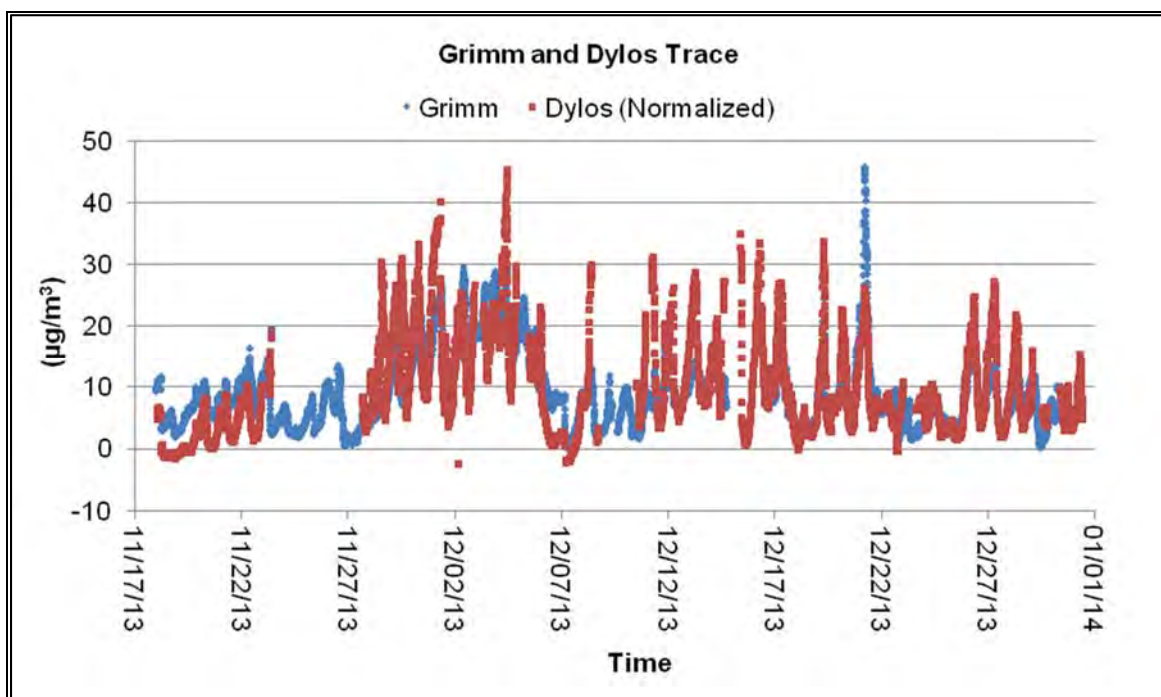
**Figure 3.4.1-7.** Grimm and normalized Dylos data (5-min averages) against time.

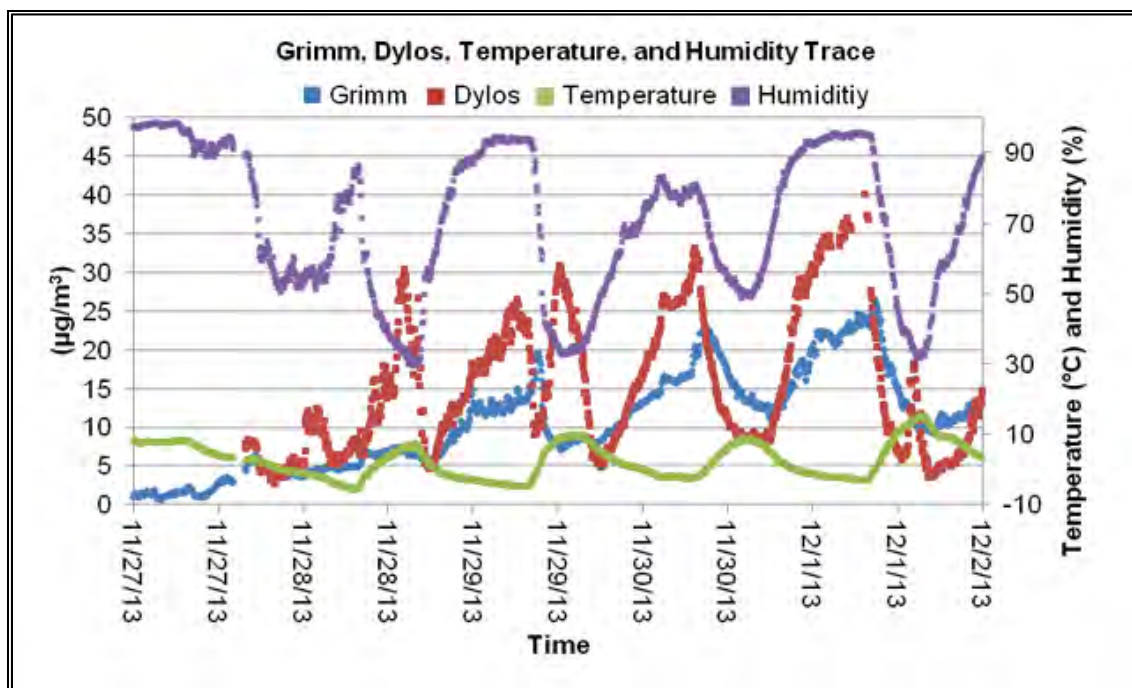
Figure 3.4.1-8. Dylos, Grimm, Temperature, and RH from November 27 to December 2, 2013.

A closer look at the data reveals discrepancies between the Dylos (normalized) and the Grimm FEM data (Figure 3.4.1-8). On the afternoons of November 28, November 29, and December 1, 2013, the Dylos showed significant and protracted spikes in particulates, whereas the Grimm indicated only very modest increases. The three spikes appear to correlate with a sudden increase in temperature and a drop in humidity, but this pattern was not consistently repeated in the rest of the data. These spikes might be related to meteorological phenomena that were not tracked in this experiment, but which feature sudden temperature and humidity changes. It is also possible that these spikes indicate a localized combustion event (e.g., idling

diesel engine) that produced large numbers of low-density particles affecting the device. Even so, we have no record of such an event occurring and it is only speculation as to one possible explanation.

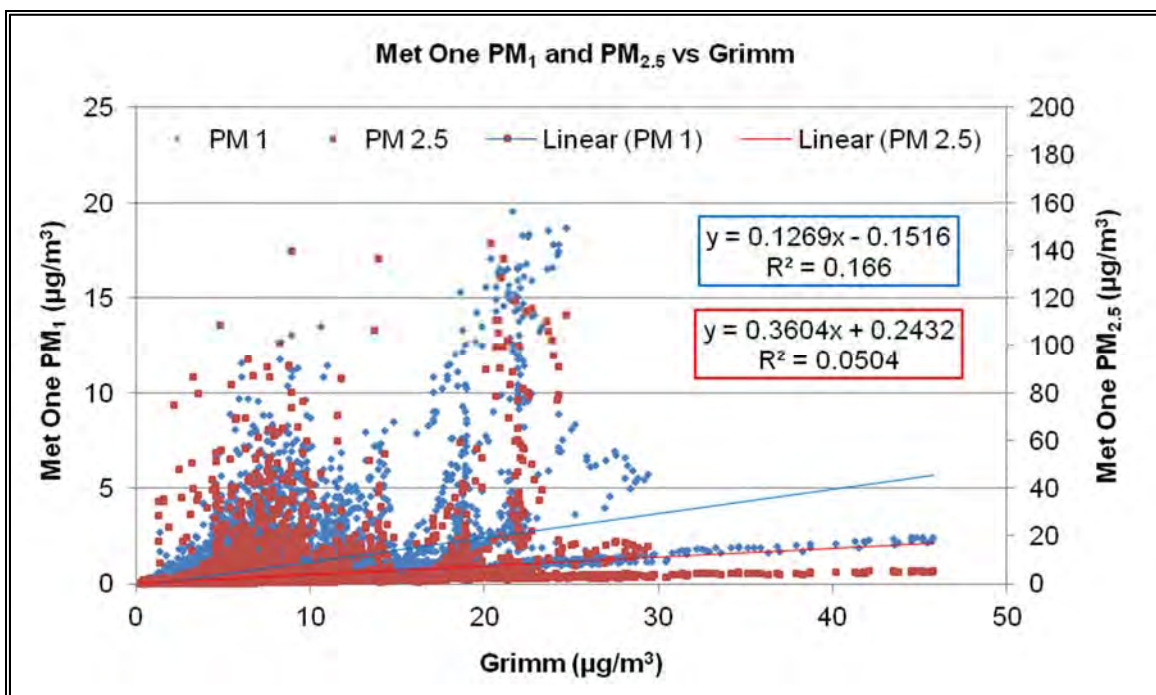
**Figure 3.5.1-1.** Grimm vs. Met One Model 831 PM<sub>1</sub> and PM<sub>2.5</sub> (5-min averages).

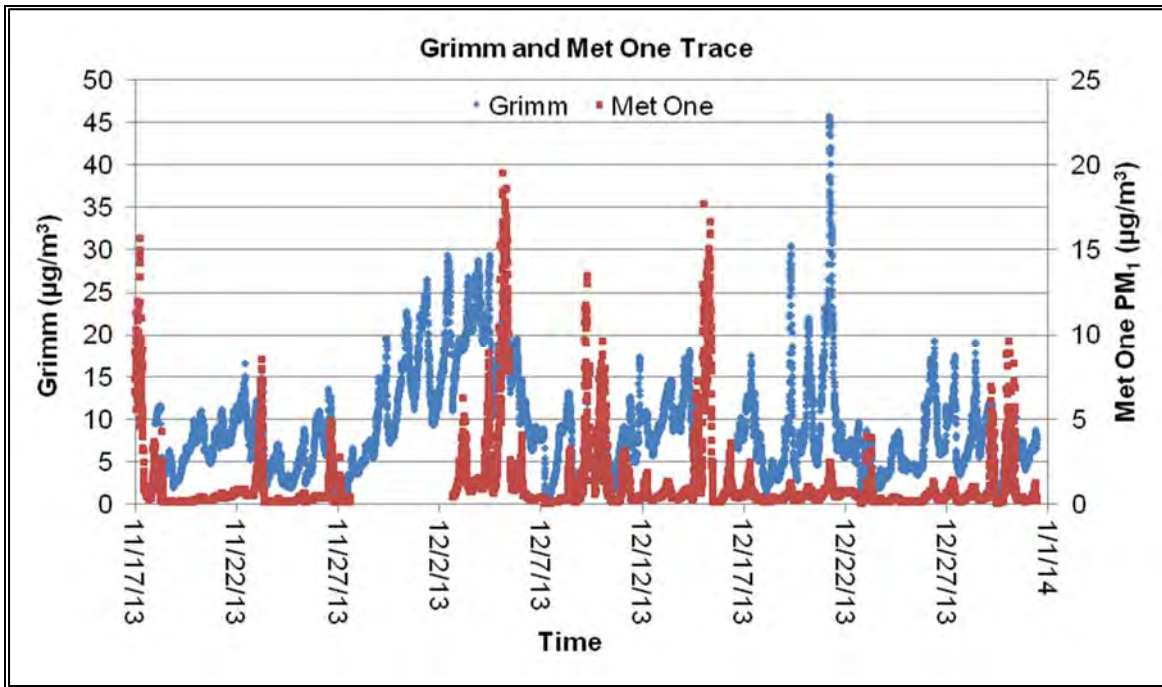
**Figure 3.5.1-2.** Grimm data and Met One Model 831 data over time.

Figure 3.5.1-2 shows that the responses from the Grimm and the Met One compare well. This comparison is further illustrated using Met One 24-hour averaged data plotted against the Grimm reference data (Figure 3.5.1-3) as well as temperature (Figure 3.5.1-4) and RH (Figure 3.5.1-5). The 24-hour averaged data suggests a correlation with the Grimm reference data, no correlation with temperature, and a strong correlation with humidity.

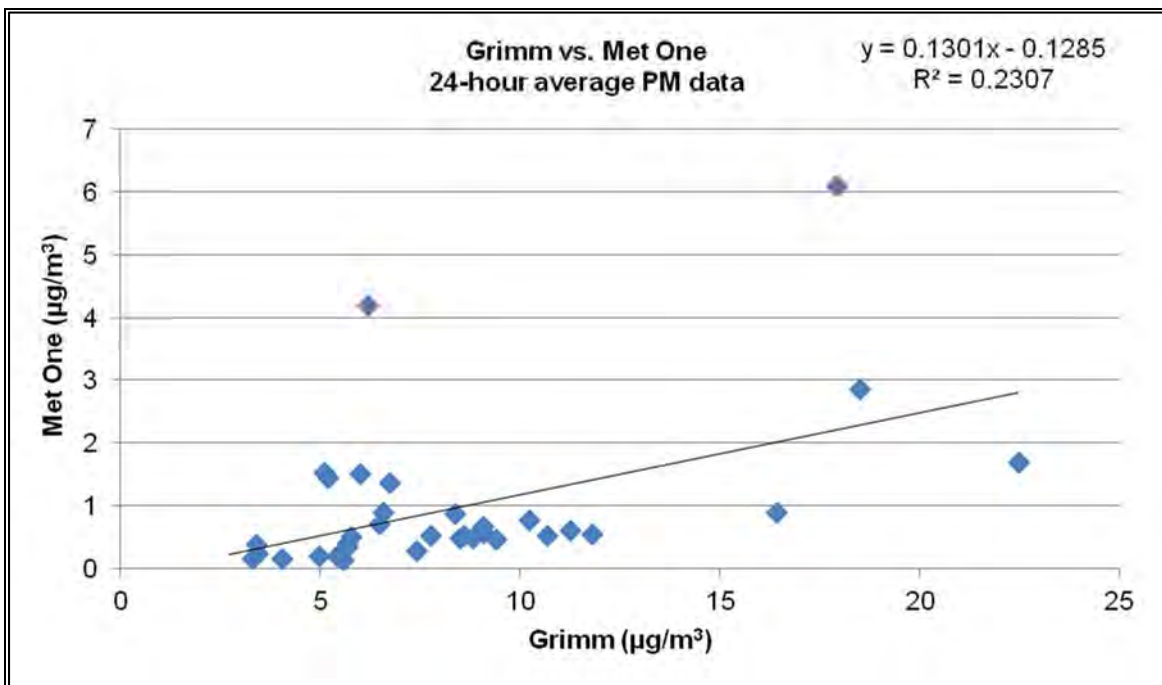
**Figure 3.5.1-3.** 24-hour time-averaged PM data comparing the Grimm reference sampler with the Met One Model 831 PM sensor.

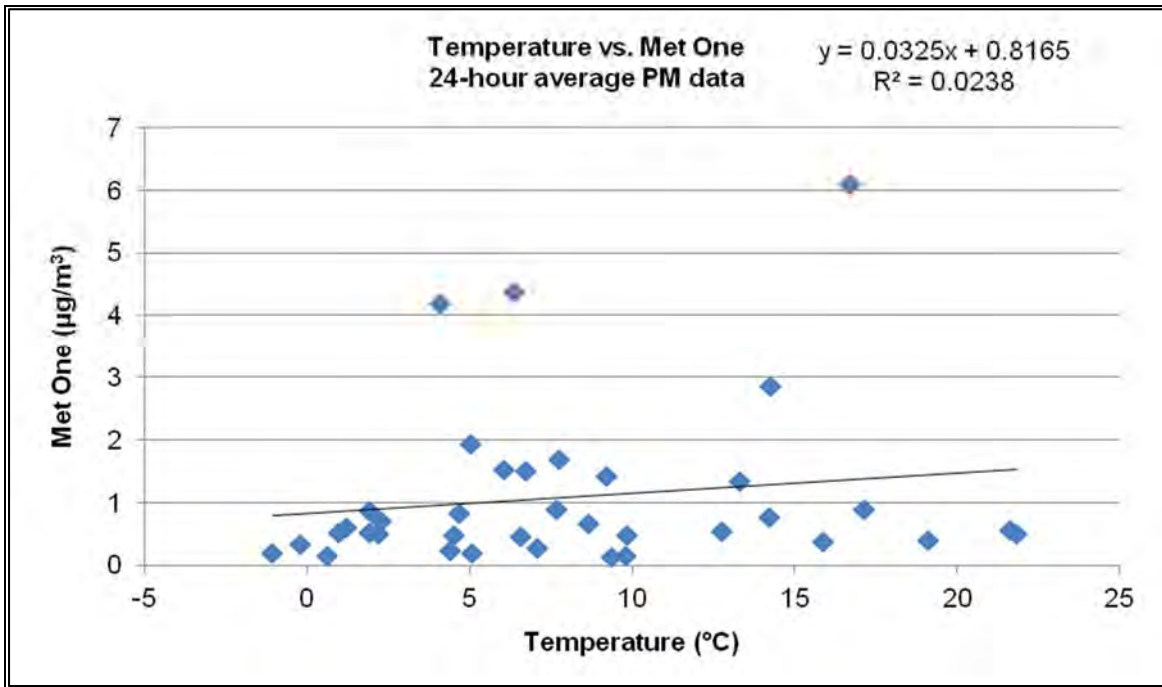
**Figure 3.5.1-4.** Temperature vs. Met One Model 831 24-hour averaged data.

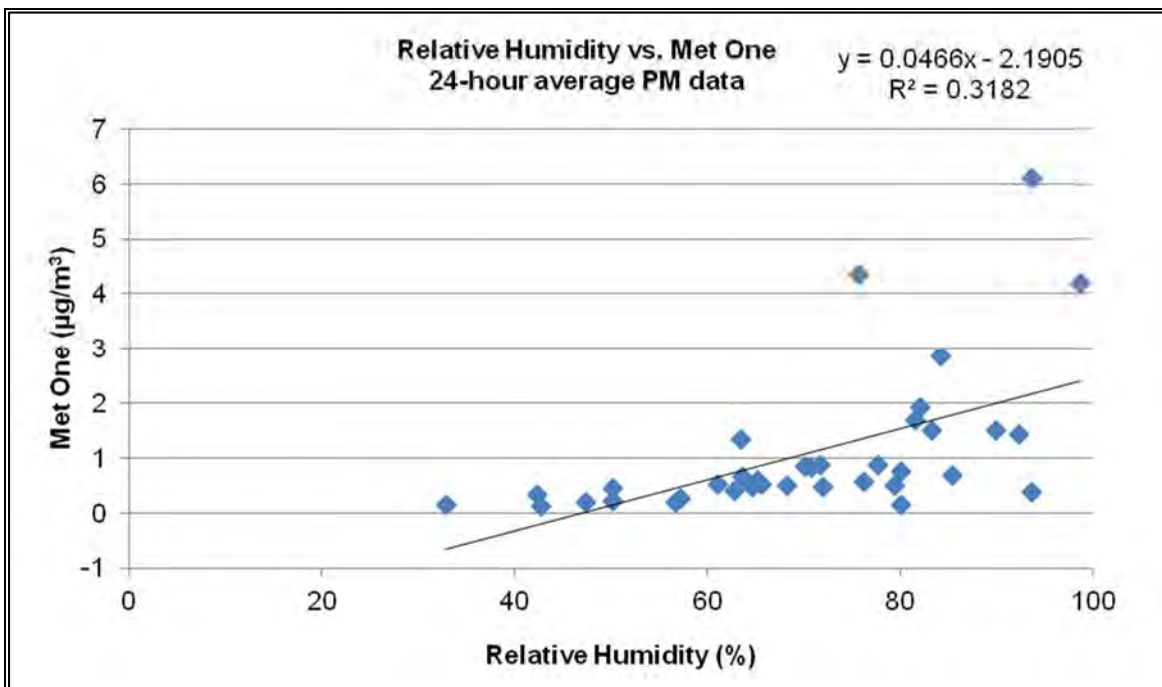
**Figure 3.5.1-5.** RH vs. Met One Model 831 24-hour averaged data.

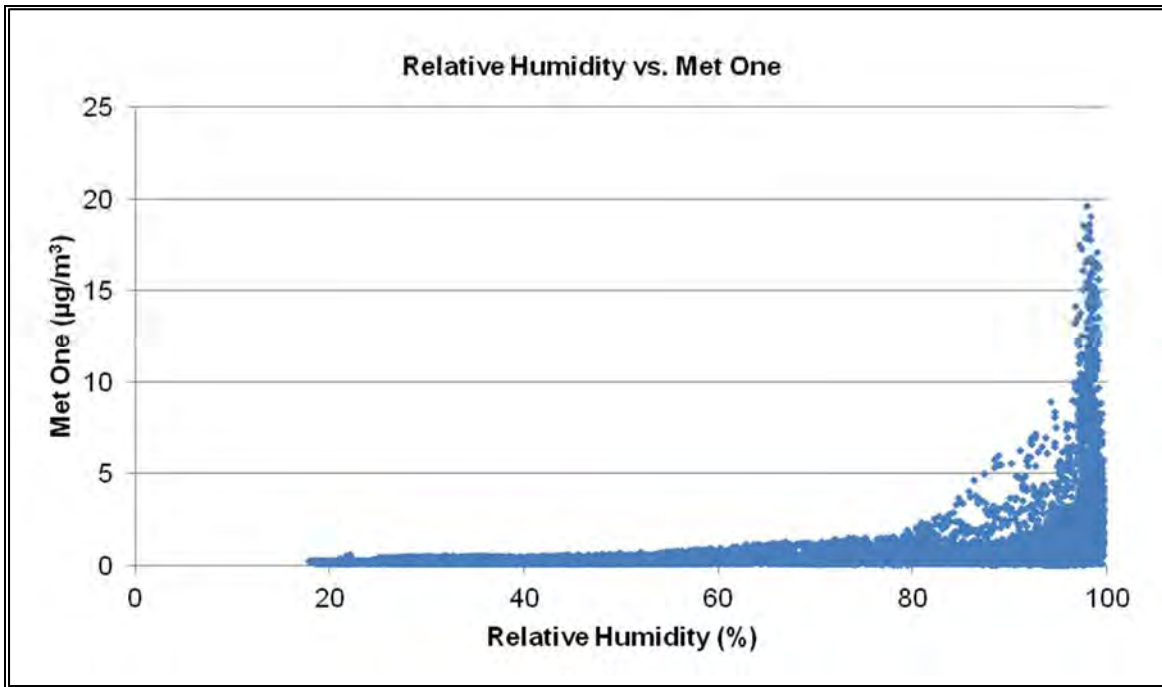
Figure 3.5.1-6. RH vs. Met One Model 831 (5-min averages).

As RH naturally fluctuated over the course of any given day, further investigation into the correlation between humidity and sensor response at the 5-min averaged time resolution was necessary. These results are shown in Figure 3.5.1-6. The Met One signal showed increased variability at high humidity. The upper bound of this variability appears to increase exponentially with rising relative humidity. As a result, all data taken at times when the relative humidity was greater than 90% were removed.

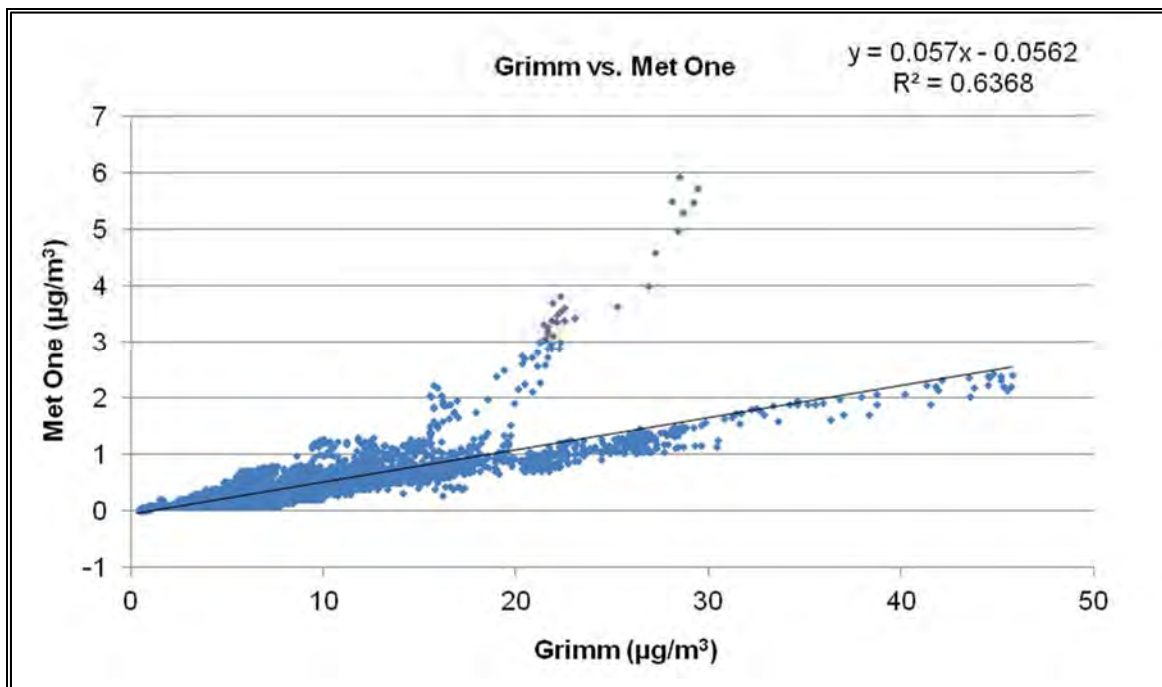
Figure 3.5.1-7. Grimm vs. Met One Model 831 (5-min averages).

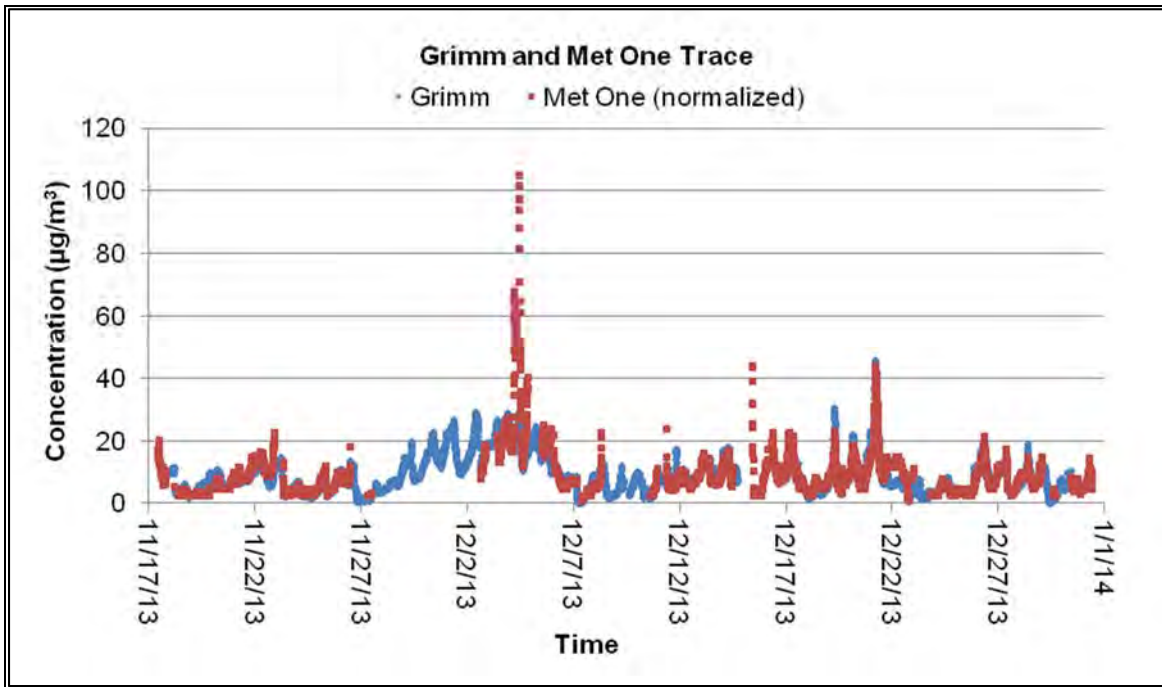
**Figure 3.5.1-8.** Grimm and normalized Met One Model 831 data (5-min averages) against time.

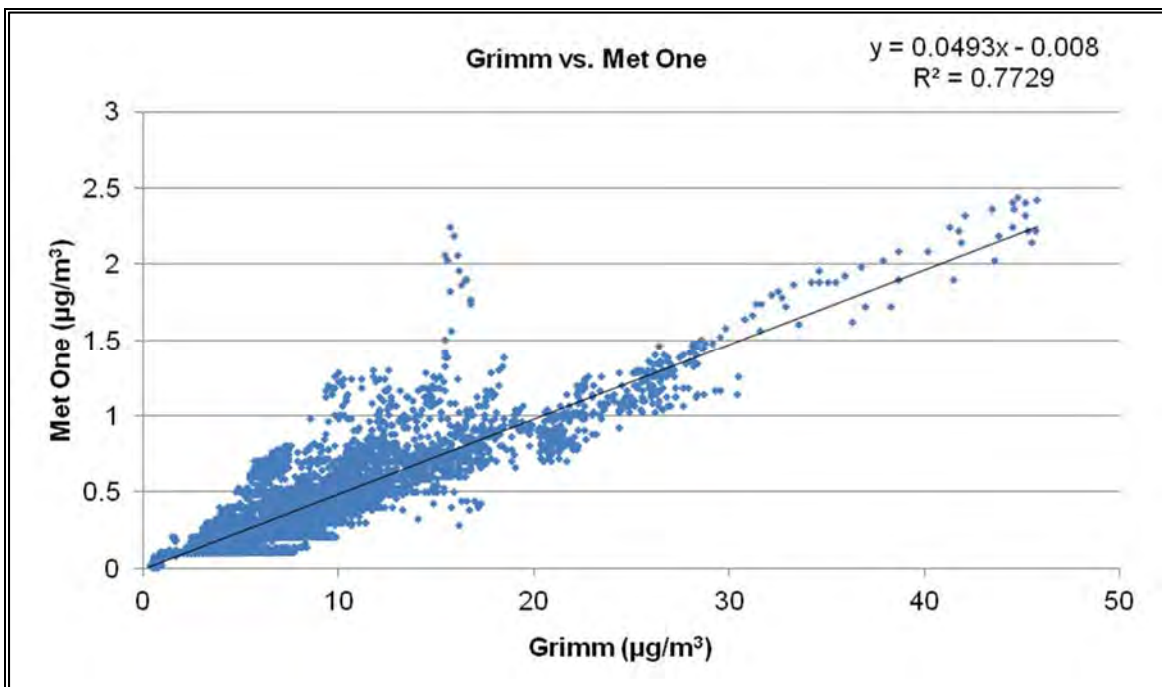
**Figure 3.5.1-9.** Grimm and Met One Model 831 data (5-min averages) with data from 04:00 to 14:00 on December 4 removed.

The spike seen on December 4, 2013 straddles data that were removed because they were taken at greater than 90% RH. It is possible there was an unrecorded drizzle or light rain event during this time that might have caused the spike. Consequently, all data collected between 04:00 and 14:00 on December 4, 2013, were removed. The scatter plot of the Met One data vs. the Grimm was remade in Figure 3.5.1-9 and renormalized in Figure 3.5.1-10.

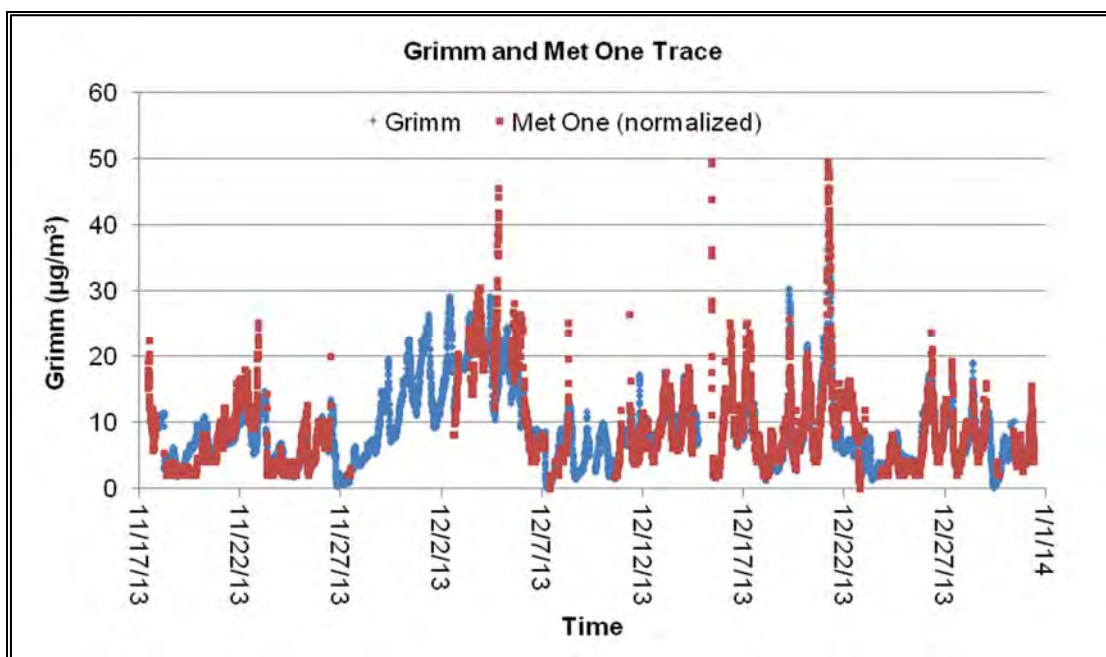
**Figure 3.5.1-10.** Grimm and renormalized Met One Model 831 data against time (5-min averages).

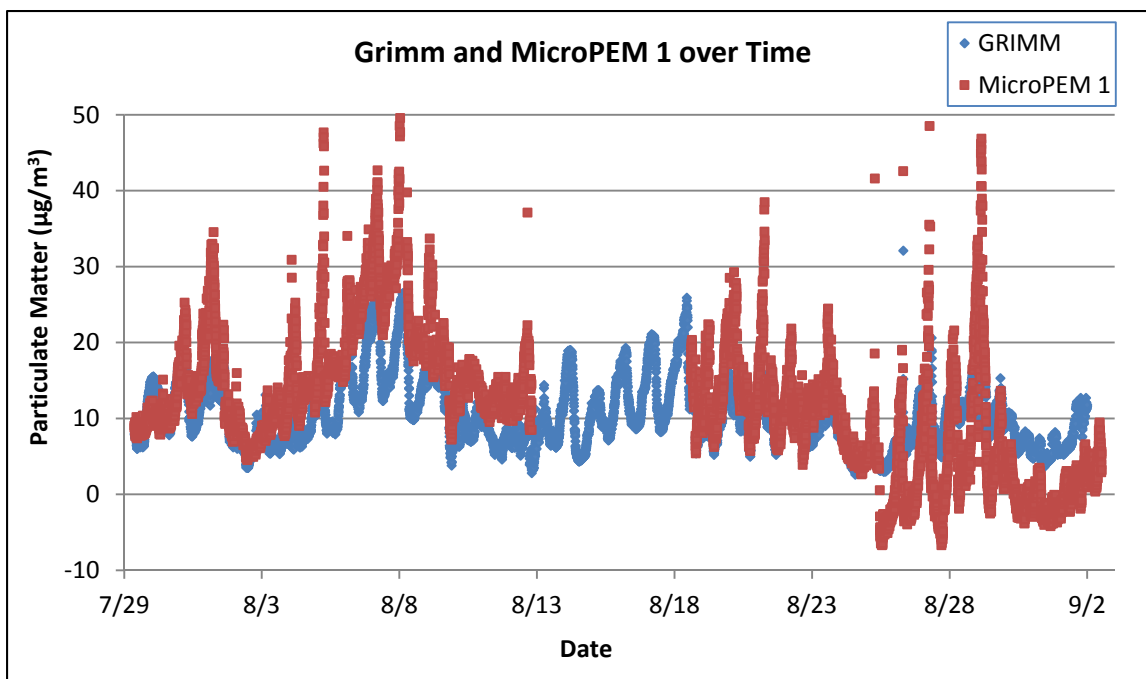
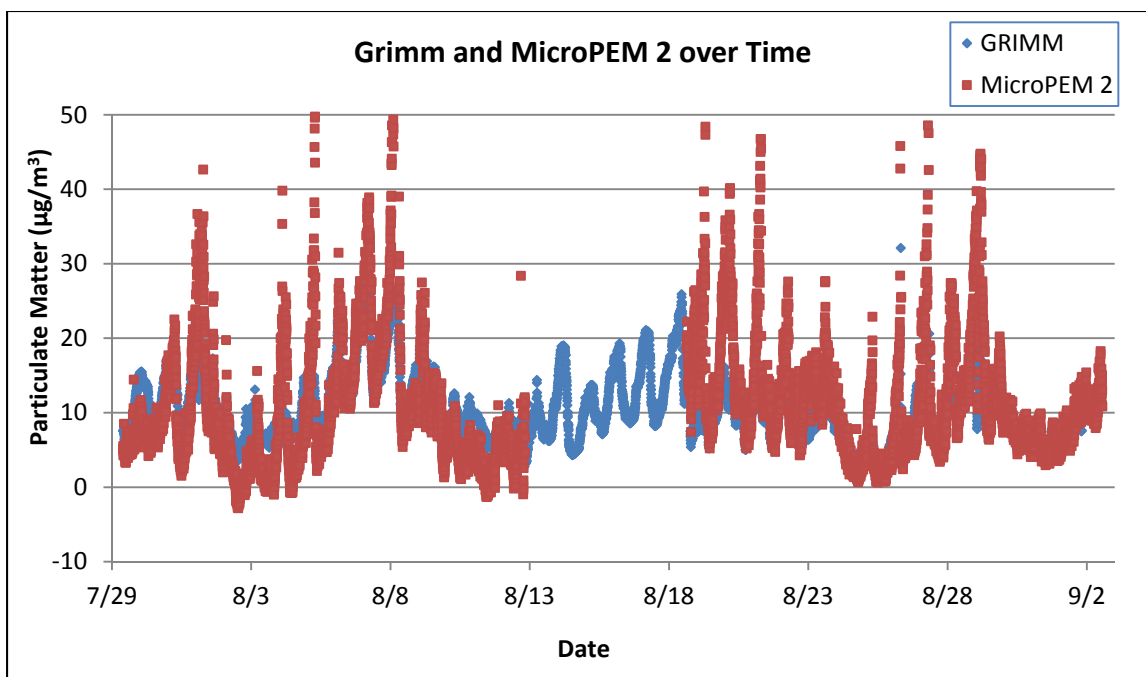
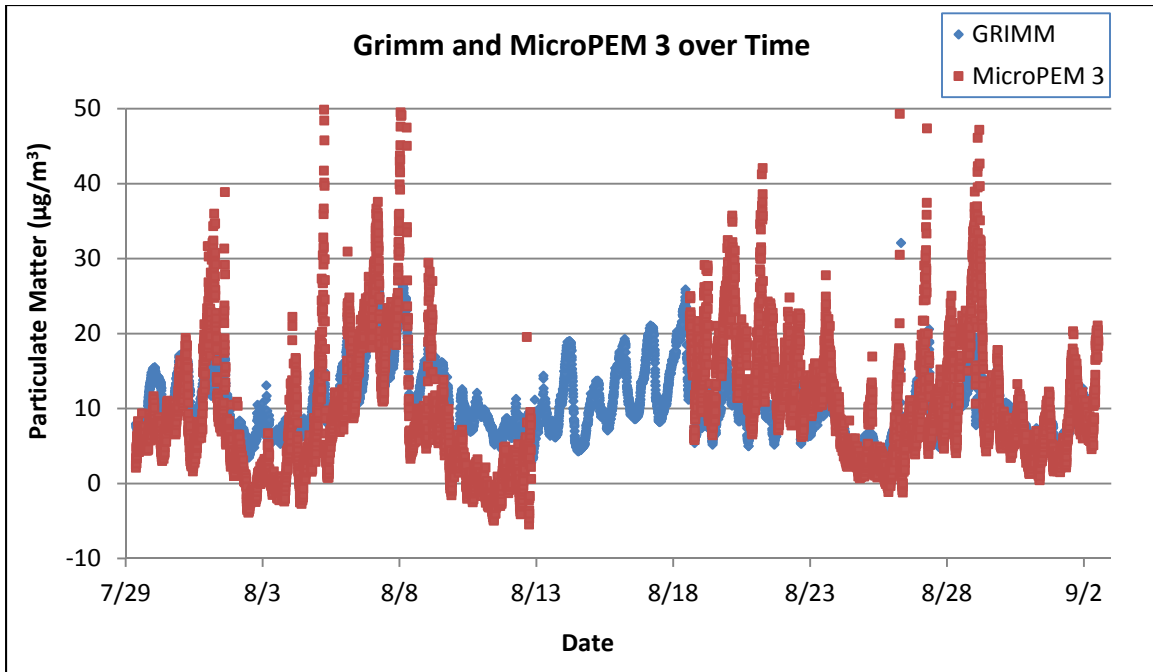
**Figure 3.6.1-1.** A trace of MicroPEM unit 1 and the Grimm over time.

**Figure 3.6.1-2.** A trace of MicroPEM unit 2 and the Grimm over time.

**Figure 3.6.1-3.** A trace of MicroPEM unit 3 and the Grimm over time.

Raw data was inspected visually for large outliers. Less than ten outliers were found and were removed manually. These outliers were highly fluctuating positive and negative signal responses, which appeared to be possibly electrical noise in nature. Data was then compiled into 5-minute block averages. Traces of each MicroPEM response over time overlaid with a trace of the Grimm over time are shown in Figure 3.6.1-1, Figure 3.6.1-2, and Figure 3.6.1-3.

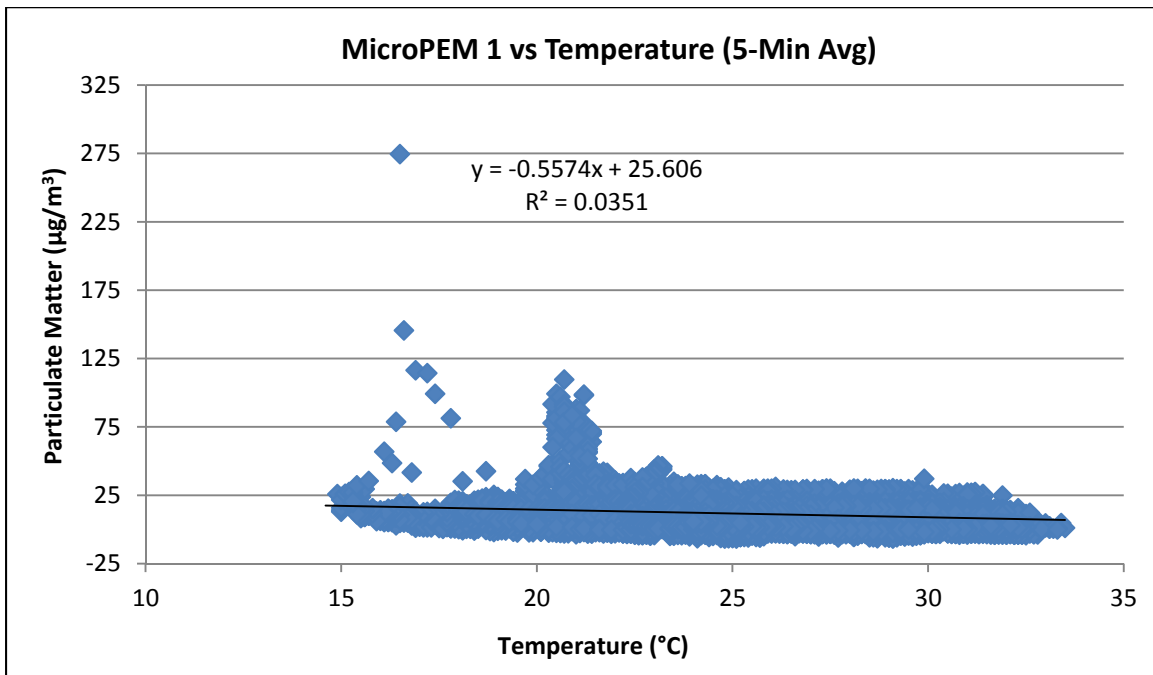
**Figure 3.6.1-4.** Scatterplot of MicroPEM 1 vs Temperature.

Figure 3.6.1-4 demonstrates that there is no correlation between the performance of MicroPEM 1 and temperature. This is in sharp contrast to the experiments conducted in the winter of 2013-2014 during which strong correlations were reported. Figure 3.6.1-5 demonstrates that relative humidity has no effect on the MicroPEM's signal below 90% RH. There is a significant cluster of aberrantly high data points when RH > 94%.

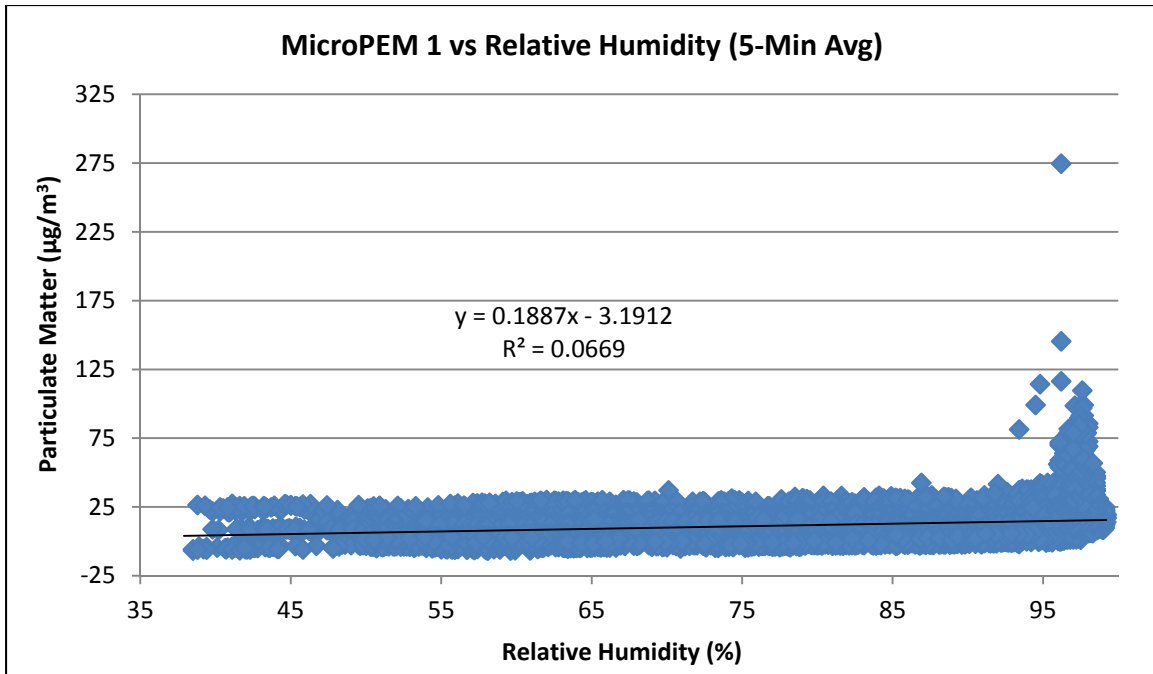
**Figure 3.6.1-5.** Scatterplot of MicroPEM 1 vs Relative Humidity

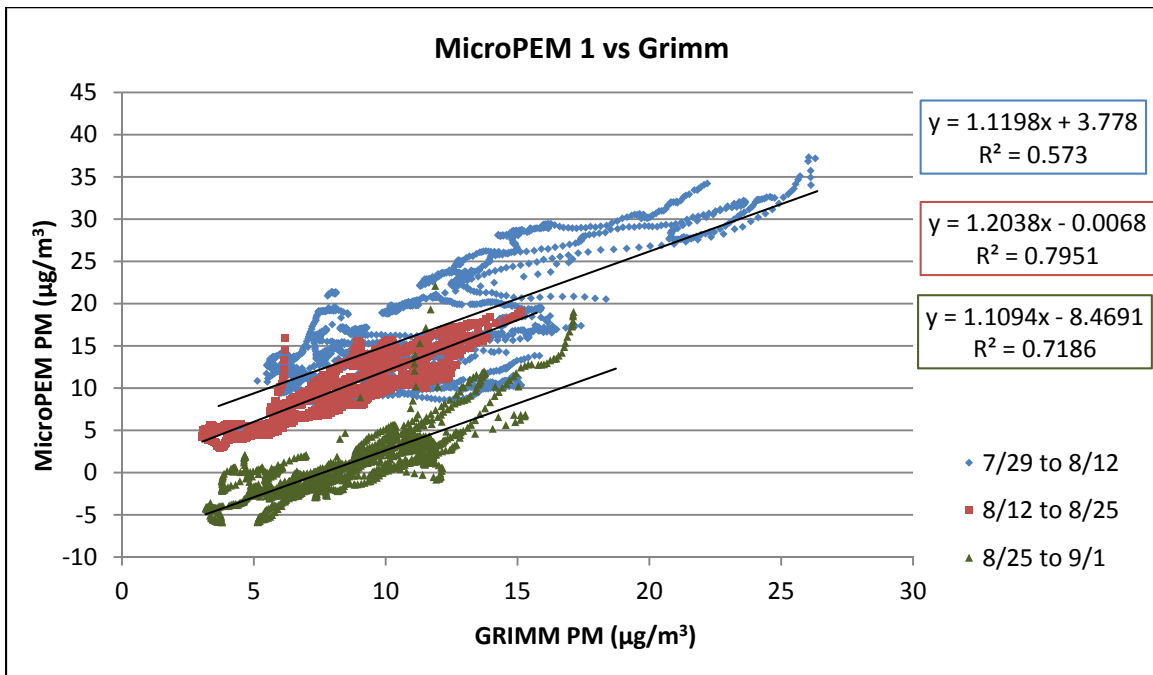
**Figure 3.6.1-6.** Scatterplot of MicroPEM 1 vs the Grimm. The data has been divided into three time periods following zeroing of the unit.

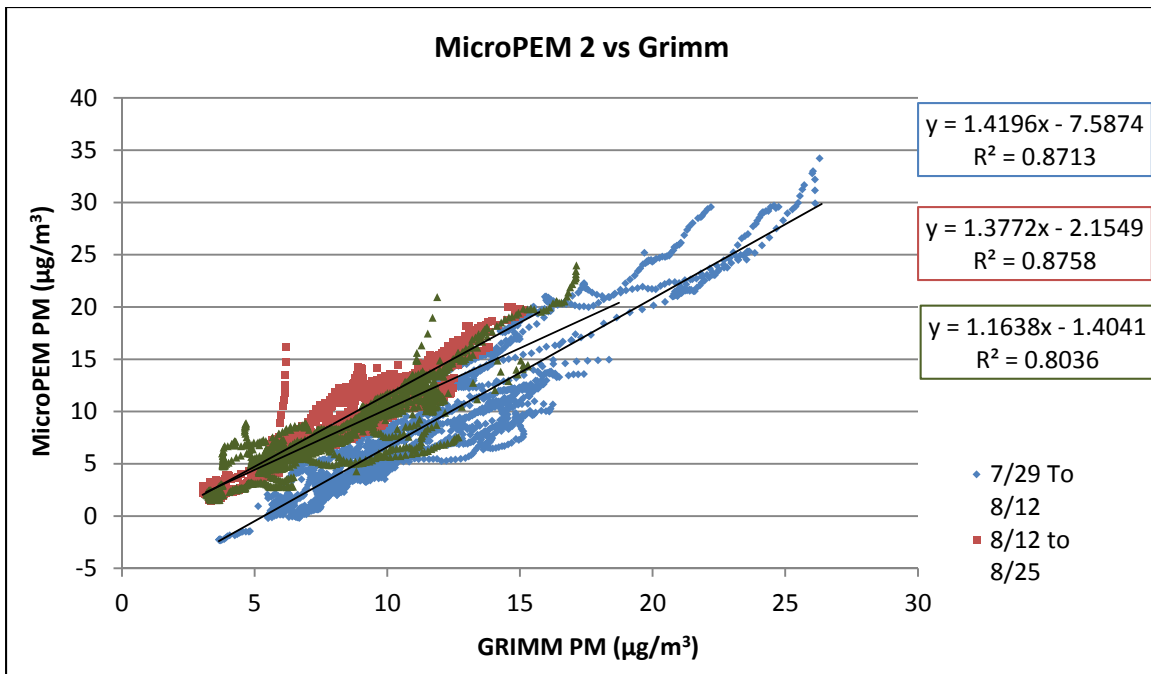
**Figure 3.6.1-7.** Scatterplot of MicroPEM 2 vs the Grimm. The data has been divided into three time periods following zeroing of the unit.
