# **Evaluation of Field-deployed Low Cost PM Sensors**

**Ron Williams**  
National Exposure Research Laboratory  
Office of Research and Development  
U.S. Environmental Protection Agency  
Research Triangle Park, NC, USA 27711

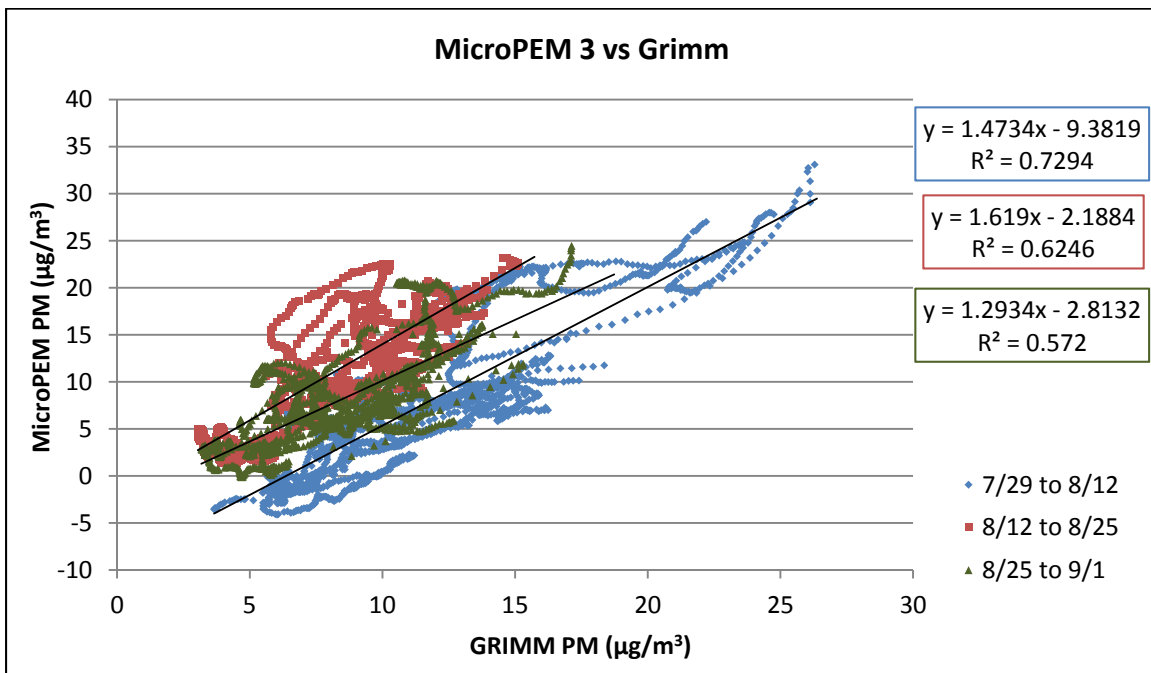
**Figure 3.6.1-8.** Scatterplot of MicroPEM 3 vs the Grimm. The data has been divided into three time periods following zeroing of the unit.

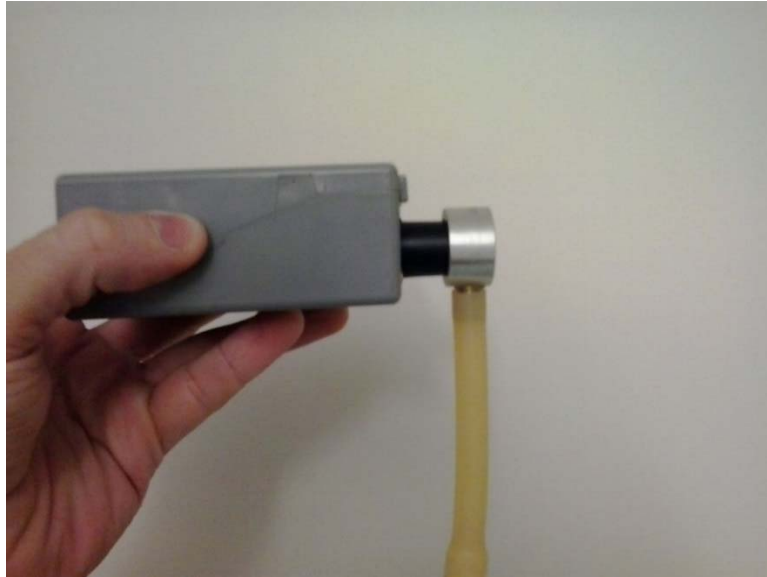
**Figure 3.6.1-9.** RTI MicroPEM with zero air filter attached.

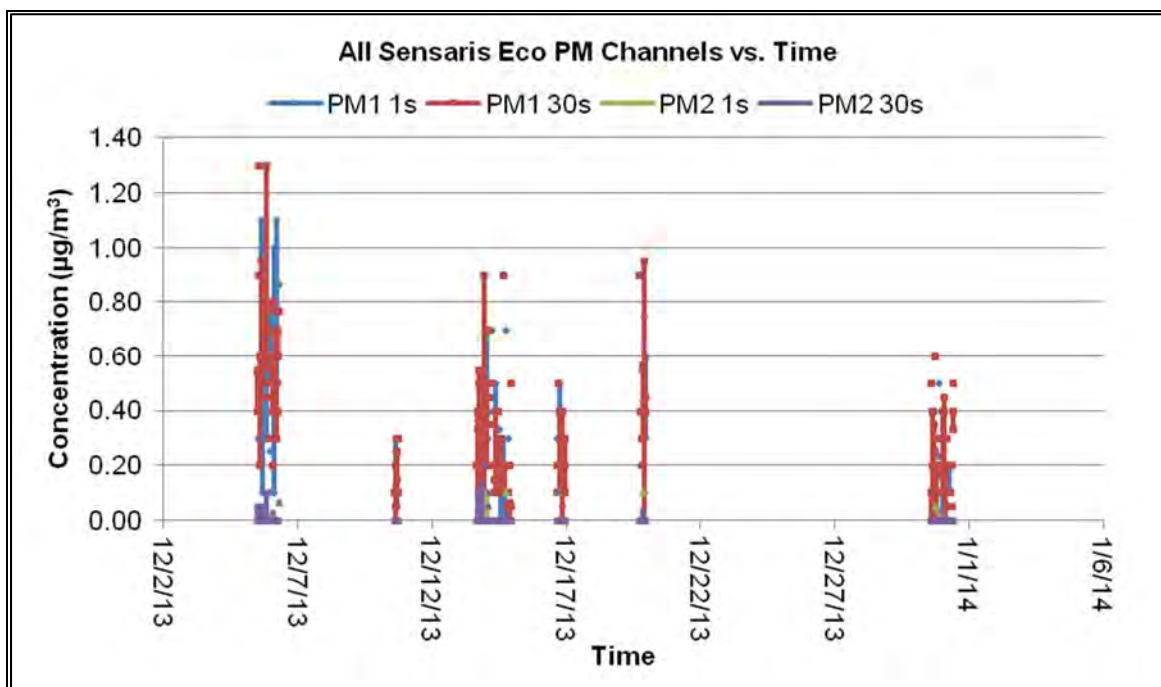
Figure 3.7.1-1. Sensaris Eco PM concentration measurements over time.

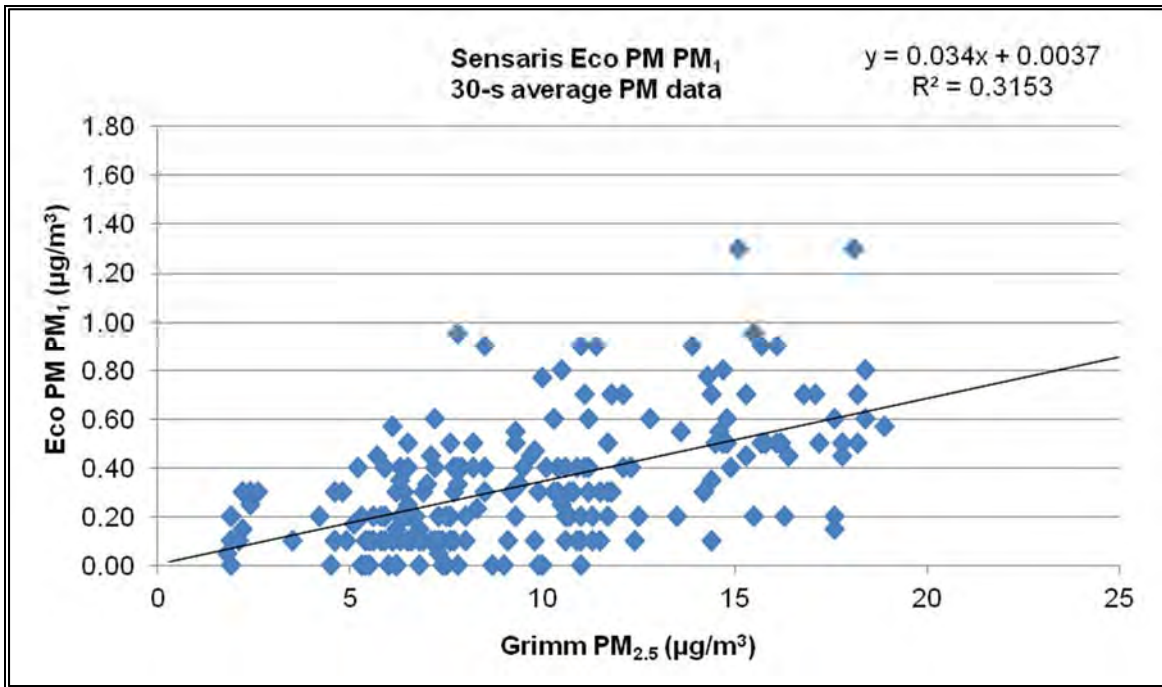
**Figure 3.7.1-2.** 30-s time-averaged PM data comparing the Grimm reference sampler with the Eco PM sensor.

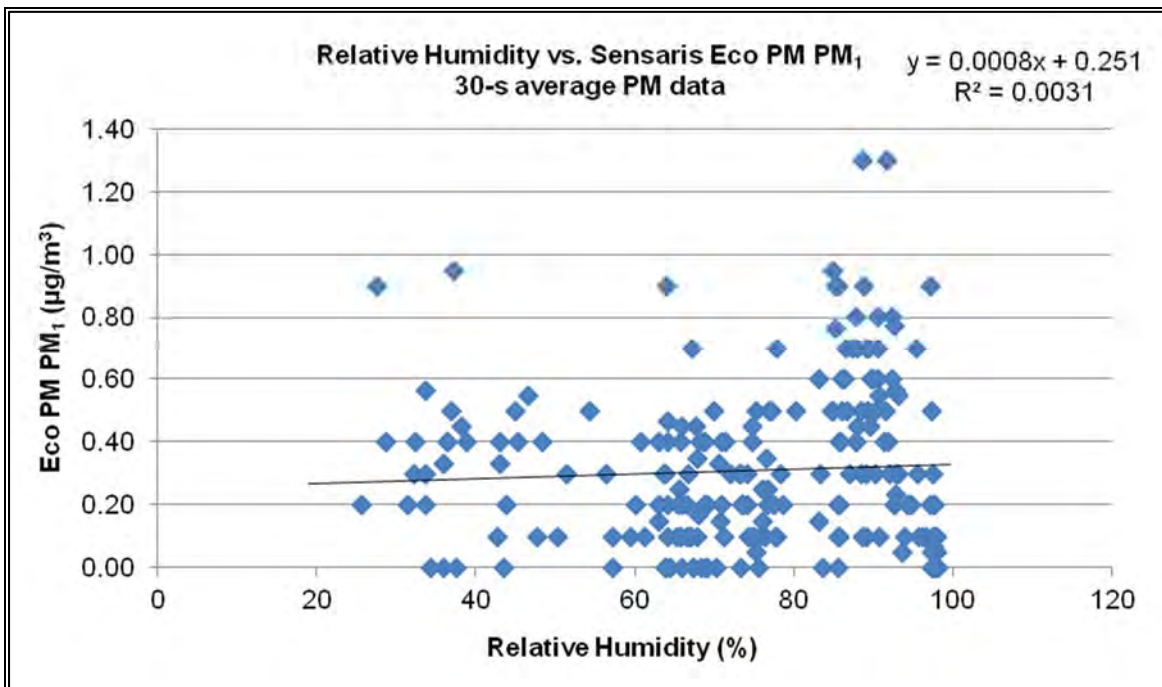
**Figure 3.7.1-3.** RH vs. Eco PM (30-s averages).

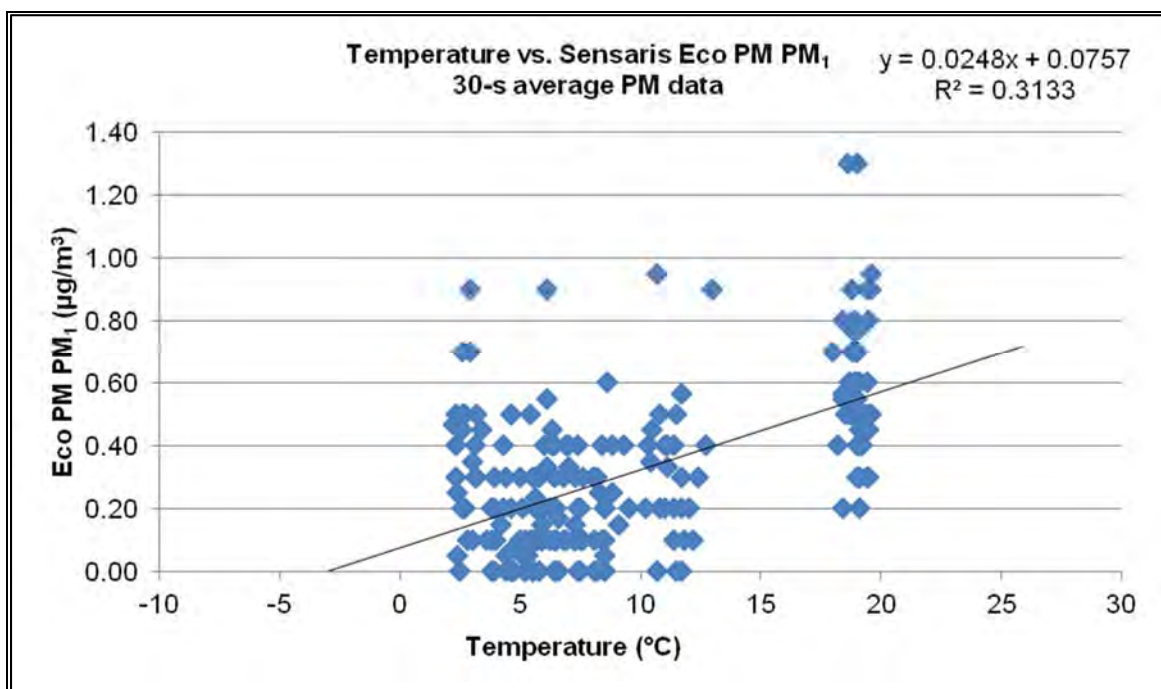
**Figure 3.7.1-4.** Temperature vs. Eco PM (30-s averages).

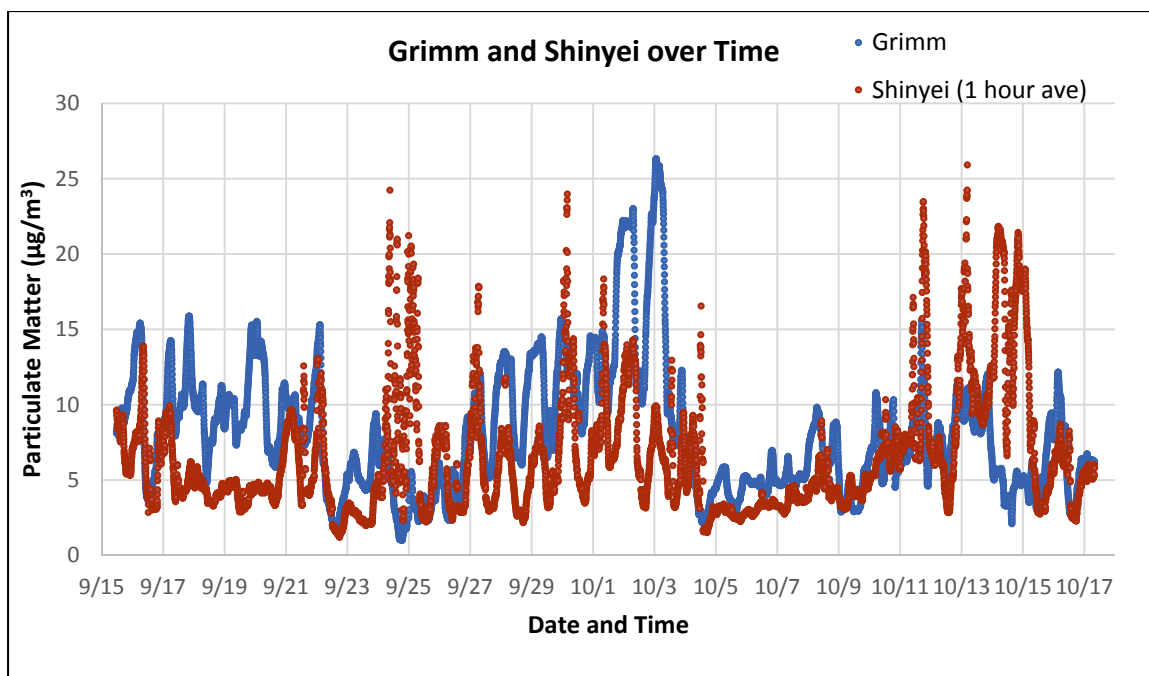
**Figure 3.8.1-1:** A trace of the Shinyei and the Grimm over time.

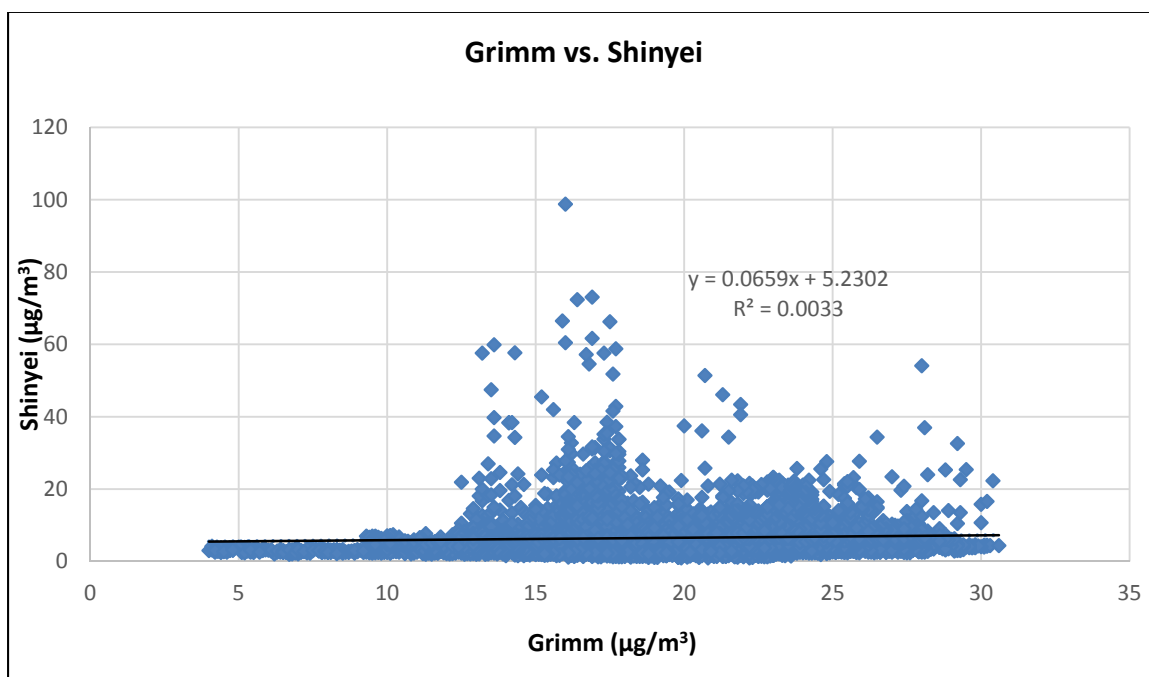
**Figure 3.8.1-2:** Grimm vs. Shinyei (5-min averages).

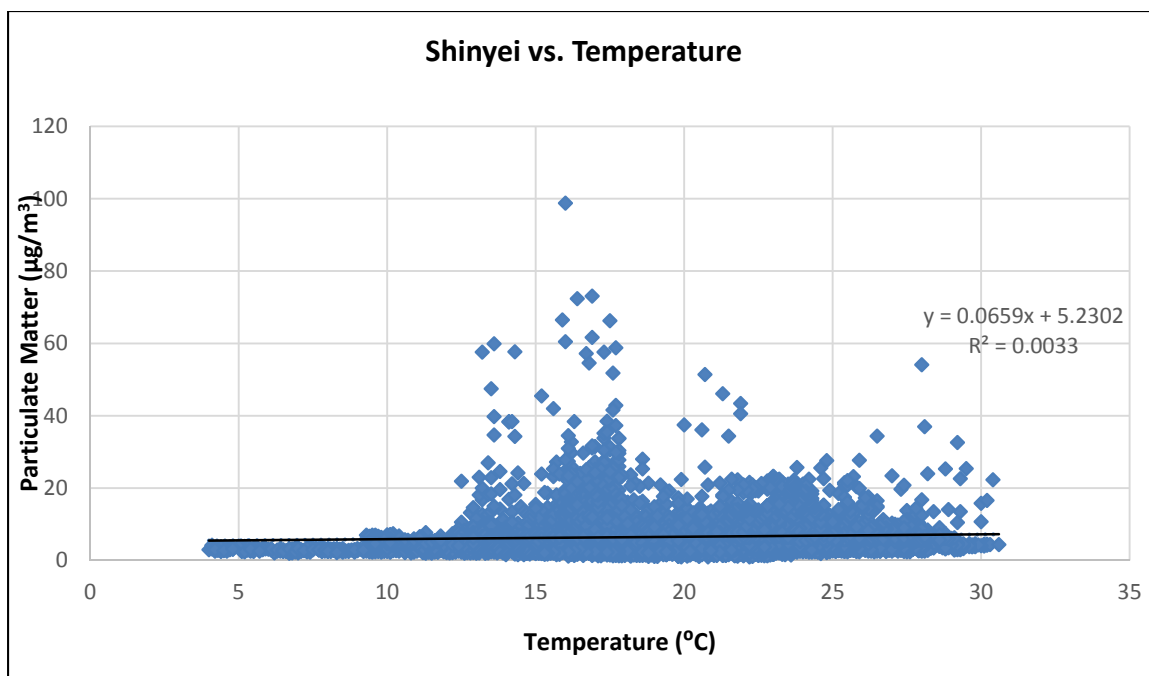
**Figure 3.8.1-3:** Scatterplot of the Shinyei vs Temperature.

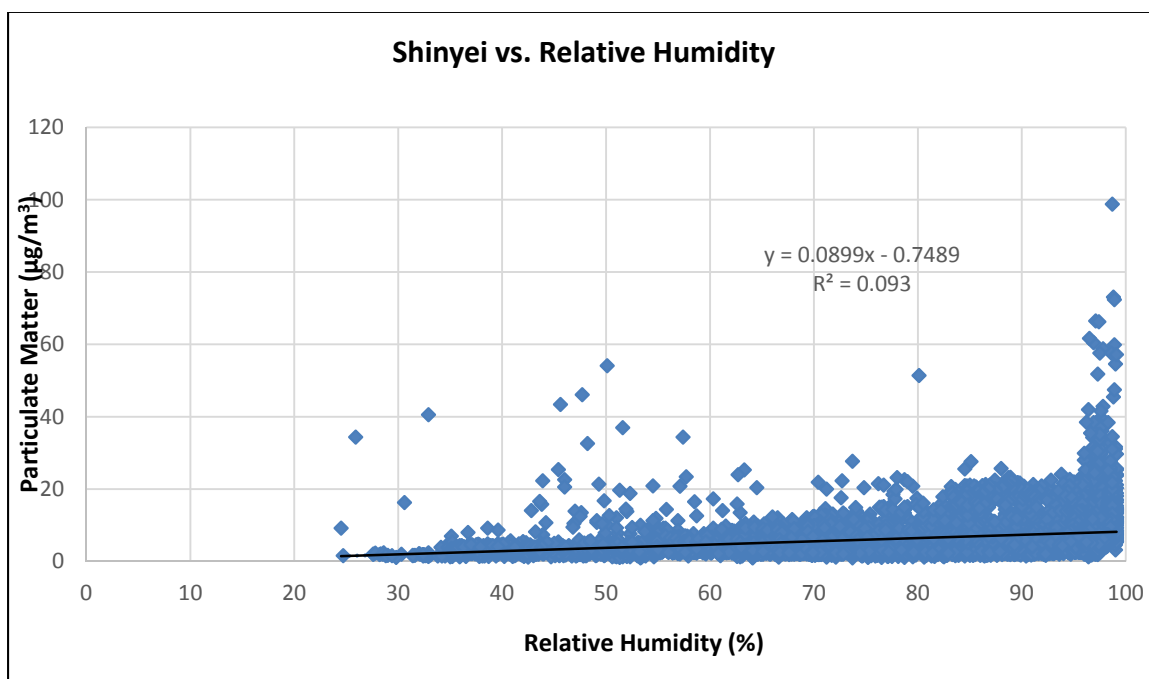
**Figure 3.8.1-4:** Scatterplot of the Shinyei vs Relative Humidity.

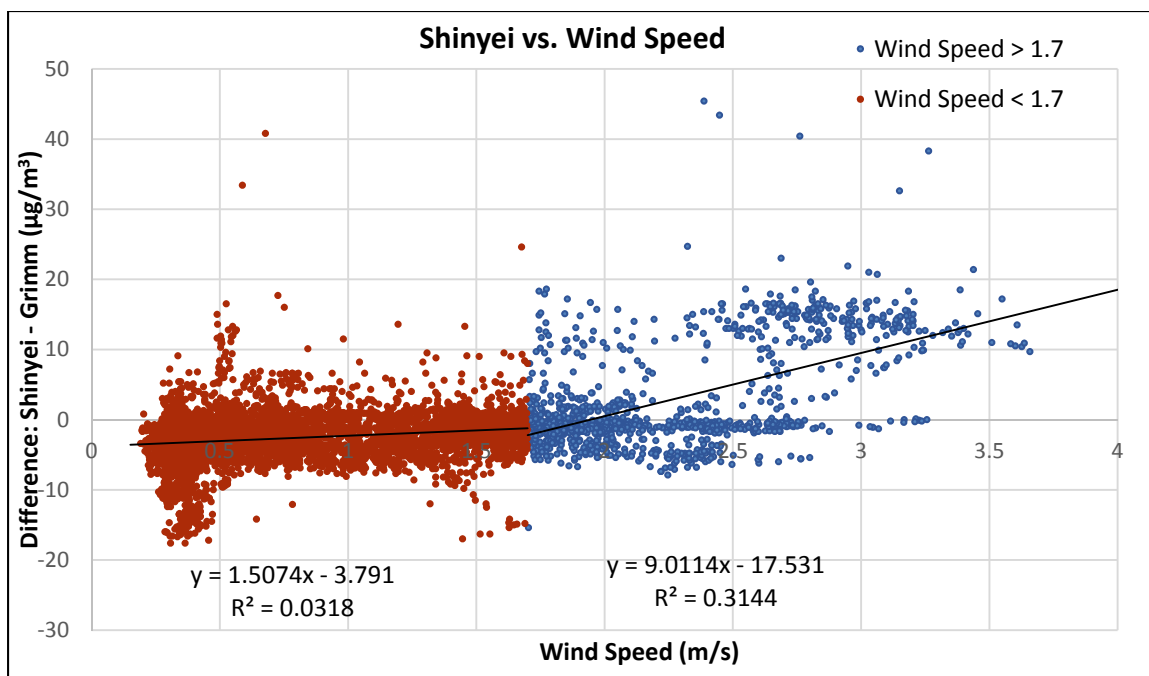
**Figure 3.8.1-5:** Scatterplot of the Shinyei vs Wind Speed. The graph is broken into two parts to illustrate the change in correlation at 1.7m/s wind speed.

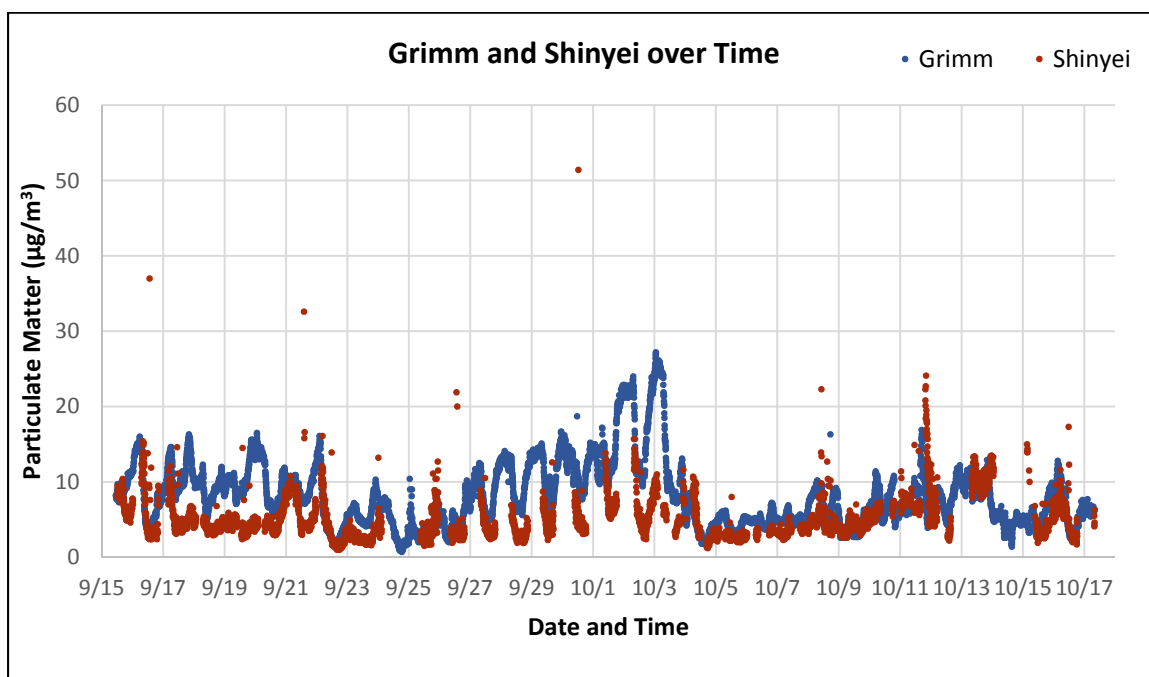
**Figure 3.8.1-6:** A trace of the Shinyei and the Grimm over time. Data affected by high humidity (>95%), winds (> 1.7m/s in a one-hour average), or within one hour of measure rainfall has been removed.

Figure 3.8.1-6 is a trace of the Shinyei data with high humidity, high wind, and rain removed alongside the Grimm data over time. Figure 3.8.1-7 is a scatterplot of the Shinyei vs the Grimm.

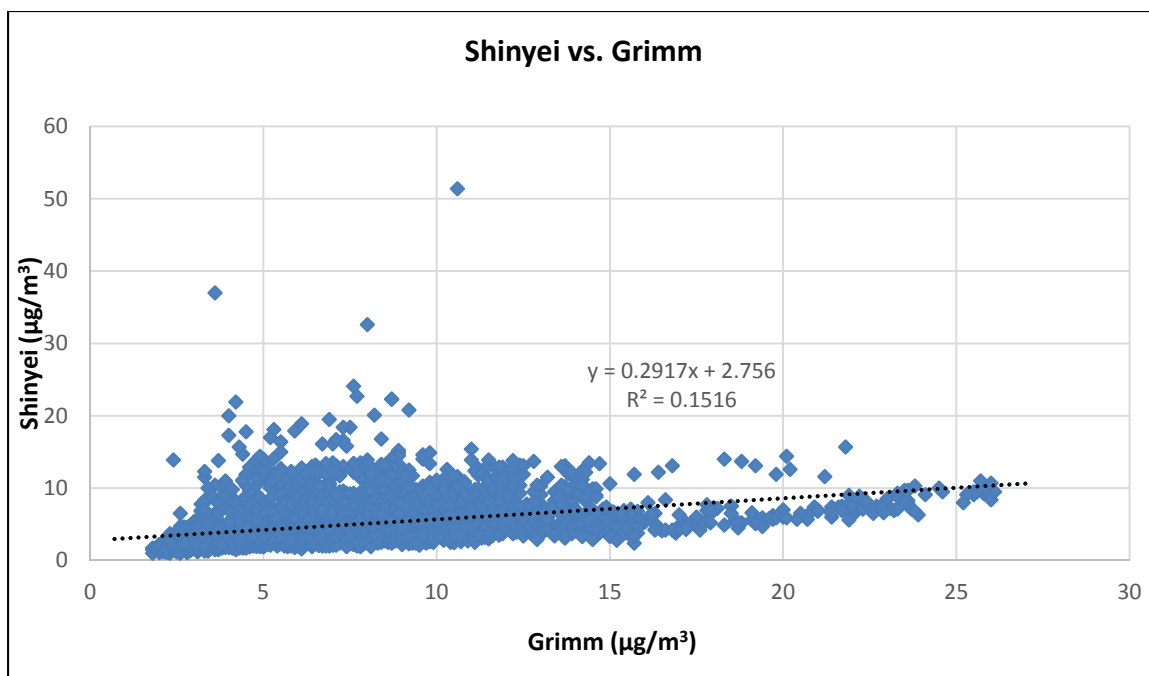
**Figure 3.8.1-7:** Scatterplot of the fully processed Shinyei data vs the Grimm.
