FIRST ANNUAL PROGRESS REPORT ON A STUDY OF
CORROSION IN MUNICIPAL INCINERATORS

BATTELLE COLUMBUS LABORATORIES

JULY 1973

D. A. Vaughan, P. D. Miller, W. K. Boyd,
H. H. Krause, and P. R. Webb

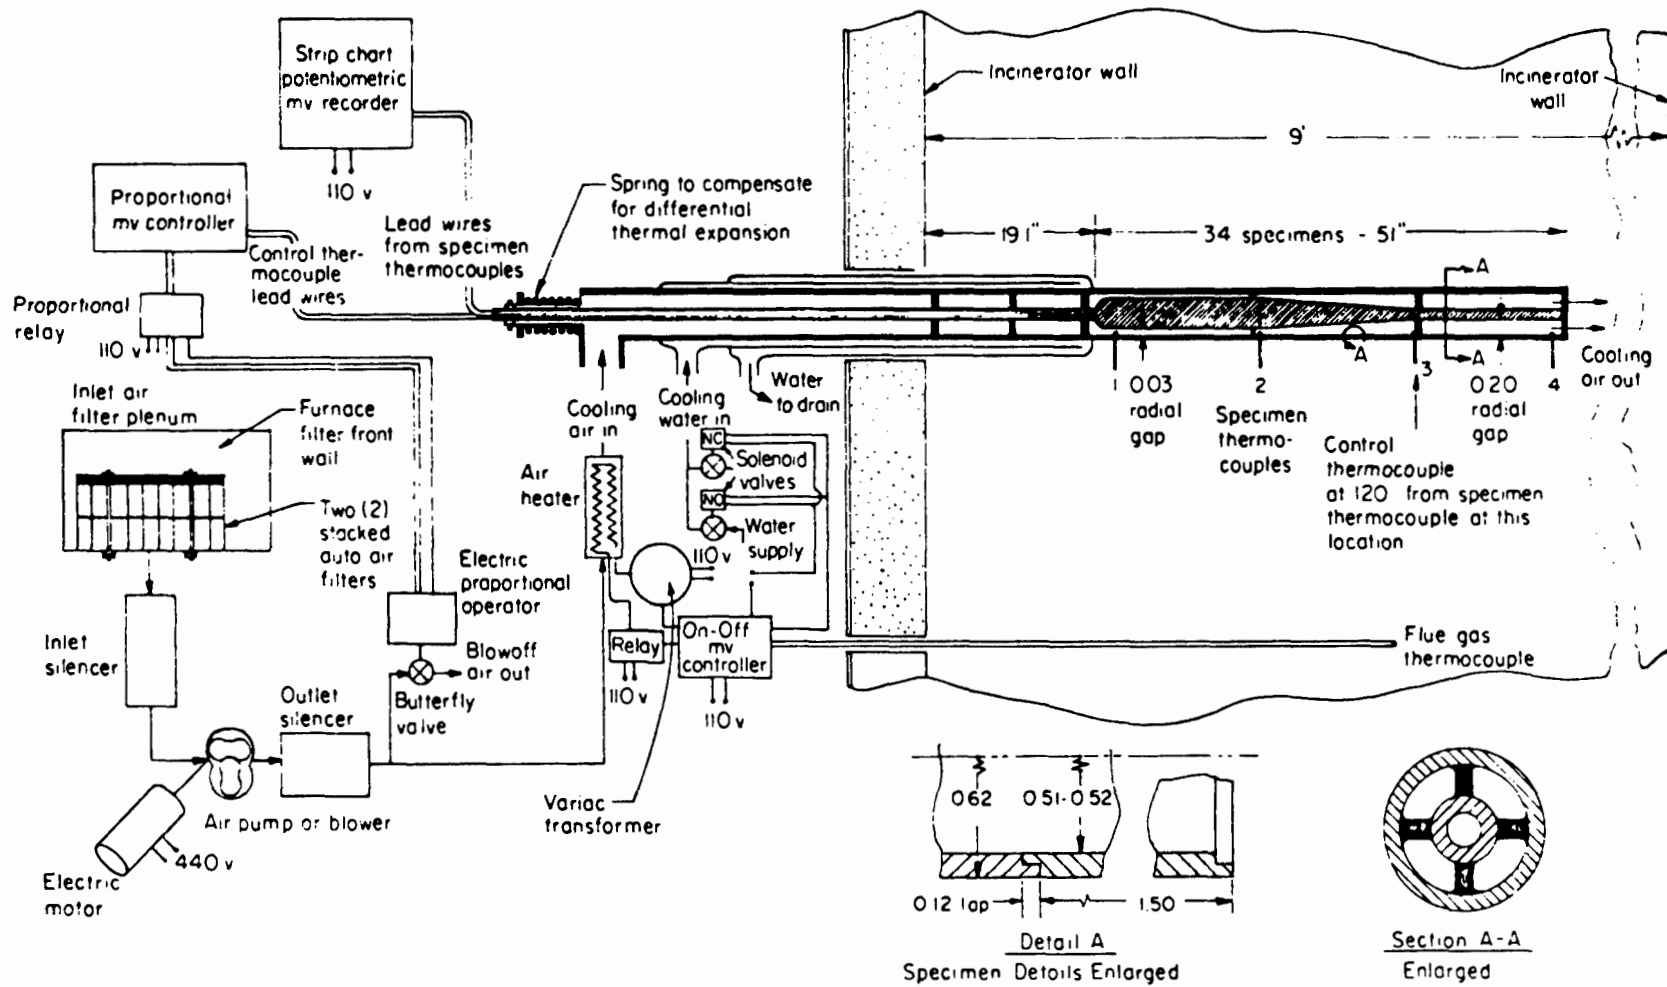
Figure 1 is a schematic of the final exposure-probe apparatus. The specimens are nested together with lap joints as shown in Detail A, and retained axially at the cooling-air-outlet end by a retainer which is fixed to the internal support tube with webs as shown in Section A-A. The axial restraining force in the internal support tube is obtained by compressing the spring on the air-inlet end of the probe at assembly. Also, the spring compensates for differential thermal expansion between the specimens and the internal support tube.

FIGURE 1. SCHEMATIC OF SPECIMEN-EXPOSURE-PROBE APPARATUS

Specimen temperatures are measured at four stations with Type K thermocouples either welded into the wall of the specimens or inserted into recesses drilled lengthwise into one end of the appropriate specimen. The thermocouple lead wires are brought out of the probe through the center of the internal support tube, so that temperatures can be recorded continuously on a strip-chart potentiometer recorder. Since the computed results indicated that the temperature variation is linear for regions with a constant gap between the internal support tube and the specimens, the four temperatures accurately define the specimen temperatures.

The specimen temperatures are controlled by regulating the amount of cooling air admitted to the probe. The output from a control thermocouple, which is attached to the specimen at the same axial location at the Thermocouple 3, is monitored by a proportional temperature controller. At the start of a test, the controller maintains this temperature by varying the amount of cooling air bypassing the probe through a motorized butterfly valve located between the blower and

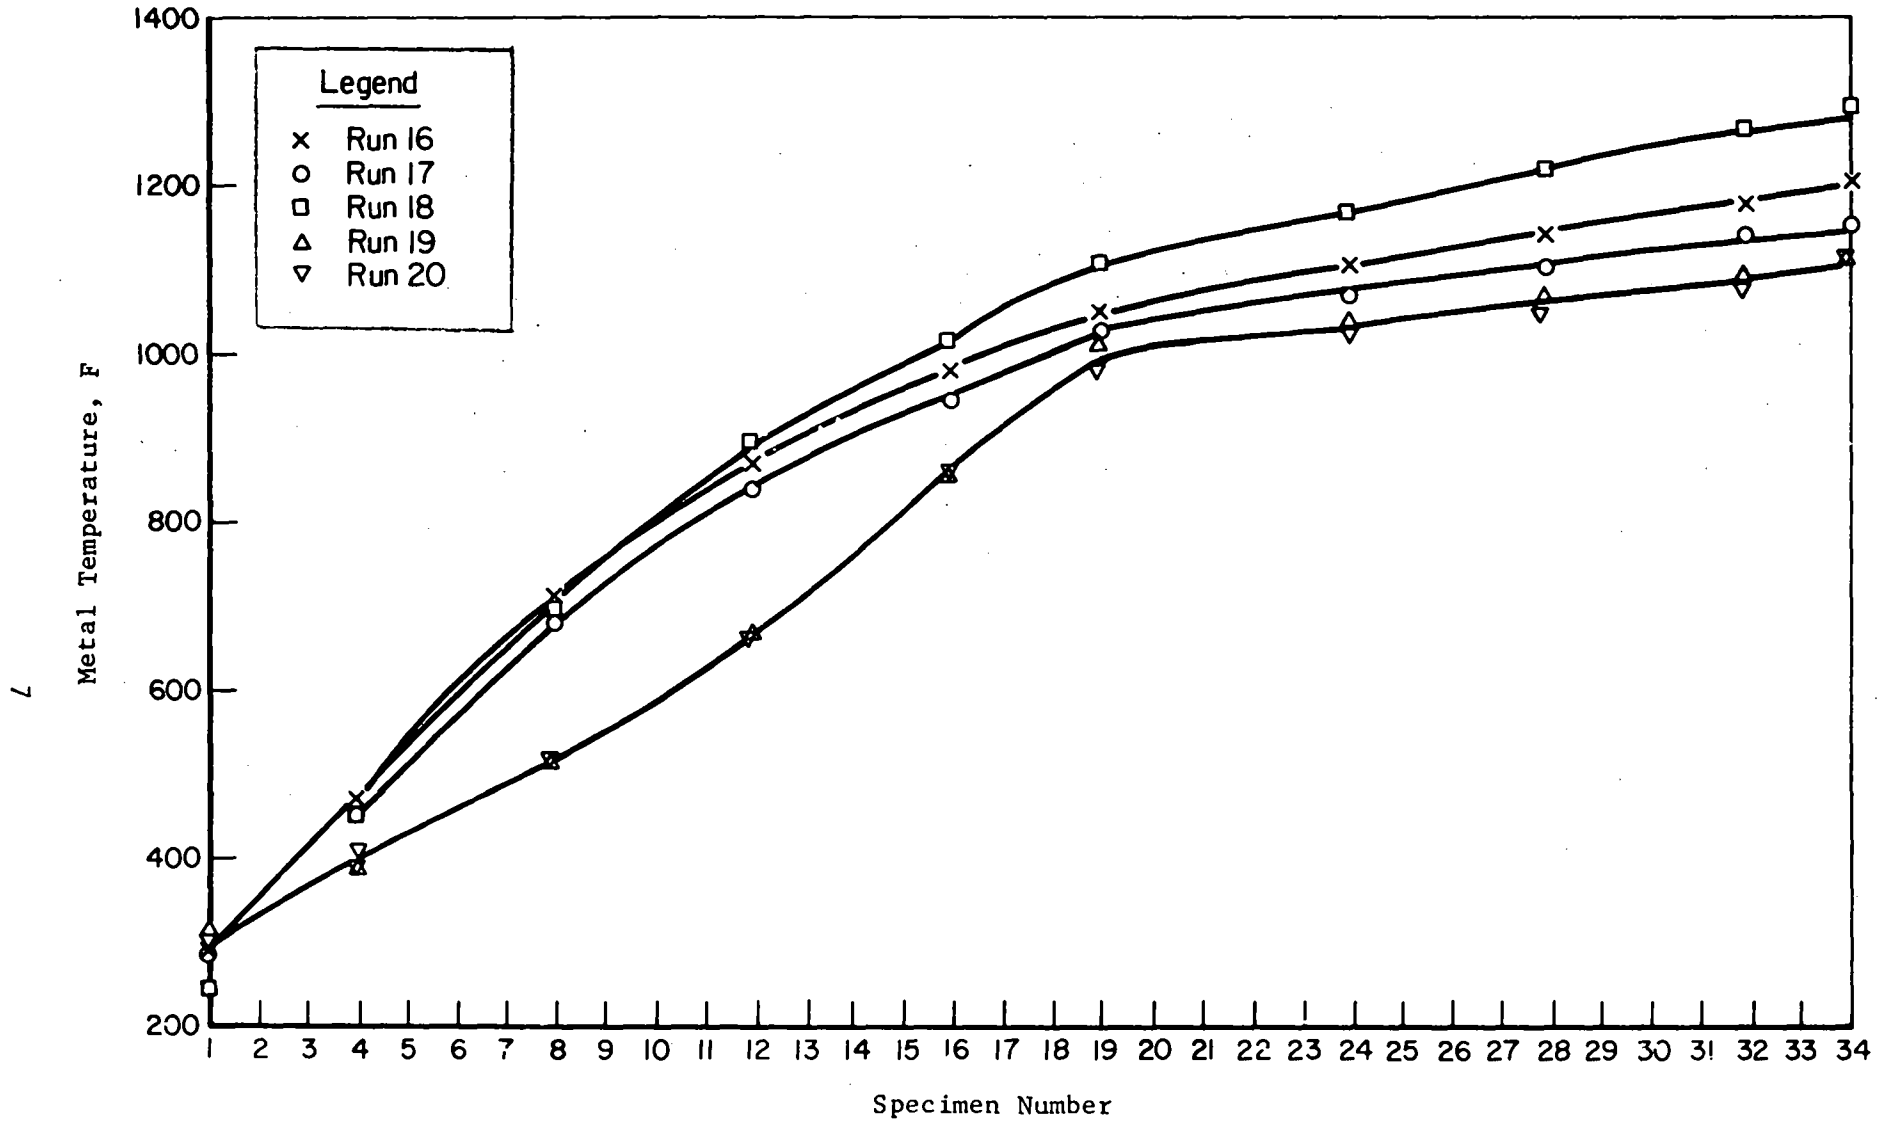
As indicated in Figure 2, the specimen temperatures varied somewhat from one experiment to another and these differences must be considered in evaluating the effect of the PVC addition on the corrosion behavior. This variation is in part a result of incinerator operation and in part the capacity of the pump used for the cooling air, the amount of which was controlled by a thermocouple on Specimen 19 of each probe. The incinerator gas temperature variation as tabulated below is determined by the type of refuse and to some extent by operator choice. Two portholes in the Miami County Incinerator, Figure 3, were employed to obtain a temperature differential of 150 F during Run 19/20.

FIGURE 2. TEMPERATURE VERSUS SPECIMEN NUMBER FOR FIVE EXPERIMENTS

The temperatures of corresponding specimens for Probes 19 and 20 were held to within about 50 F, but the first 20 specimens were at as much as 200 F lower temperature than the other probes. In the case of Probe 18, the temperatures of Specimens 16-34 were significantly (80 - 100 F) higher than those for other probe runs. These higher specimen temperatures resulted from the higher gas temperatures in the incinerator for this experiment. Probes 19 and 20 were exposed simultaneously at positions having 150 F difference in gas temperature to evaluate this effect on the corrosion rate.

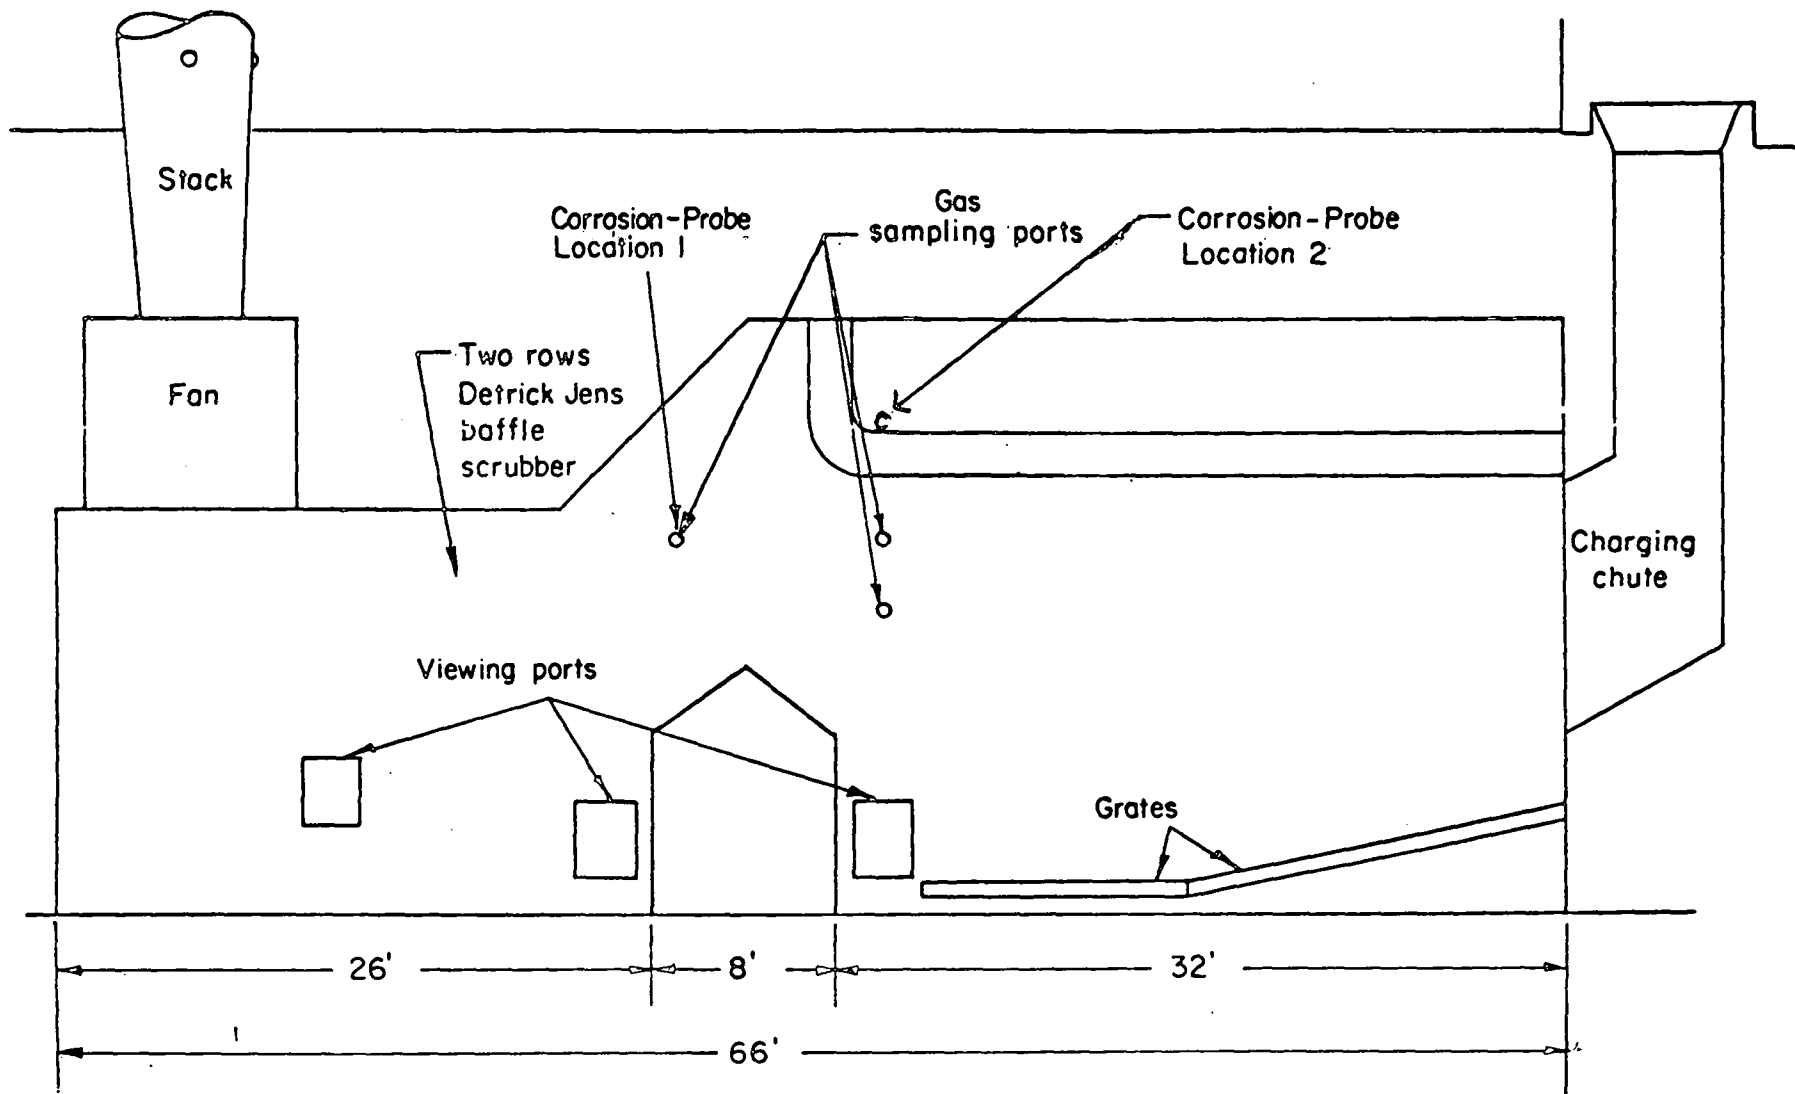
FIGURE 3. SKETCH OF MIAMI INCINERATOR

Scale: 1/8 inch = 1 foot.

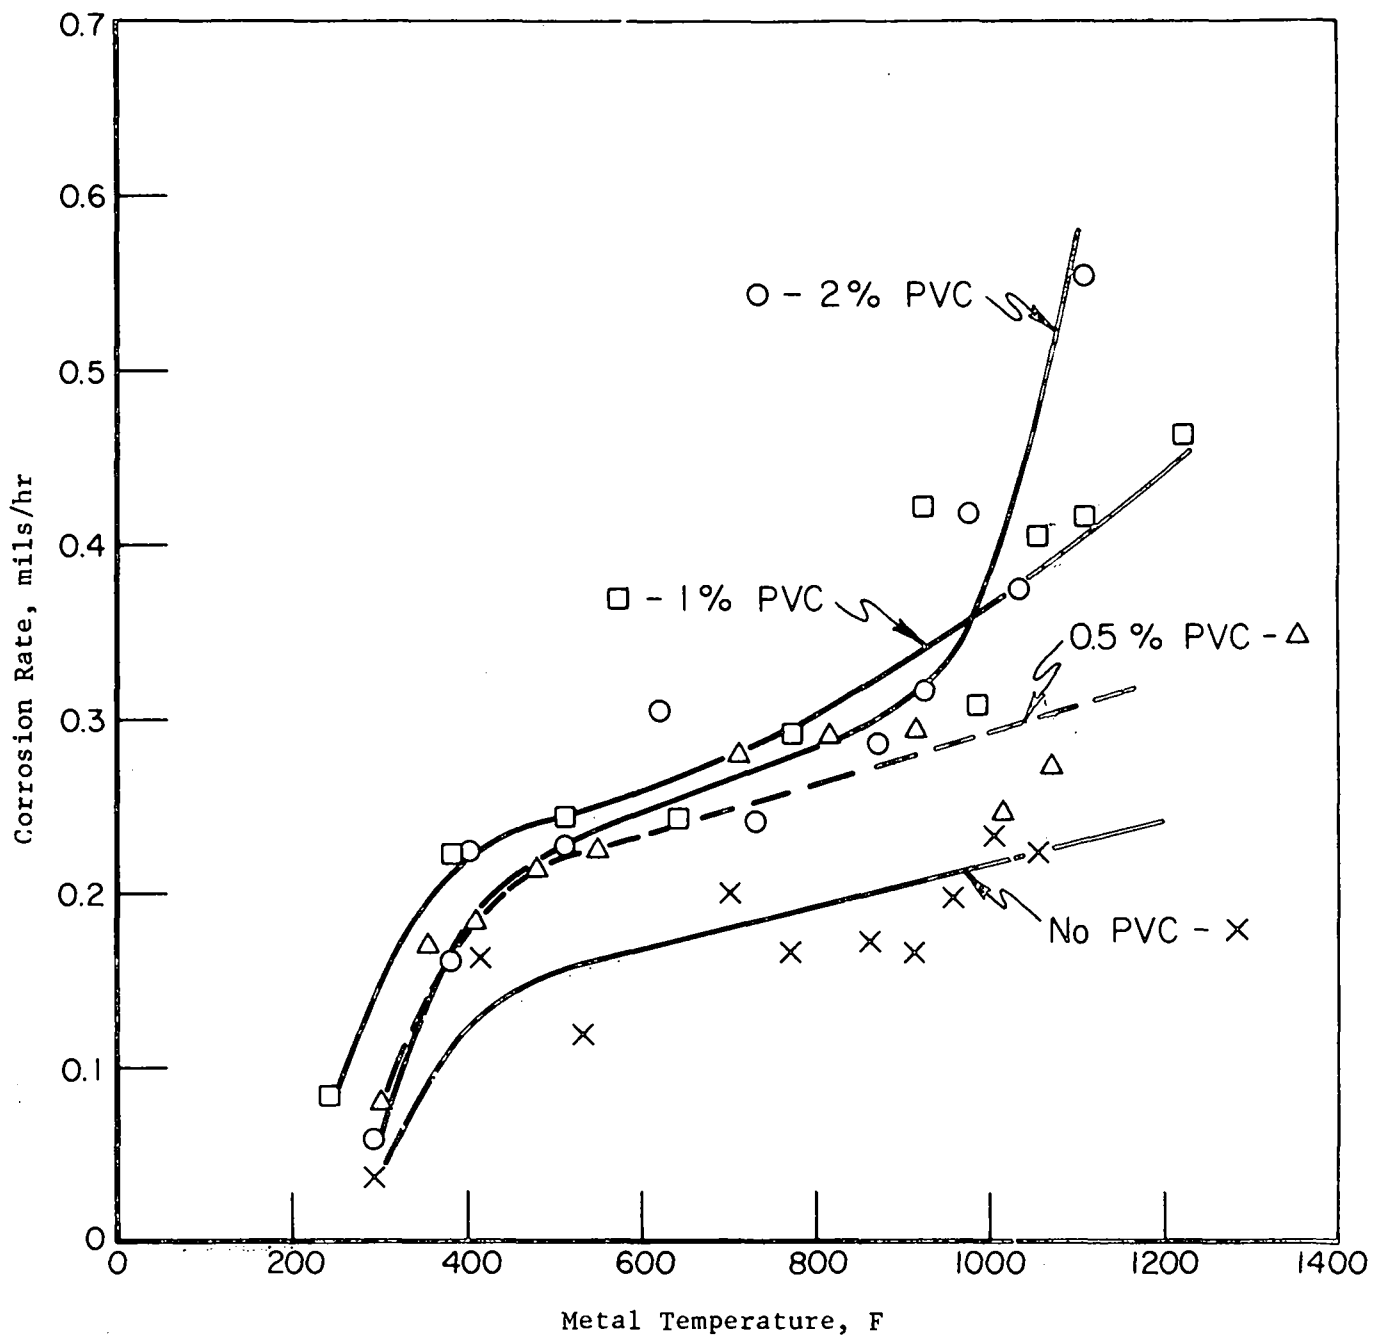
The effect of temperature on the corrosion rate of the A106 and T11 steels when exposed to hot gases resulting from incineration of refuse to which 0-2 percent PVC was added are shown in Figures 4 and 5, plots of corrosion rate versus temperature for the various amounts of PVC added to the refuse. These data show a significant increase in the corrosion rates of the low-alloy steels with temperature and with the addition of PVC to the refuse. However, the increase in corrosion rate for these steels is not proportional to the amount of PVC added except for specimens allowed to heat to above 1000 F for which the corrosion rate increases linearly with PVC addition. This observation is shown graphically in Figures 6 and 7, plots of isothermal corrosion rate versus the amount of PVC added to the refuse. The addition of even 1/2 percent PVC to the refuse increases the corrosion rate of specimens, held at temperatures between 300 F and 900 F by nearly as much as does the addition of 1 or 2 percent PVC. In this range of specimen temperatures, the addition of 1 percent PVC increased

FIGURE 4. CORROSION RATE OF A106 STEEL VERSUS TEMPERATURE FOR DIFFERENT PVC LOADS.

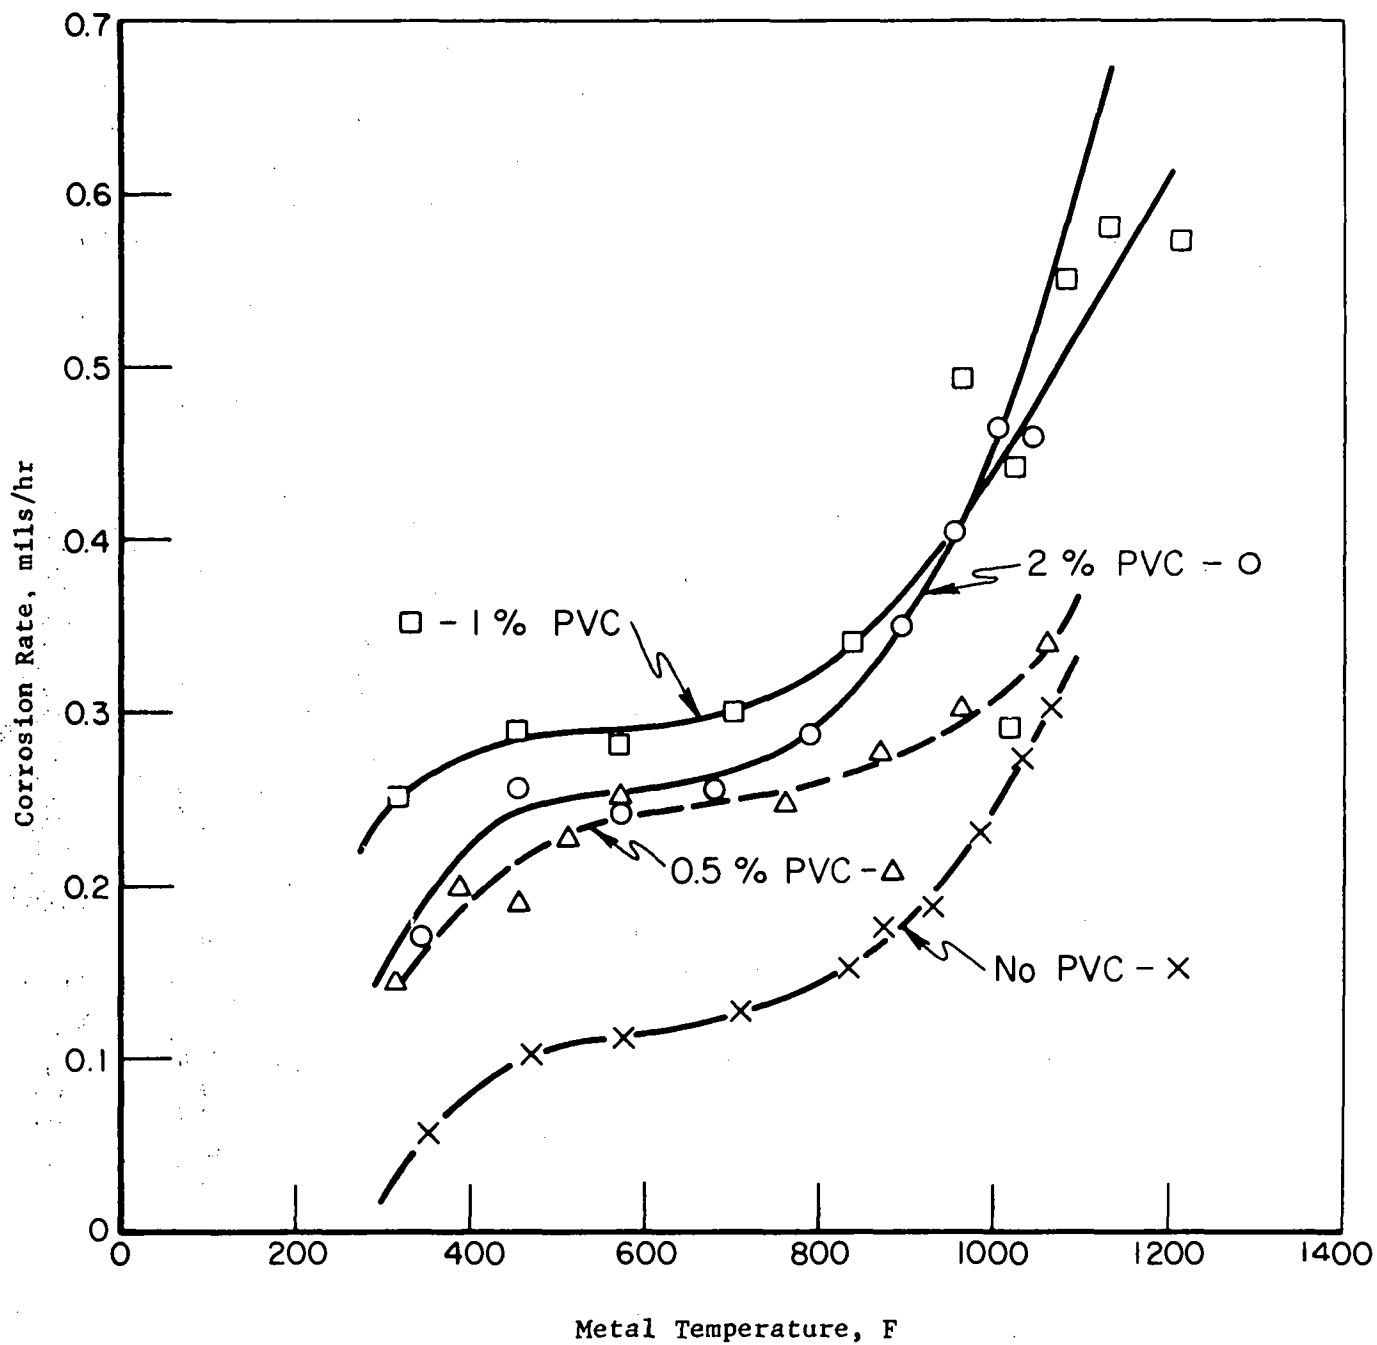
FIGURE 5. CORROSION RATES OF T11 STEEL AS A FUNCTION OF SPECIMEN TEMPERATURE FOR DIFFERENT PVC LOADS

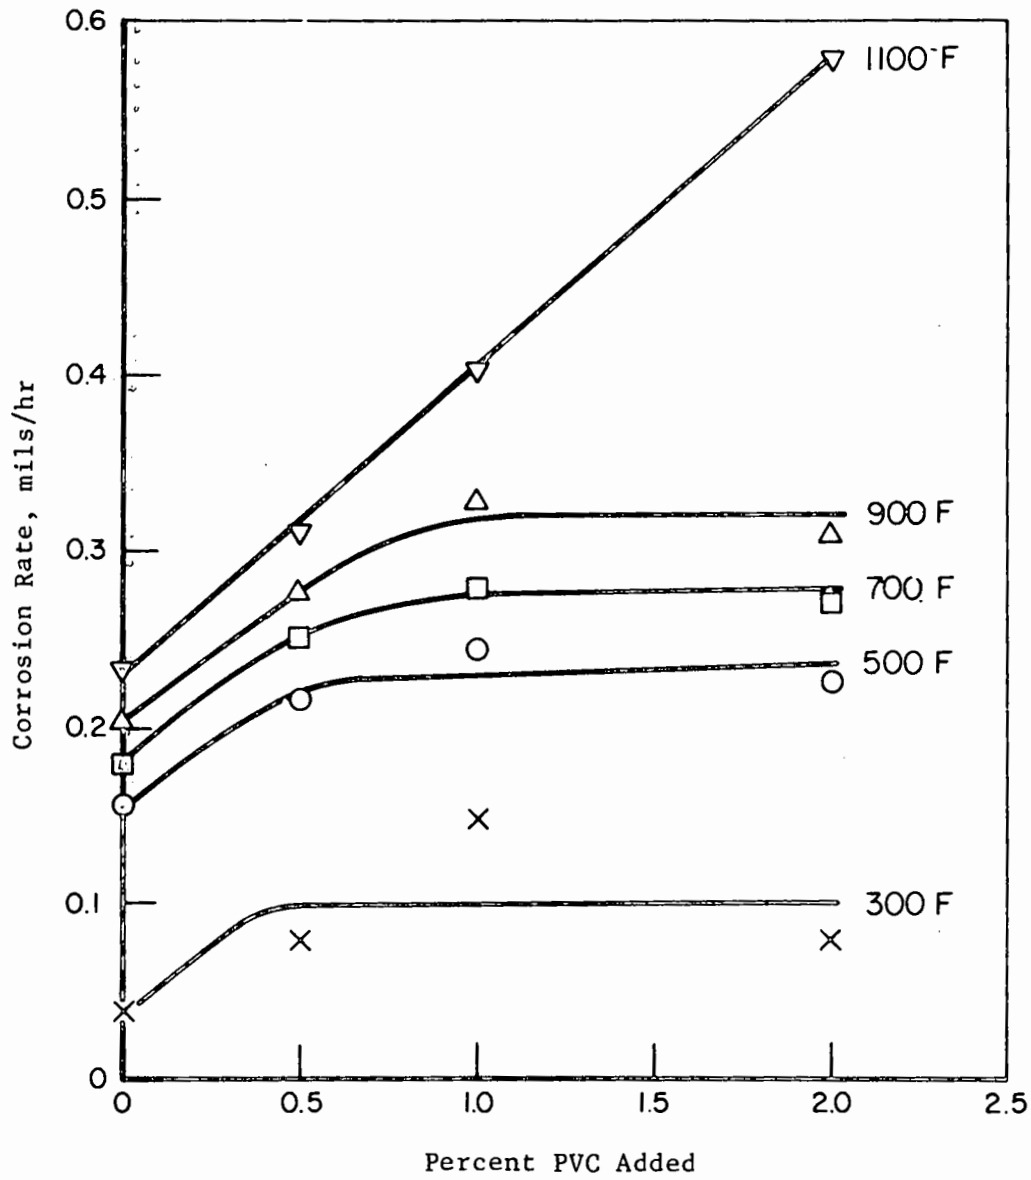
FIGURE 6. CORROSION RATE OF A106 STEEL AT VARIOUS TEMPERATURES VERSUS PERCENT PVC ADDED TO REFUSE

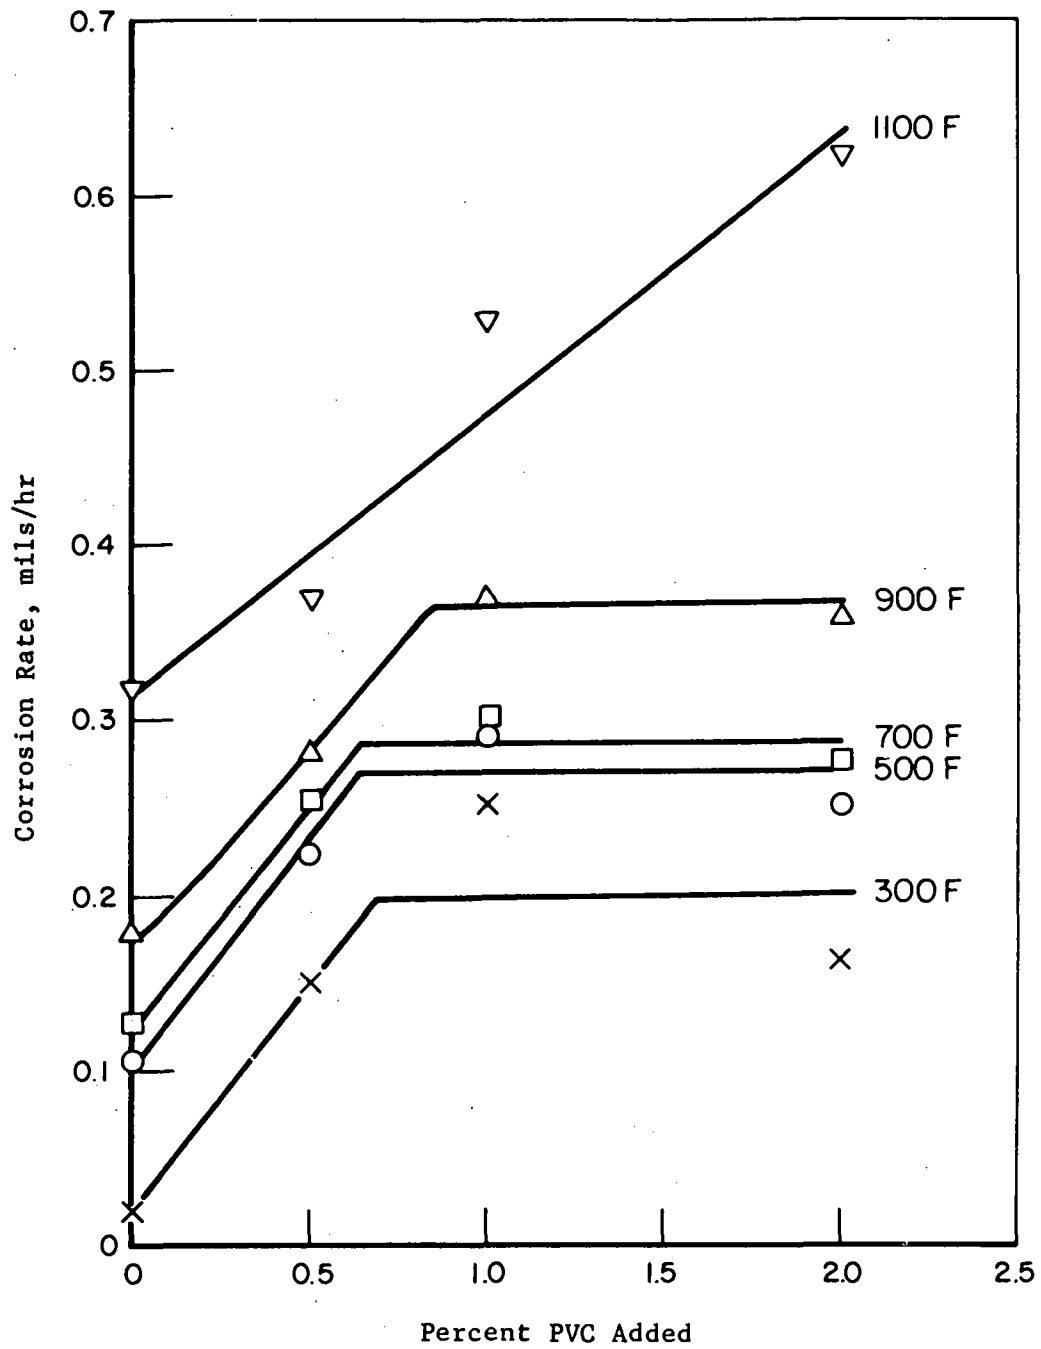
FIGURE 7. CORROSION RATE OF T11 STEEL AT VARIOUS TEMPERATURES VERSUS PERCENT PVC ADDED TO REFUSE

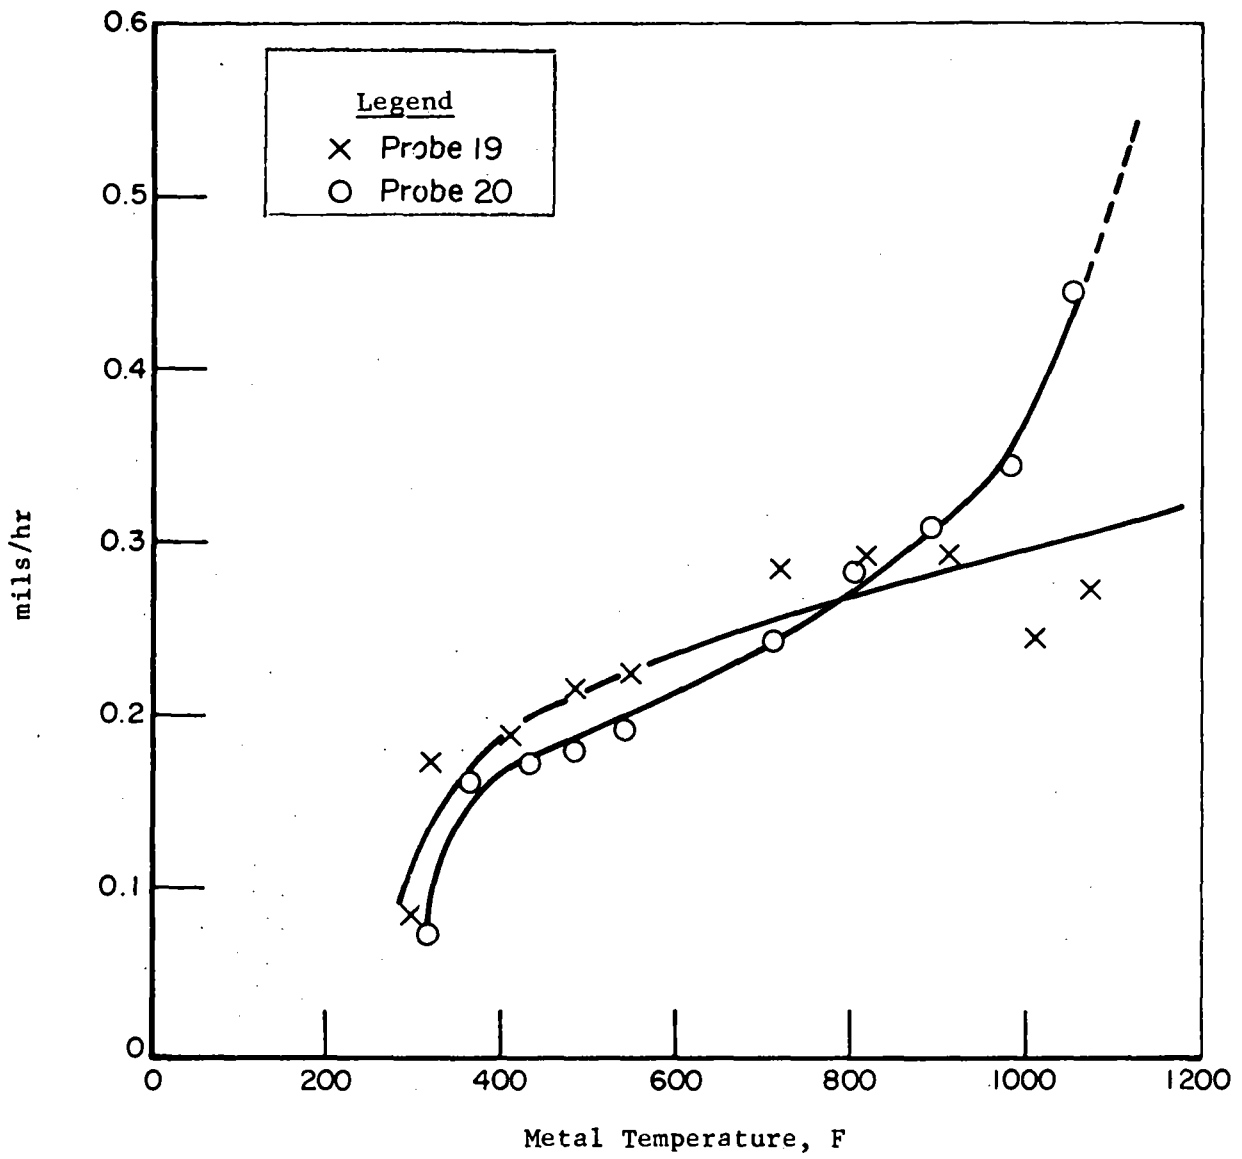
An evaluation of these variables was made during the run with Probes 19 and 20, the results of which are shown in Figures 8 and 9. The major effect of incinerator gas temperature, which was 1400 F for Probe 19 and 1550 F for Probe 20, on corrosion rate was found to occur with specimens whose temperature exceeded 800 F. The 150 F hotter gas caused a marked increase in corrosion rate and the difference increased with increasing specimen temperature for both the Al06 and the T11 steel. This increase in corrosion rate, because of the hotter incinerator gas, was observed also for the stainless steels as described in the next section. It is evident from Figure 9 that preoxidizing had no significant effect on the corrosion rate of the T11 steel specimens on Probes 19 or 20.

FIGURE 8. EFFECT OF GAS TEMPERATURE ON CORROSION RATE OF A106 STEEL

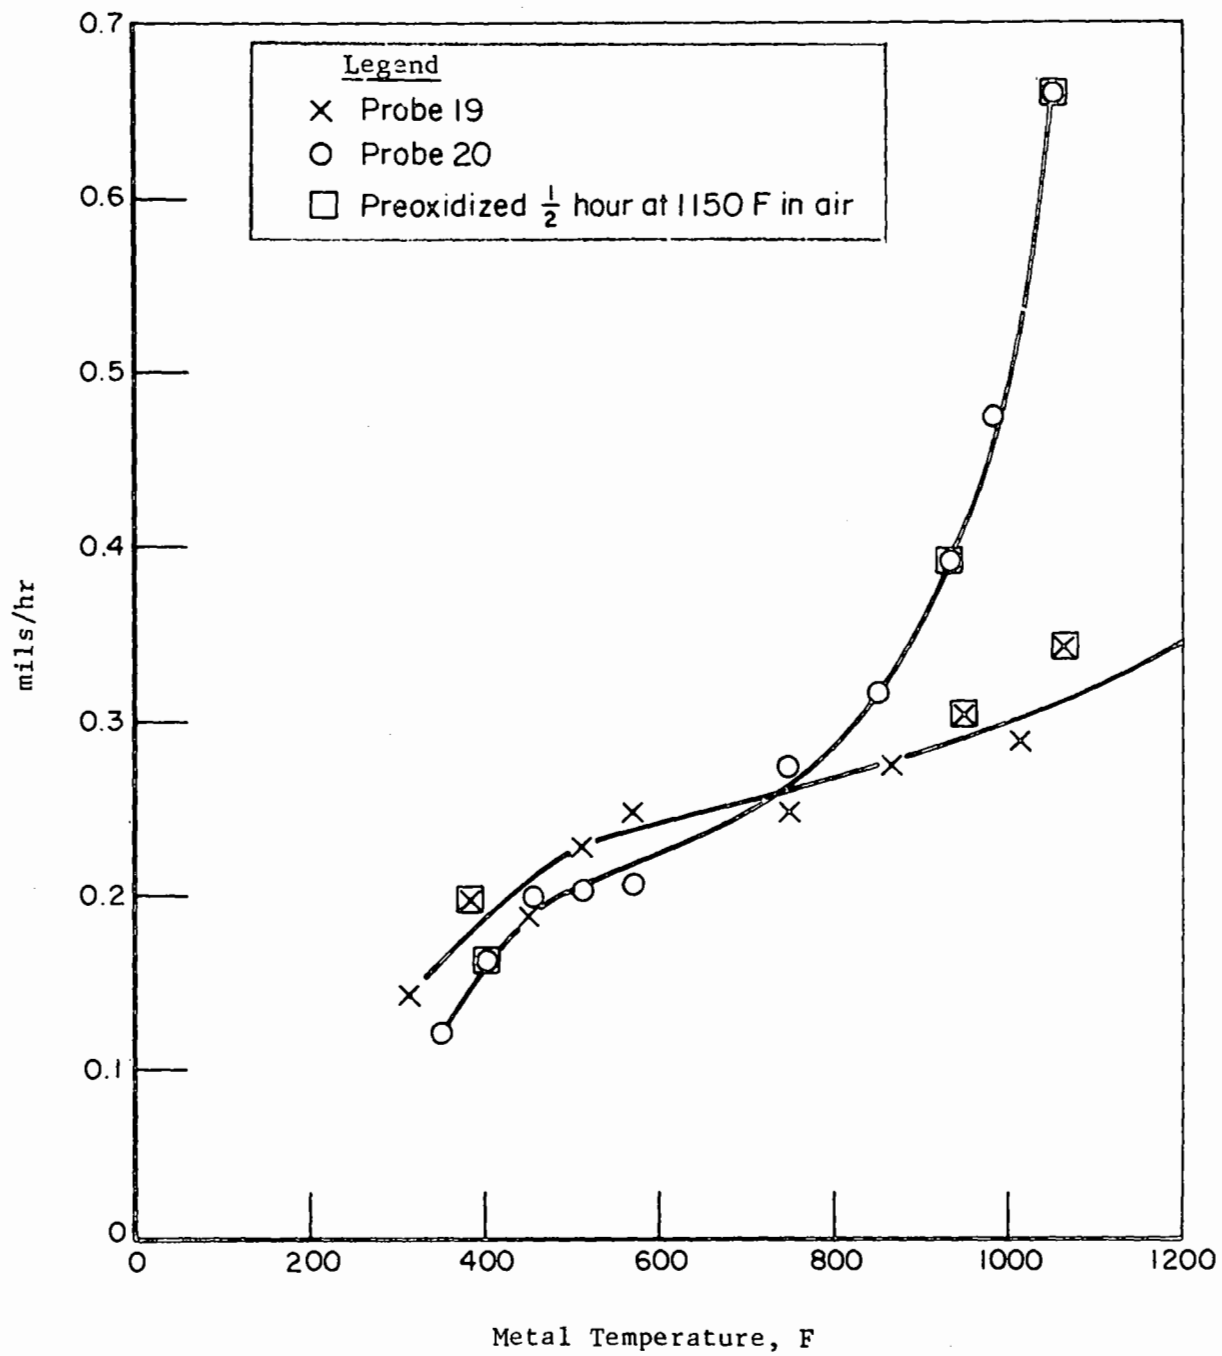
FIGURE 9. EFFECT OF GAS TEMPERATURE ON CORROSION RATE OF T11 STEEL

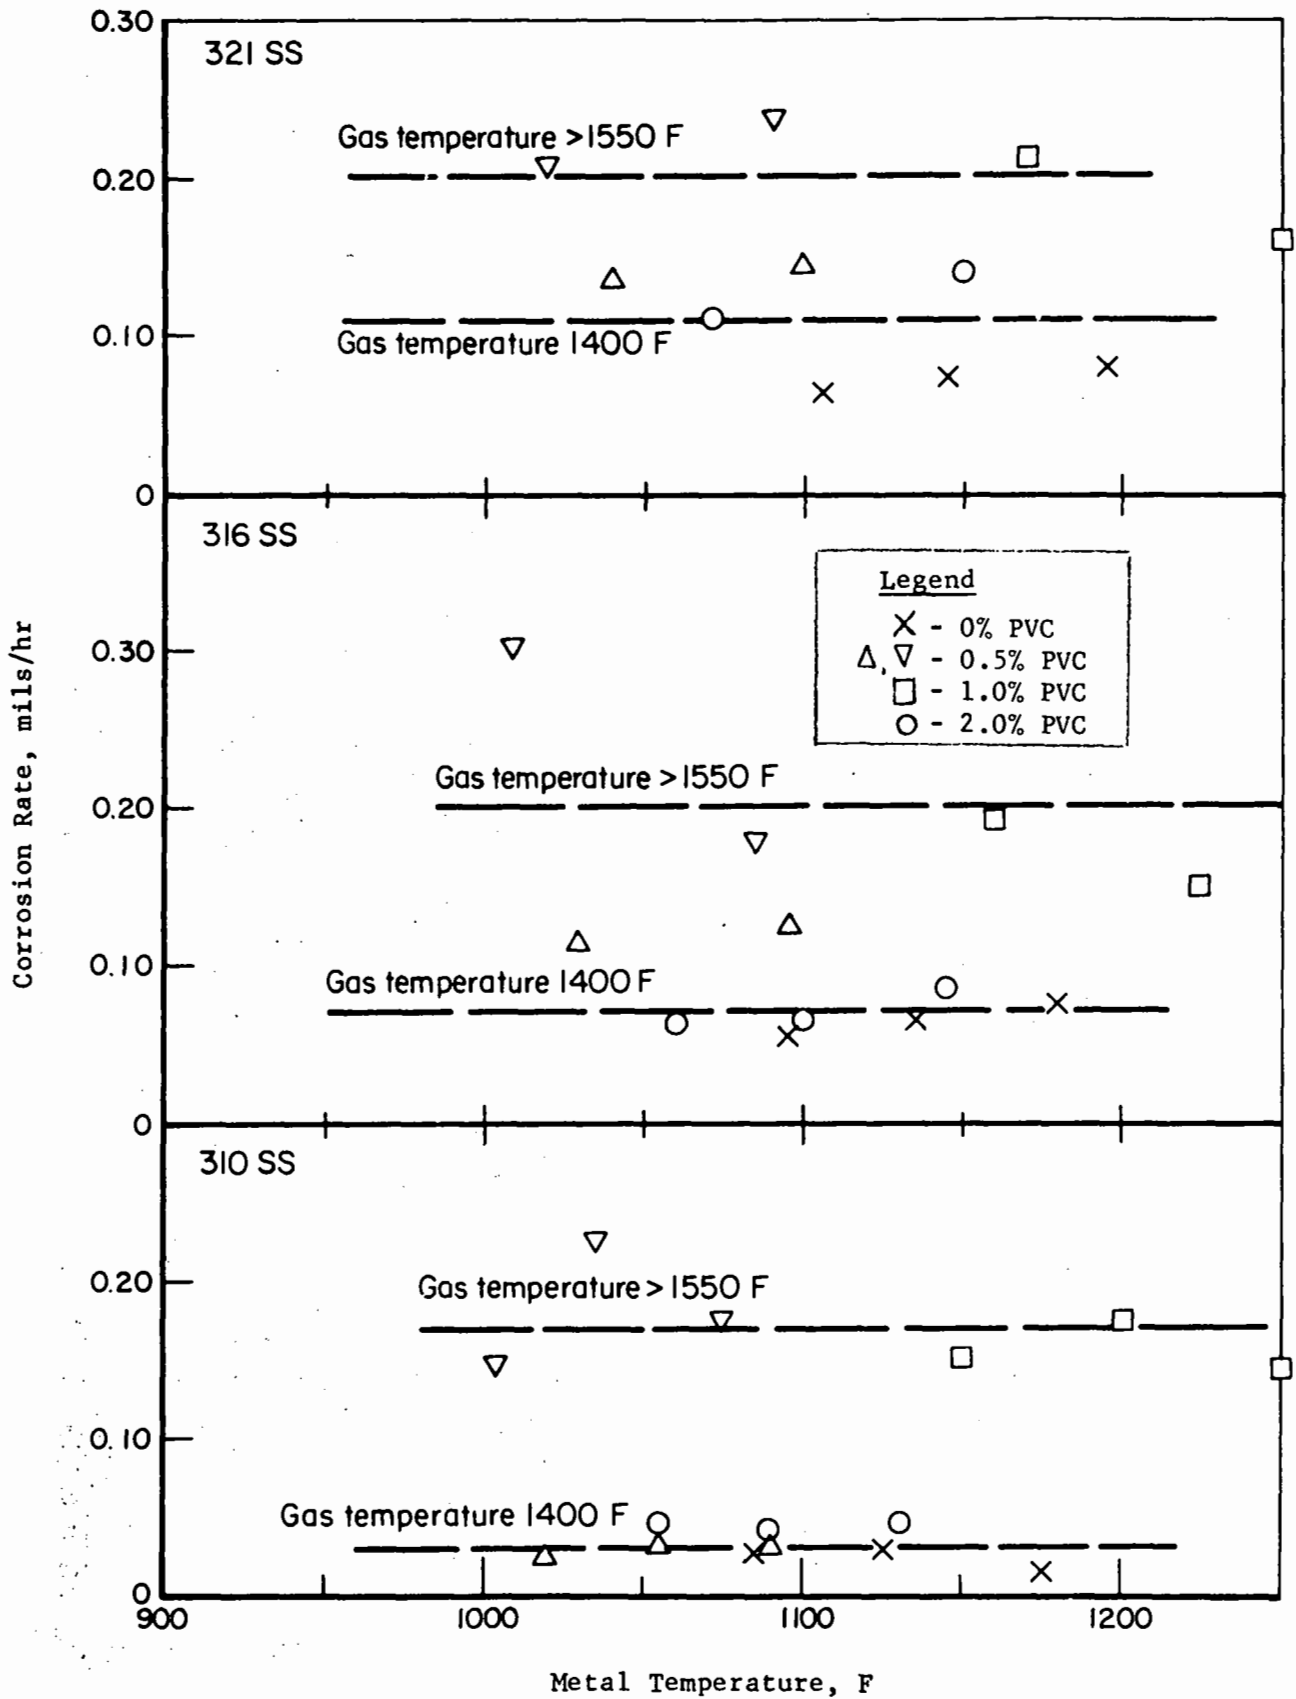
FIGURE 10. CORROSION RATE OF ALLOY INDICATED VERSUS TEMPERATURE

The major mode of attack is intergranular with some pitting corrosion and grain fallout which produces a grainy (sugar-like) surface. Preoxidation of Alloys 446 and 825 for 1/2 hour in air at 1150 F did not significantly alter the mode or the extent of attack, see Figure 11. Furthermore, no systematic differences in corrosion rates of the high alloy steels were observed that could be related to the amount of PVC added to the refuse. If the heat transfer tubes are located in an incinerator gas whose temperature does not exceed 1400 F, the corrosion rate of the stainless steels would be expected to be 1/6 to 1/10 that of the low-alloy steels depending upon metal temperatures maintained. The high-alloy steels do not suffer as severe a loss in corrosion resistance with increasing metal temperature as is observed with the low alloy steels. However, all steels investigated are very sensitive to incinerator gas temperature when the specimen temperature exceeds 800 F.

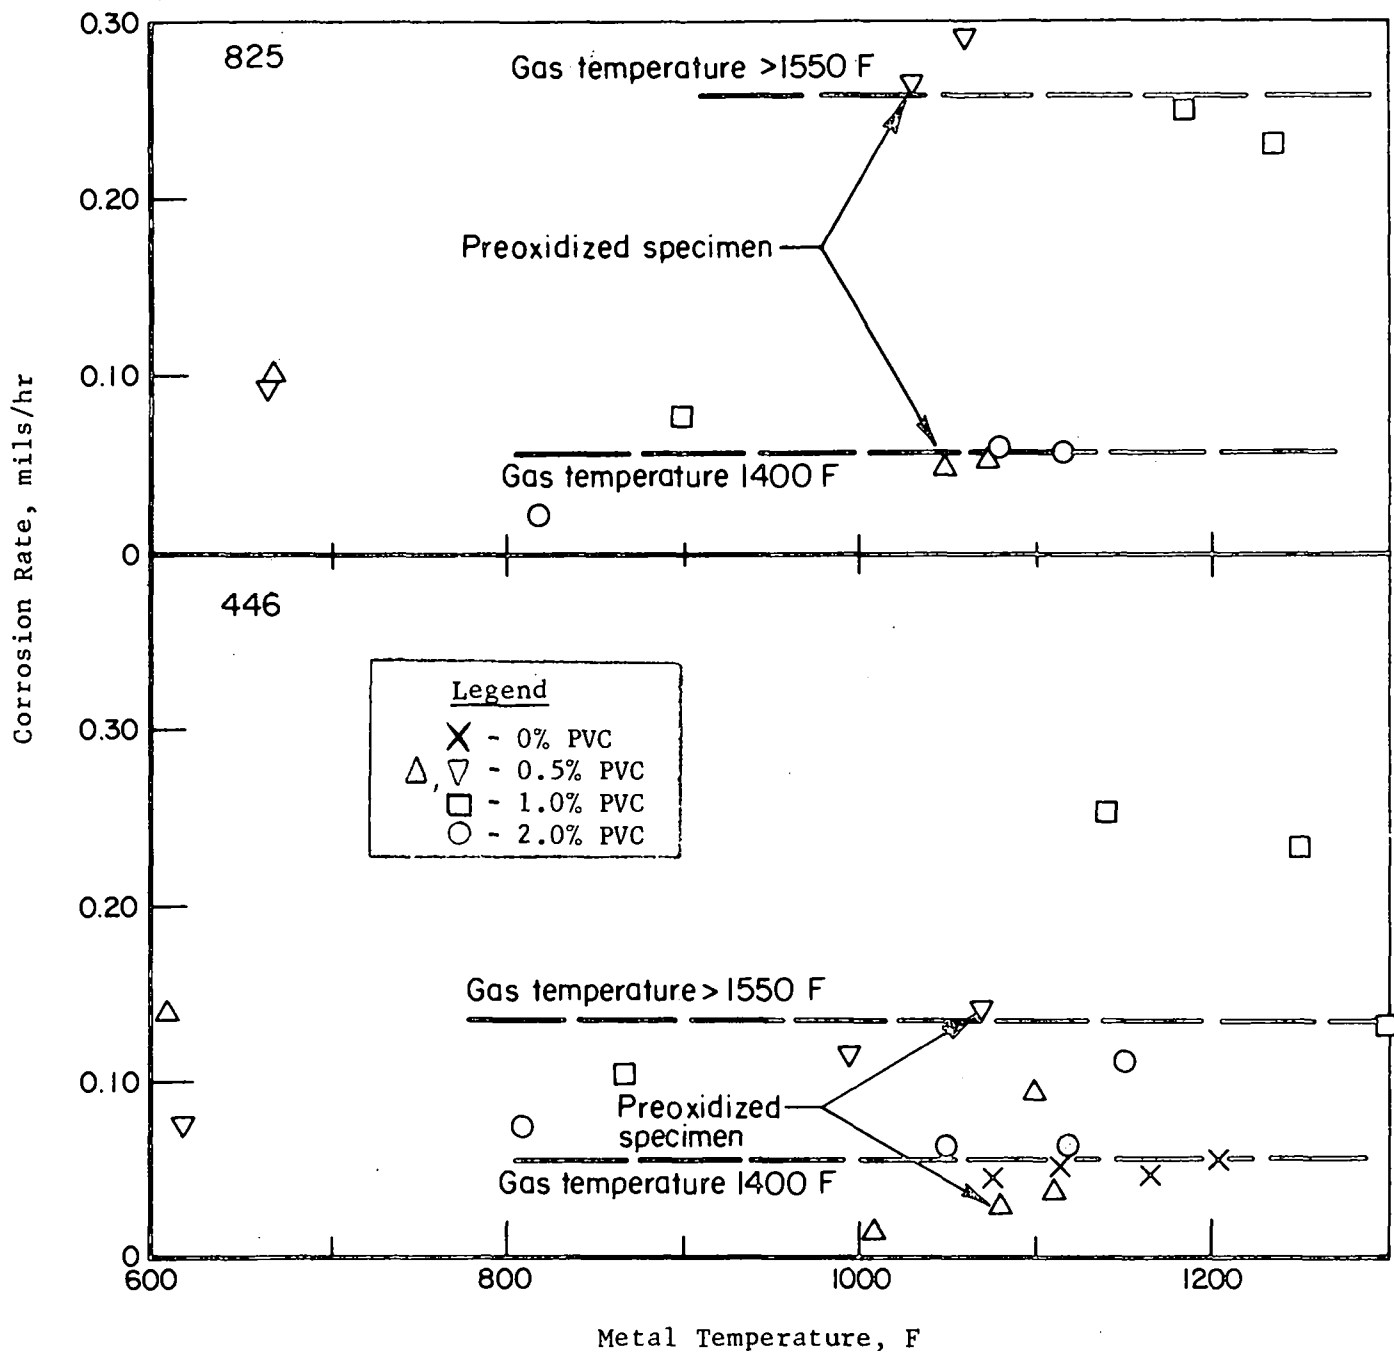
FIGURE 11. CORROSION RATE OF ALLOYS INDICATED VERSUS TEMPERATURE

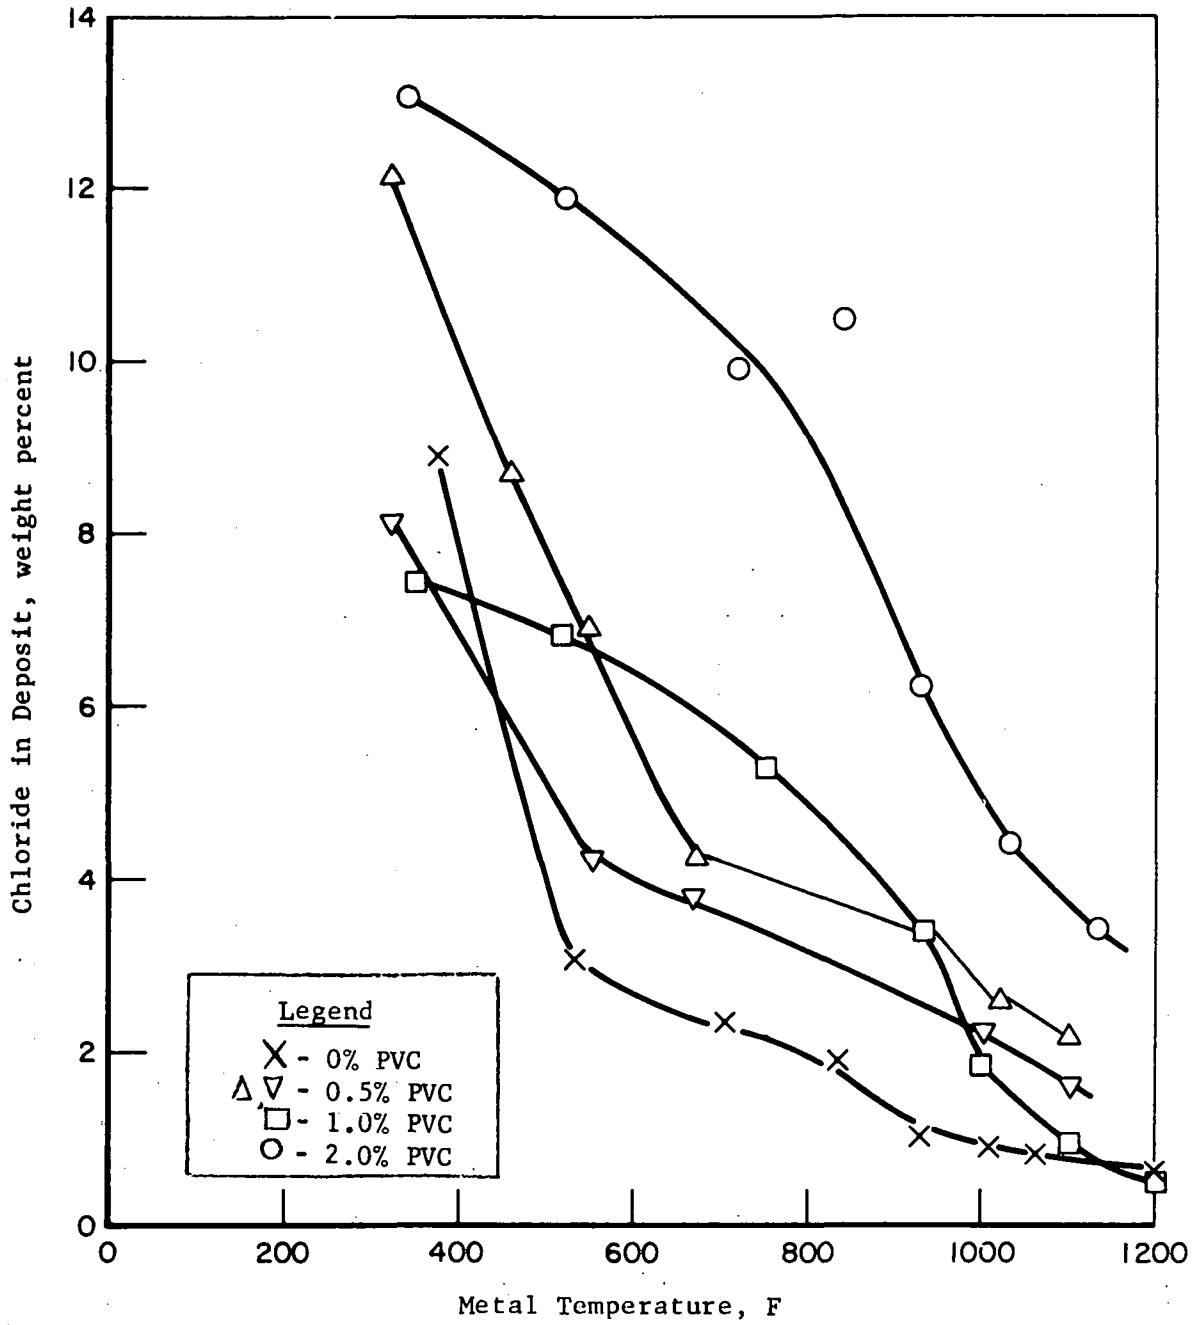
FIGURE 12. CHLORIDE CONCENTRATION IN DEPOSIT ON PROBES VERSUS METAL TEMPERATURE

The data presented in Table 4 illustrate large hourly as well as daily variations in nearly all of the components of the incinerator gas. Although the average HCl contents from the two samplings of the gas for Runs 17 and 18 and the amount obtained in the all-day collection of Run 19/20 are higher than for Run 16, they do not appear to be in proportion to the amount of PVC added to the refuse. On the other hand, the chloride content in the deposits on the corrosion probes do vary with the amount of the PVC addition to the refuse (see Figures 12 and 13). Thus, it would appear that a
