# Field Demonstration of Innovative Condition Assessment Technologies for Water Mains: Leak Detection and Location

**FIELD DEMONSTRATION OF INNOVATIVE CONDITION ASSESSMENT TECHNOLOGIES  
FOR WATER MAINS: LEAK DETECTION AND LOCATION**

**Bruce Nestleroth, Stephanie Flamberg, Wendy Condit, and John Matthews  
Battelle**

**March 2012**

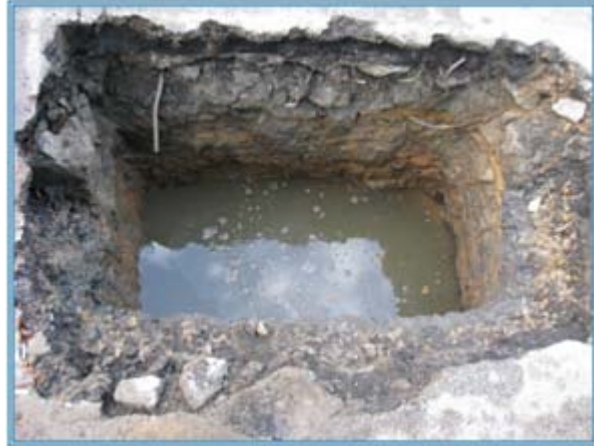
PipeSpy locating a simulated leak at Pit 4
